**SECTION 022000
ASSESSMENT**

December 9, 2022

Re: Asbestos Containing Material Survey
Skyhawk Hall, FLC
1000 Rim Drive
Durango CO, 81301

FORT LEWIS COLLEGE
SKYHAWK HALL

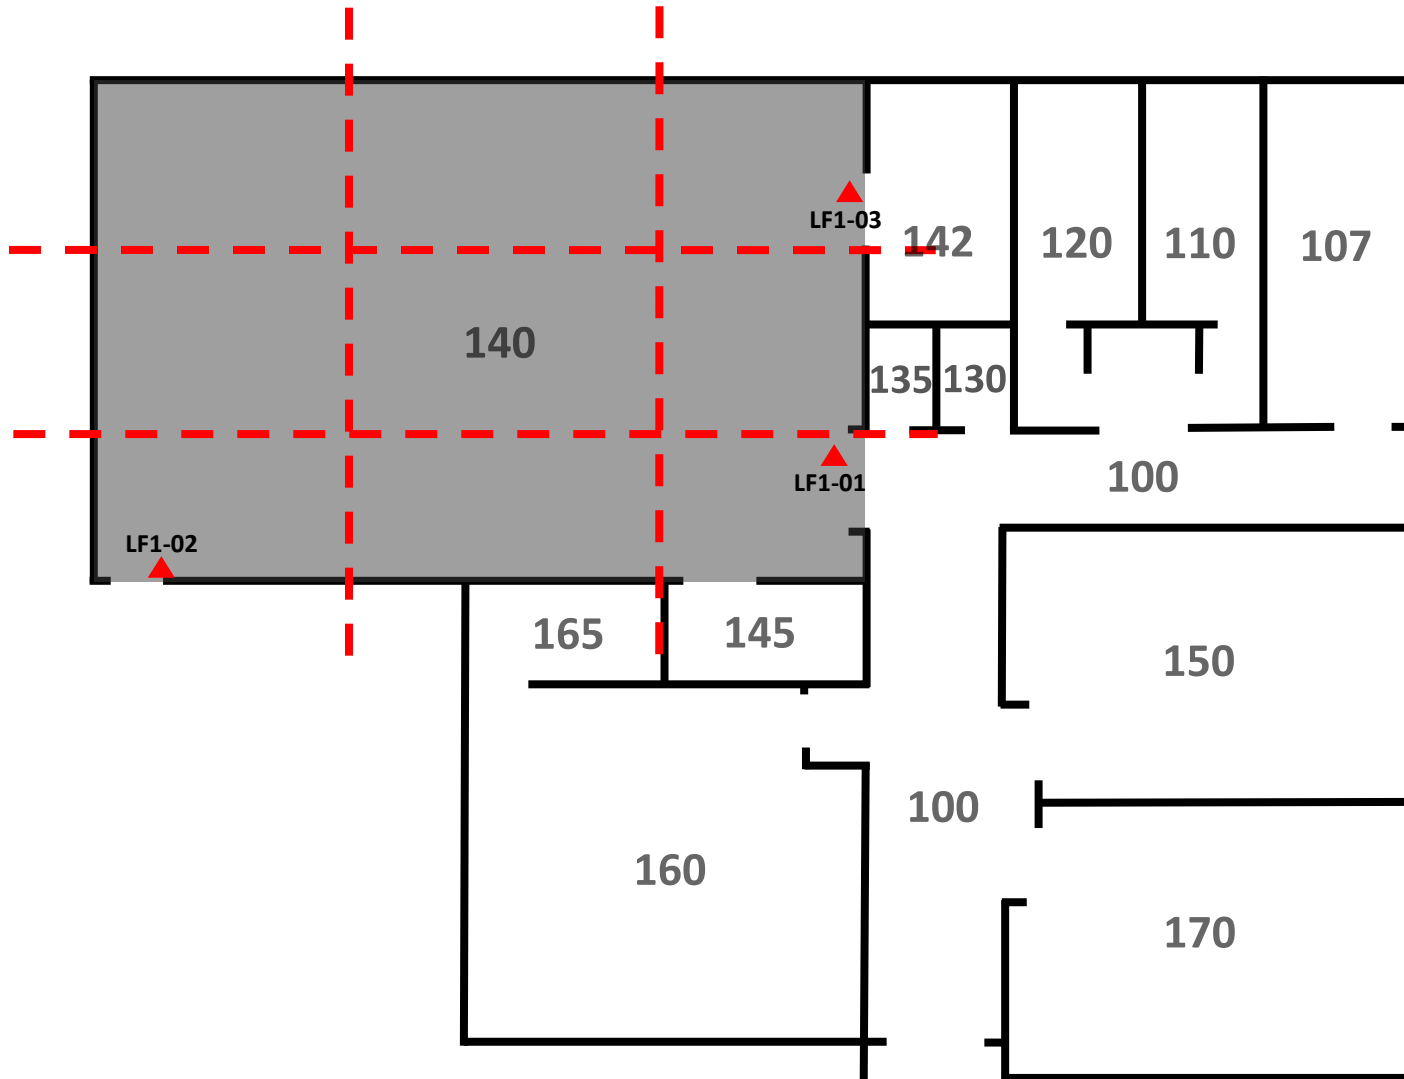
Random sampling diagram #1

LF1 – Fake wood pattern linoleum + tan brittle mastic
~ 1510 SF

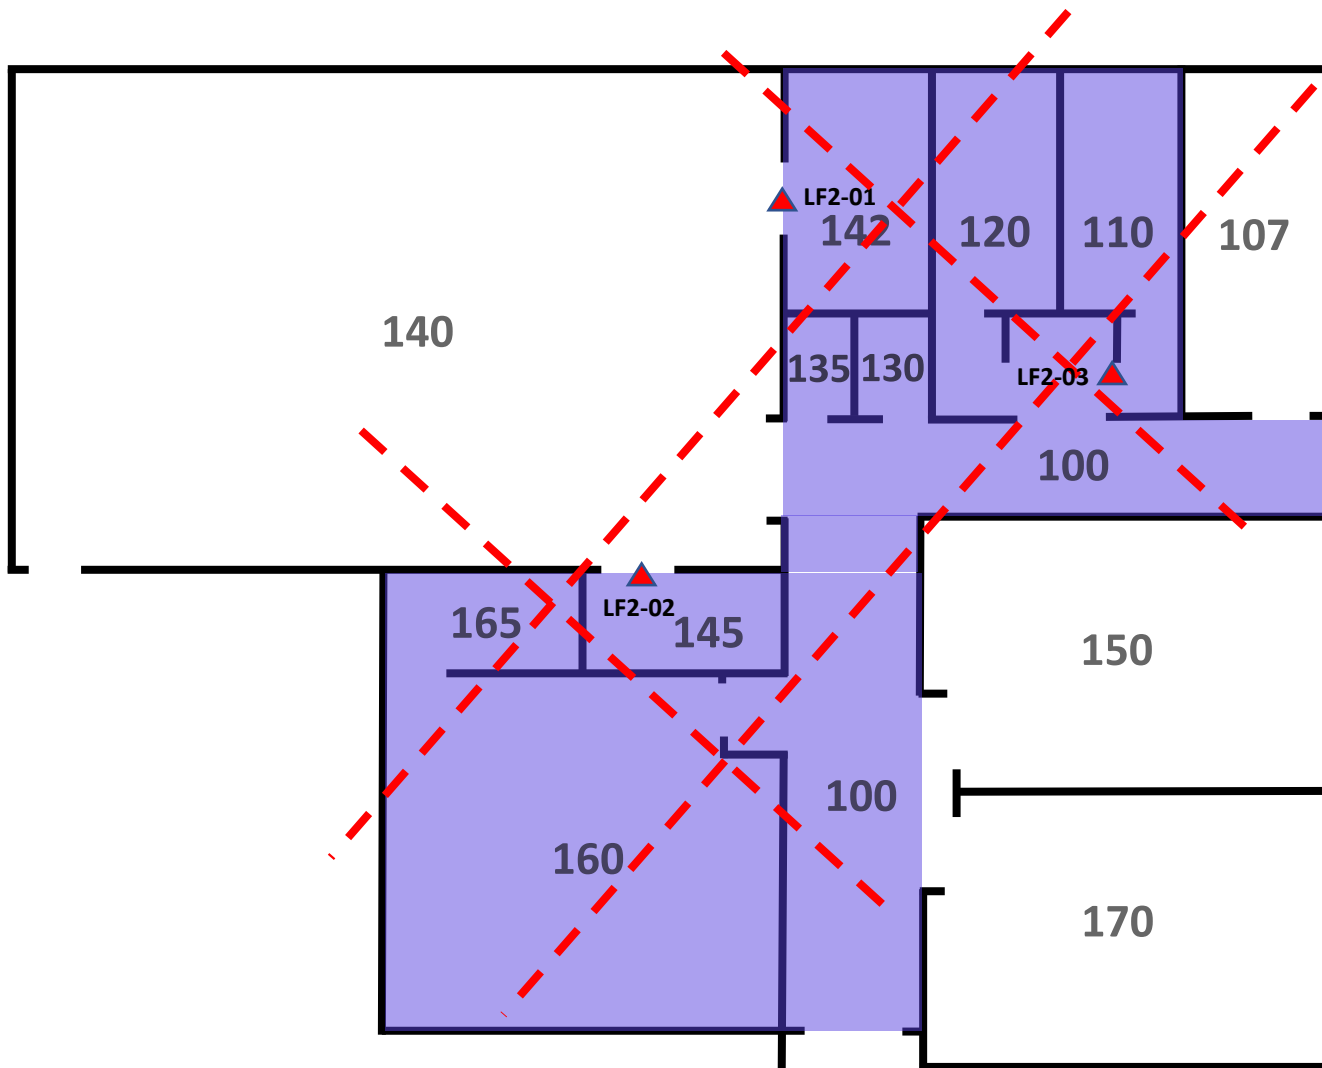
Random sampling diagram #2

LF2 – 12"x12" white linoleum tile w/ blue streaks with yellowish, dry crumbly mastic ~ 1950 SF

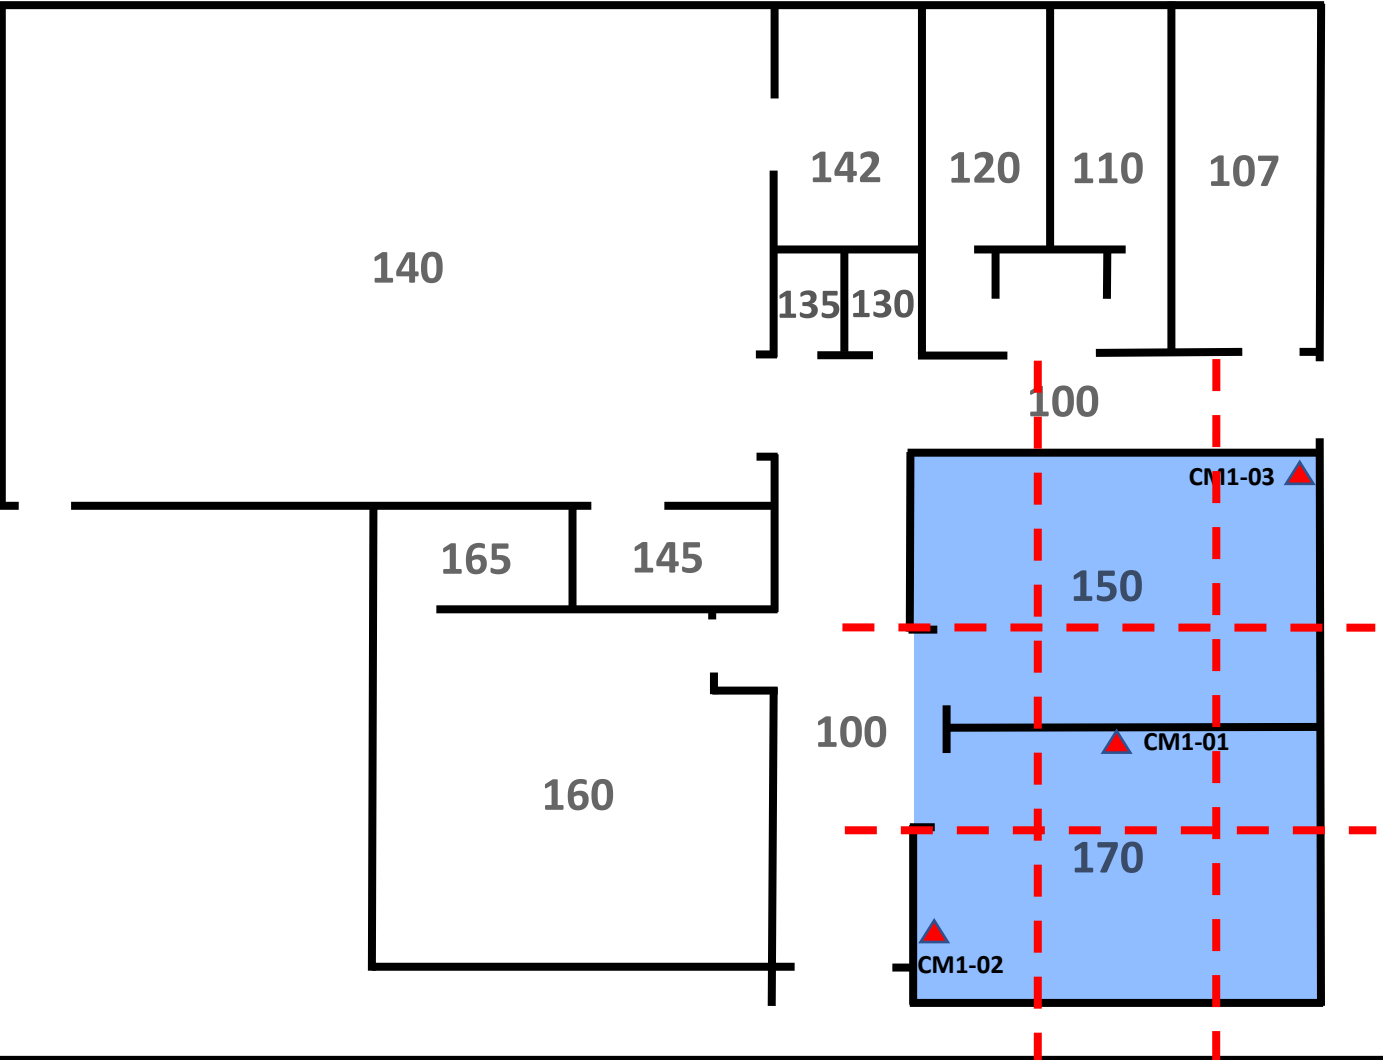
Random sampling diagram #3

CM1 – Sticky, brownish mastic ~ 1000SF

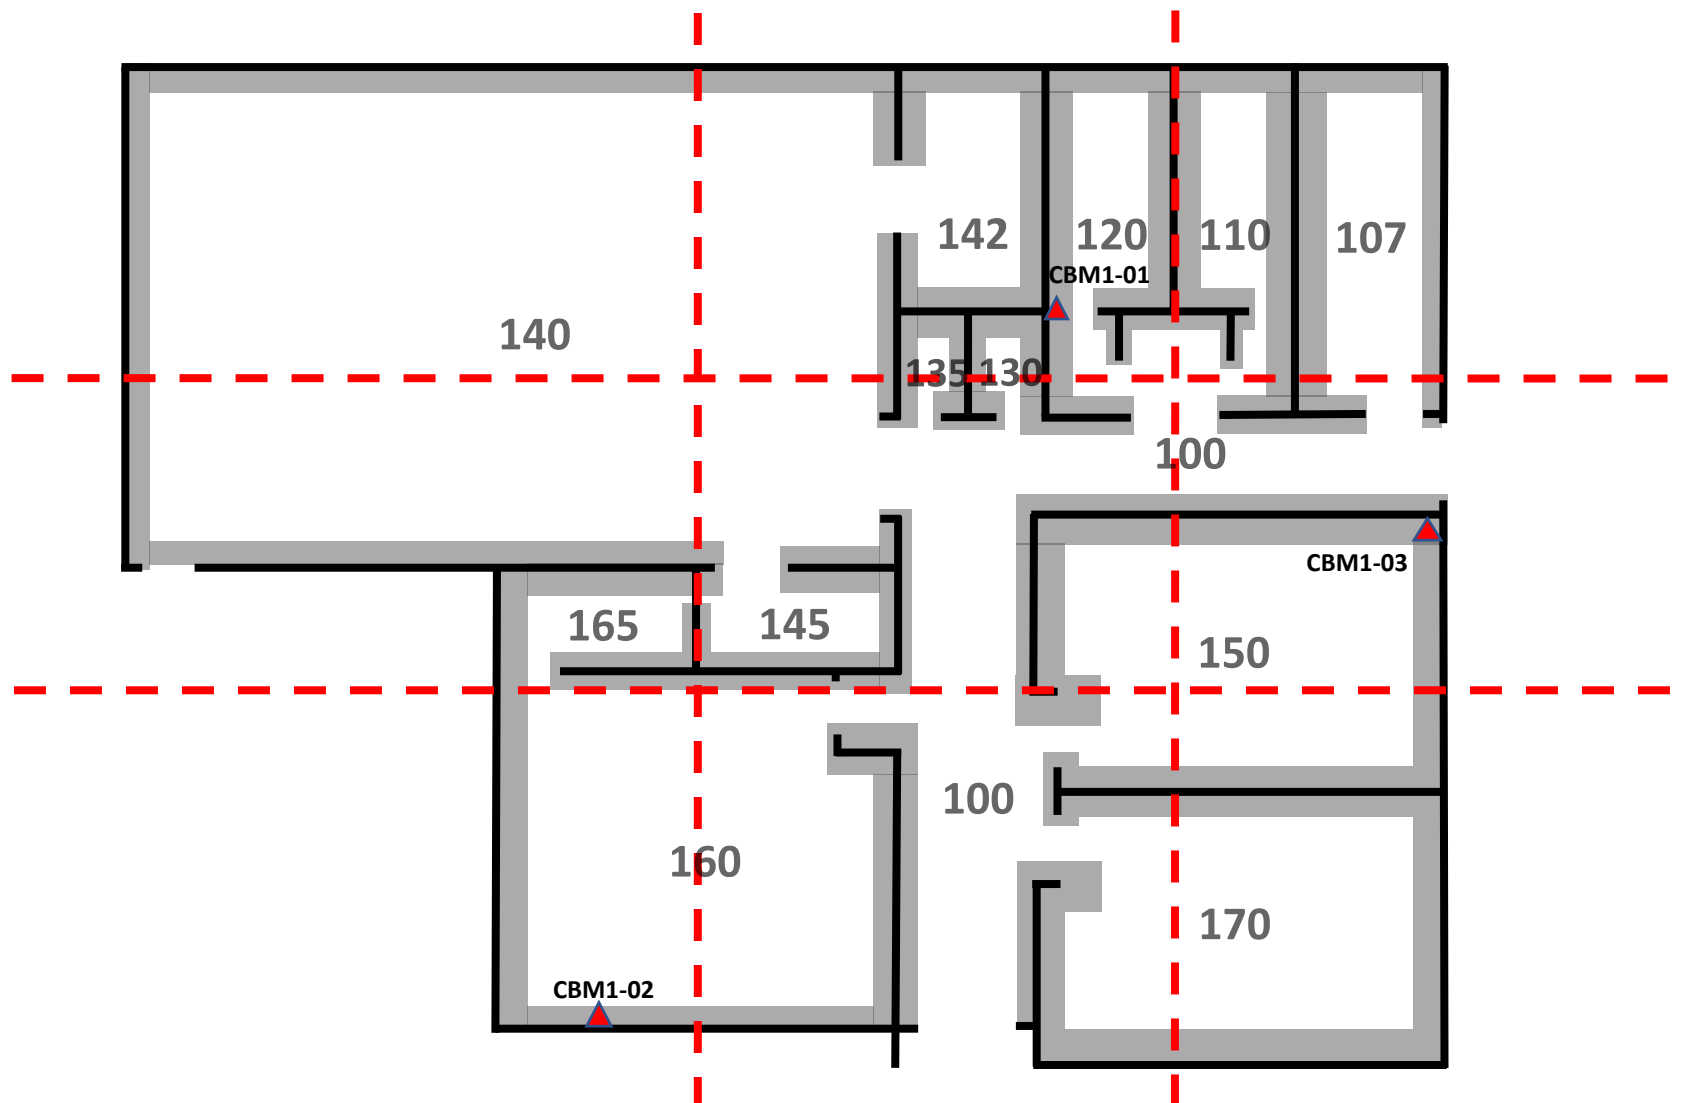
Random sampling diagram #4
- CBM1- 4" Cream colored, pliable cove base mastic ~ 227 SF

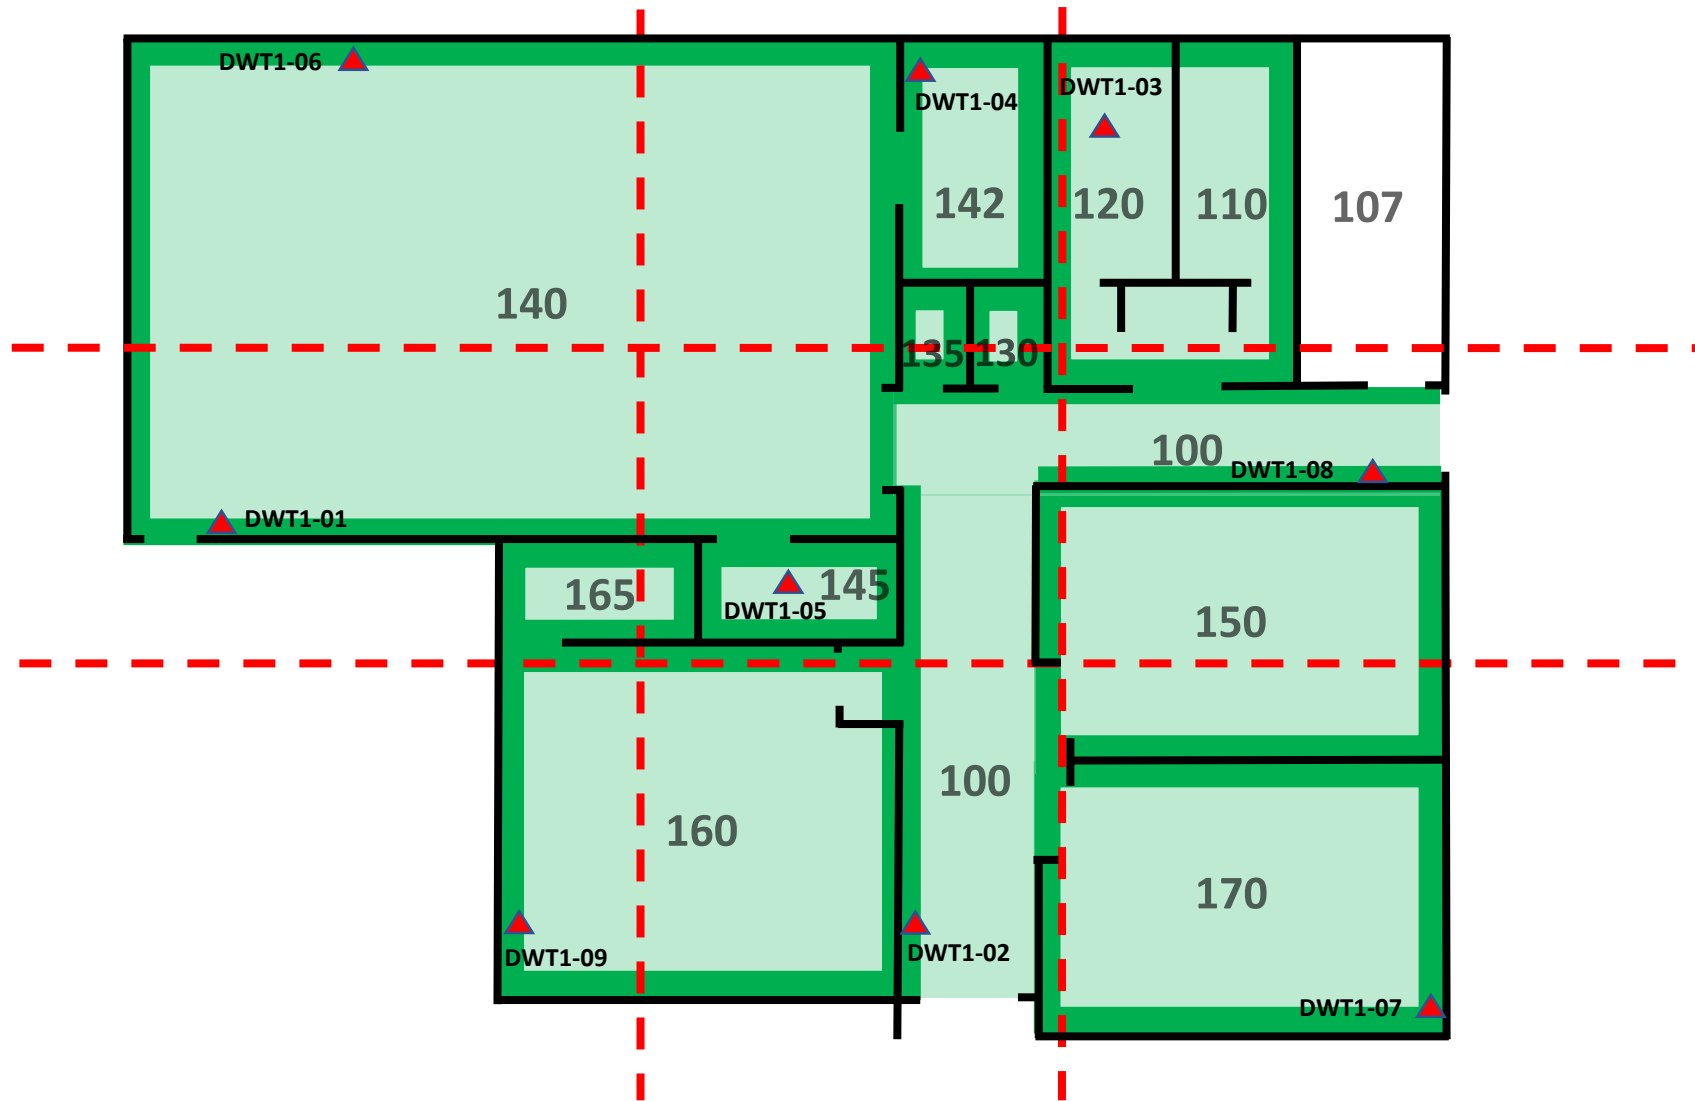
Random sampling diagram #5

DWT1 - Orange peel texture on drywall with white or tan paint
~11,635 SF

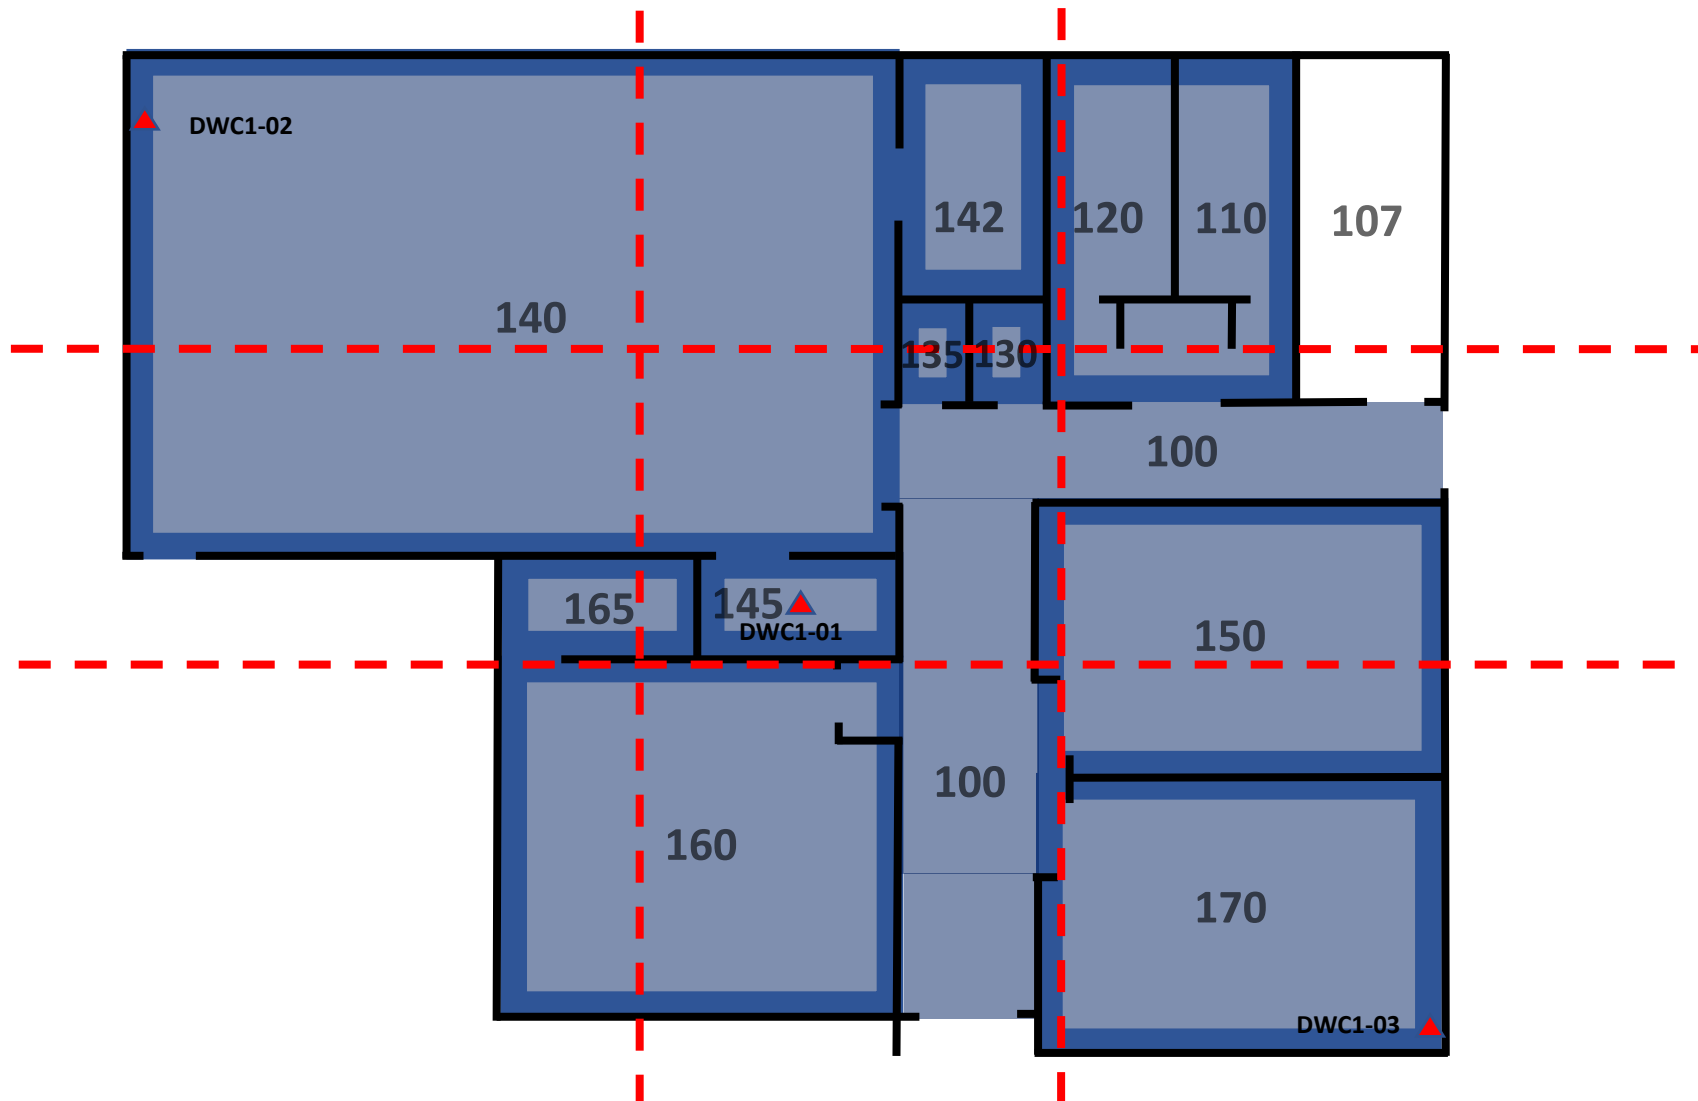
Random
sampling
diagram #6

DWC1- White
drywall composite
with brown paper
and texture
~11,635 SF

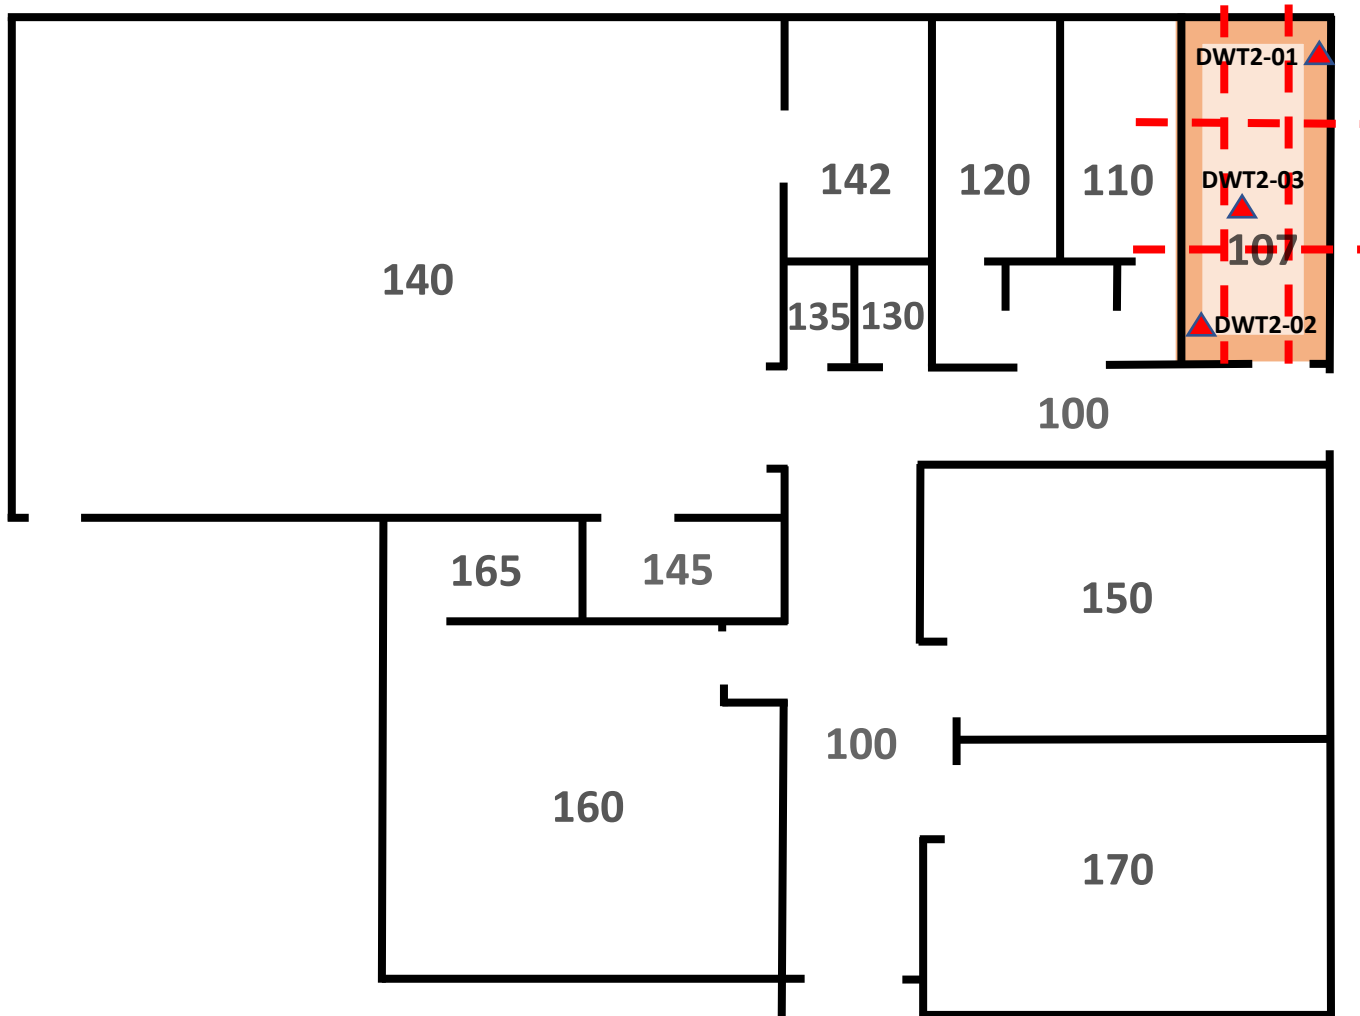
Random sampling diagram #7

DWT2 – Smooth texture on walls and ceiling of room #107
~ 780 SF

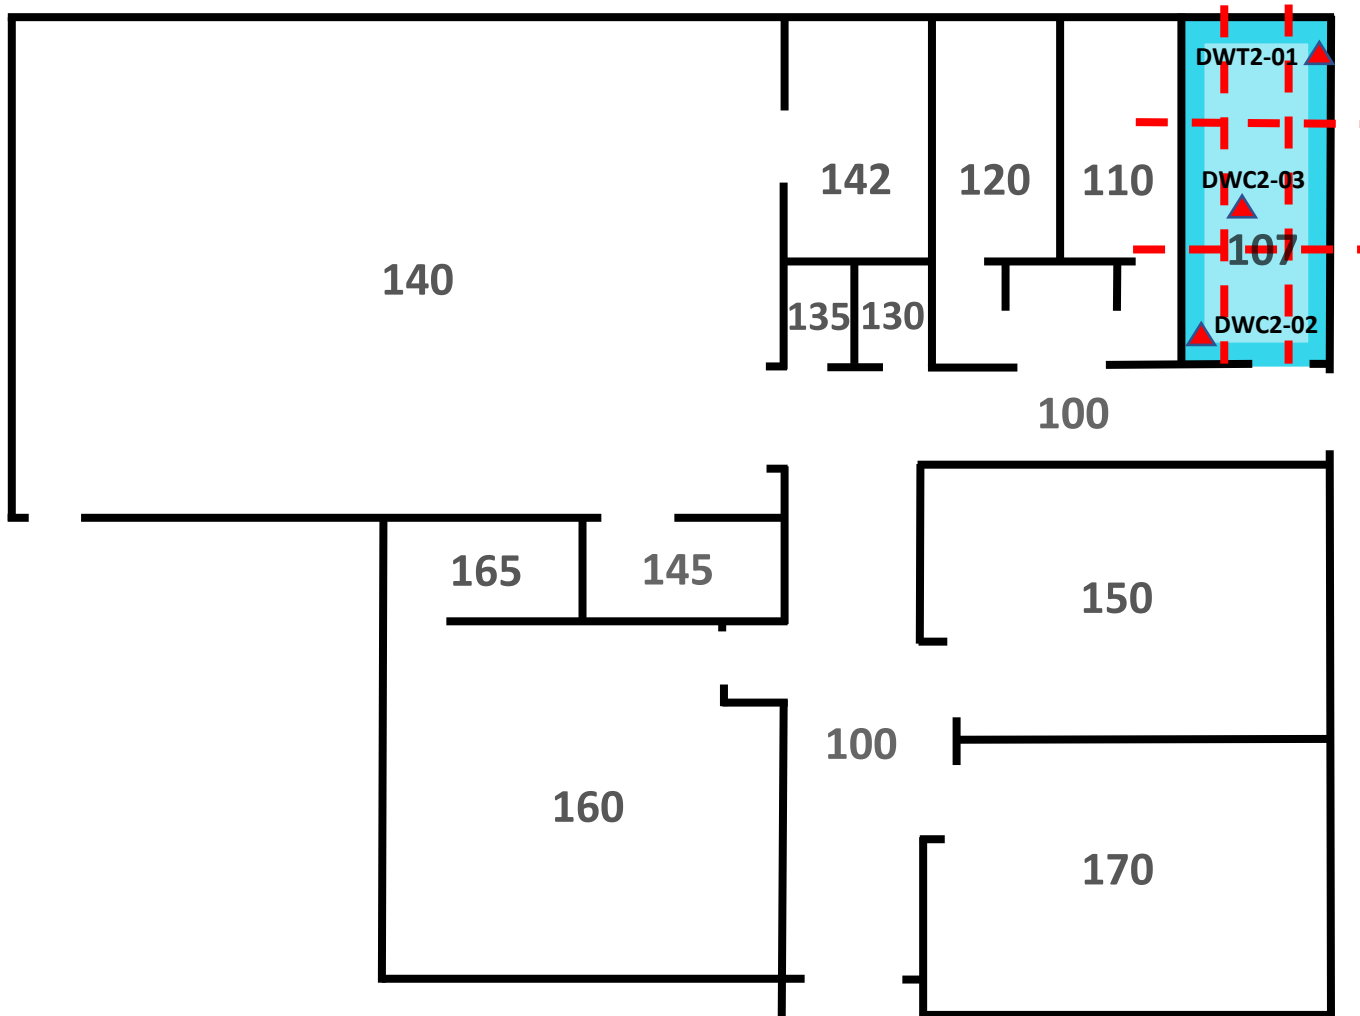
Random
sampling
diagram #8

DWC2 – White
drywall under
white paint
~780 SF

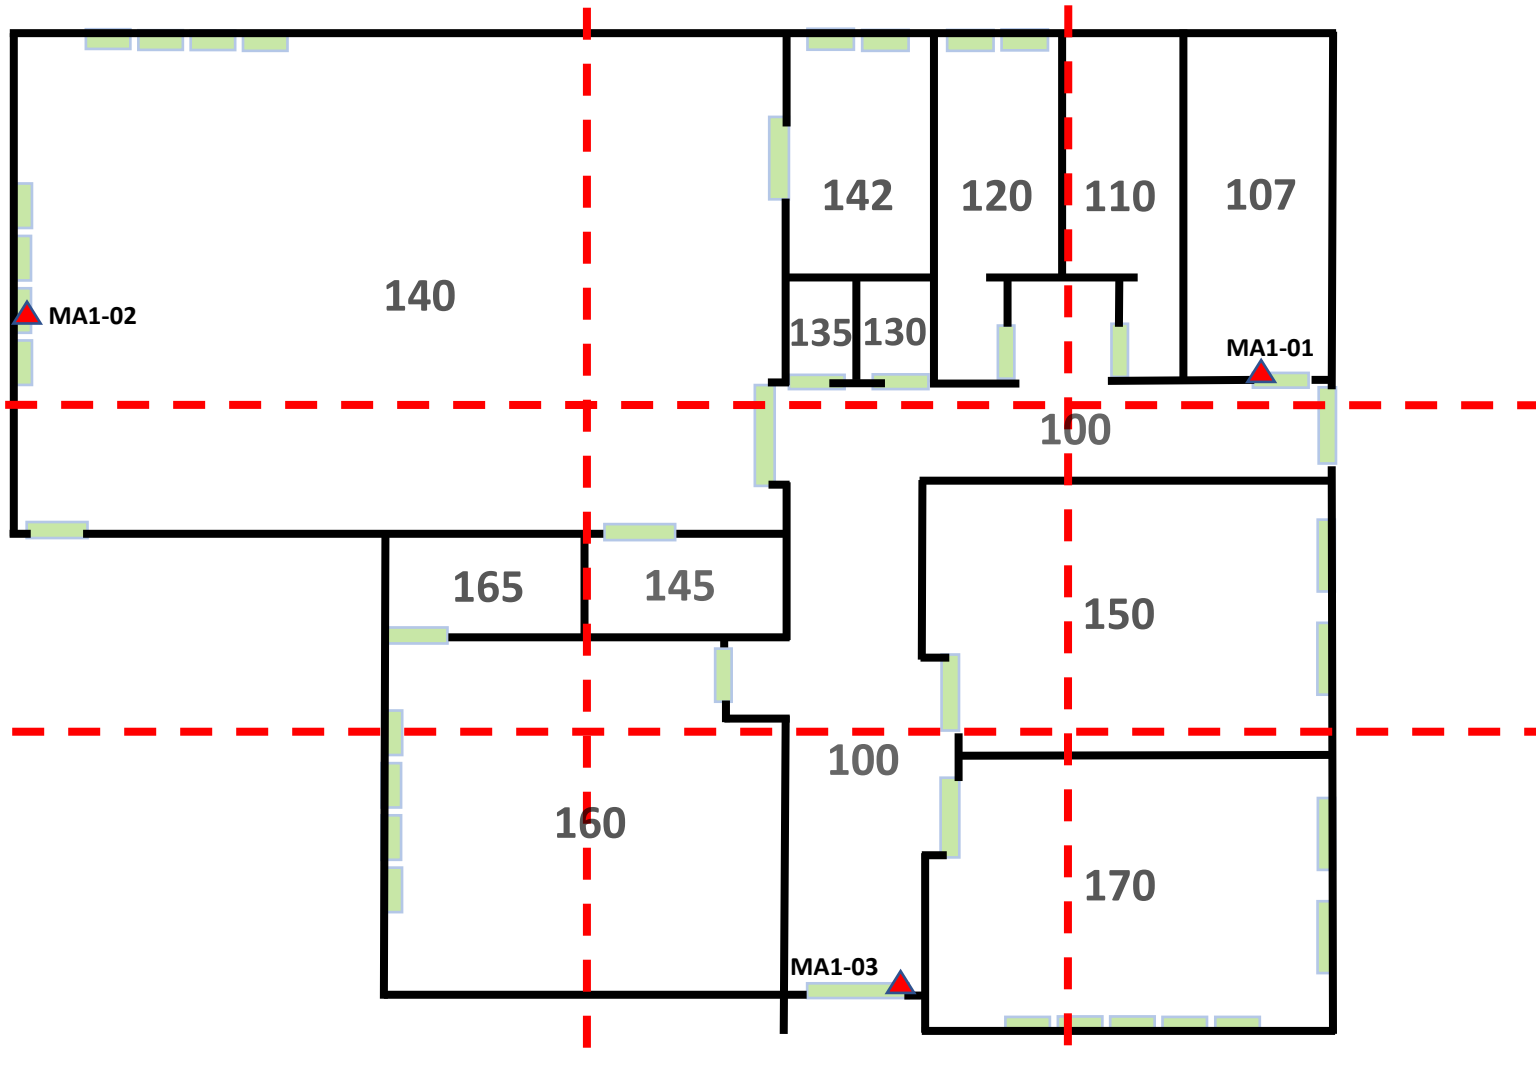
Random sampling diagram #9

MA1 - 4" white, pliable, silicone-like caulking around doors & windows ~ 5 SF

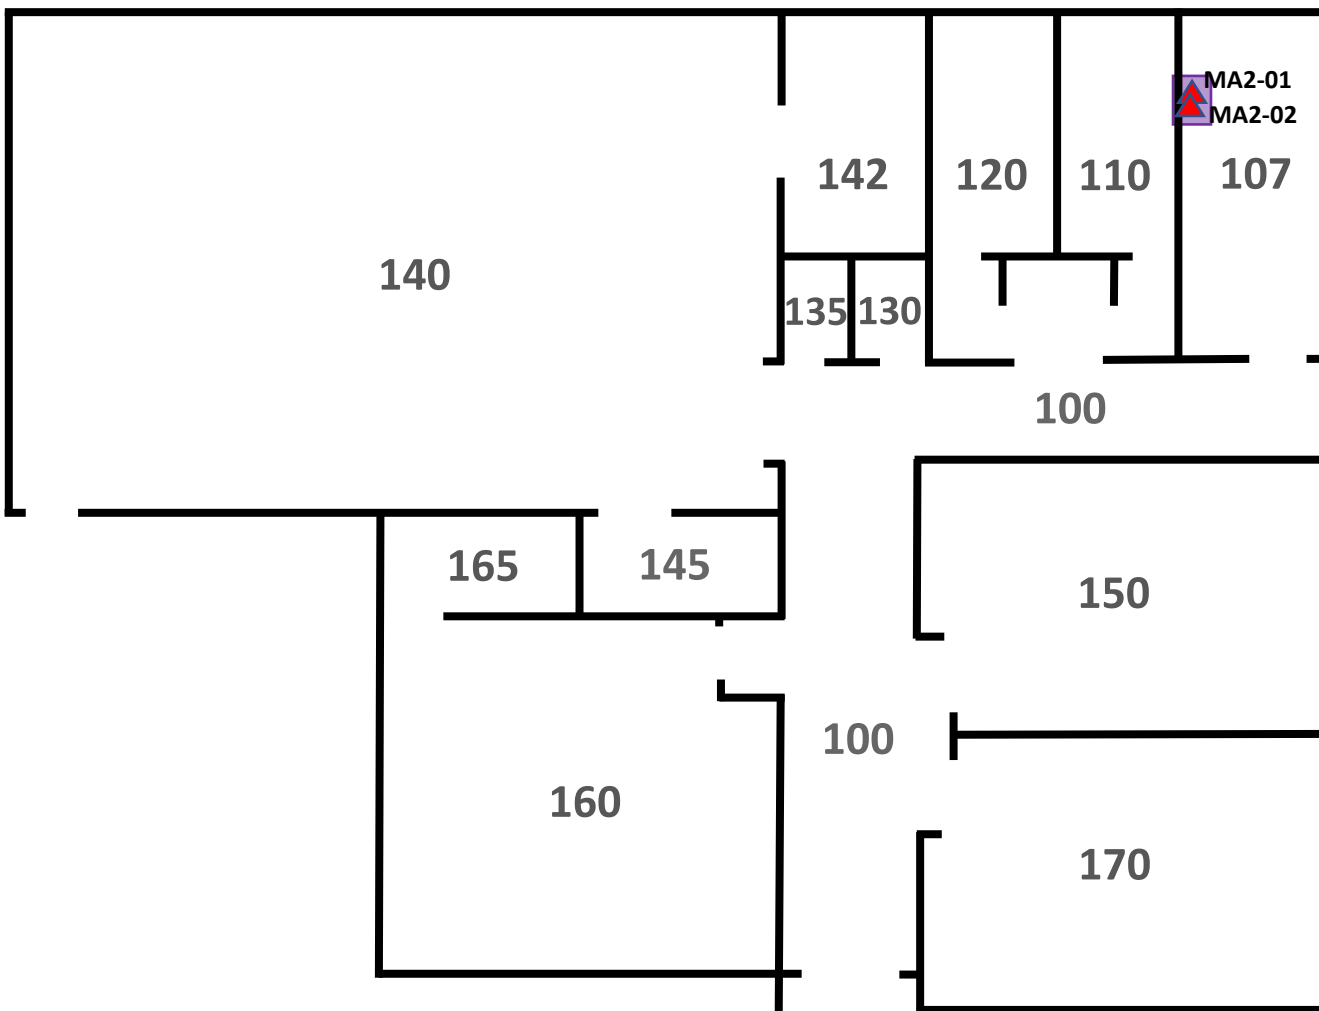
MA2 – Gray, sticky
mastic & old
Teflon tape, on
steel pipe “air-
line” connections
>1 SF

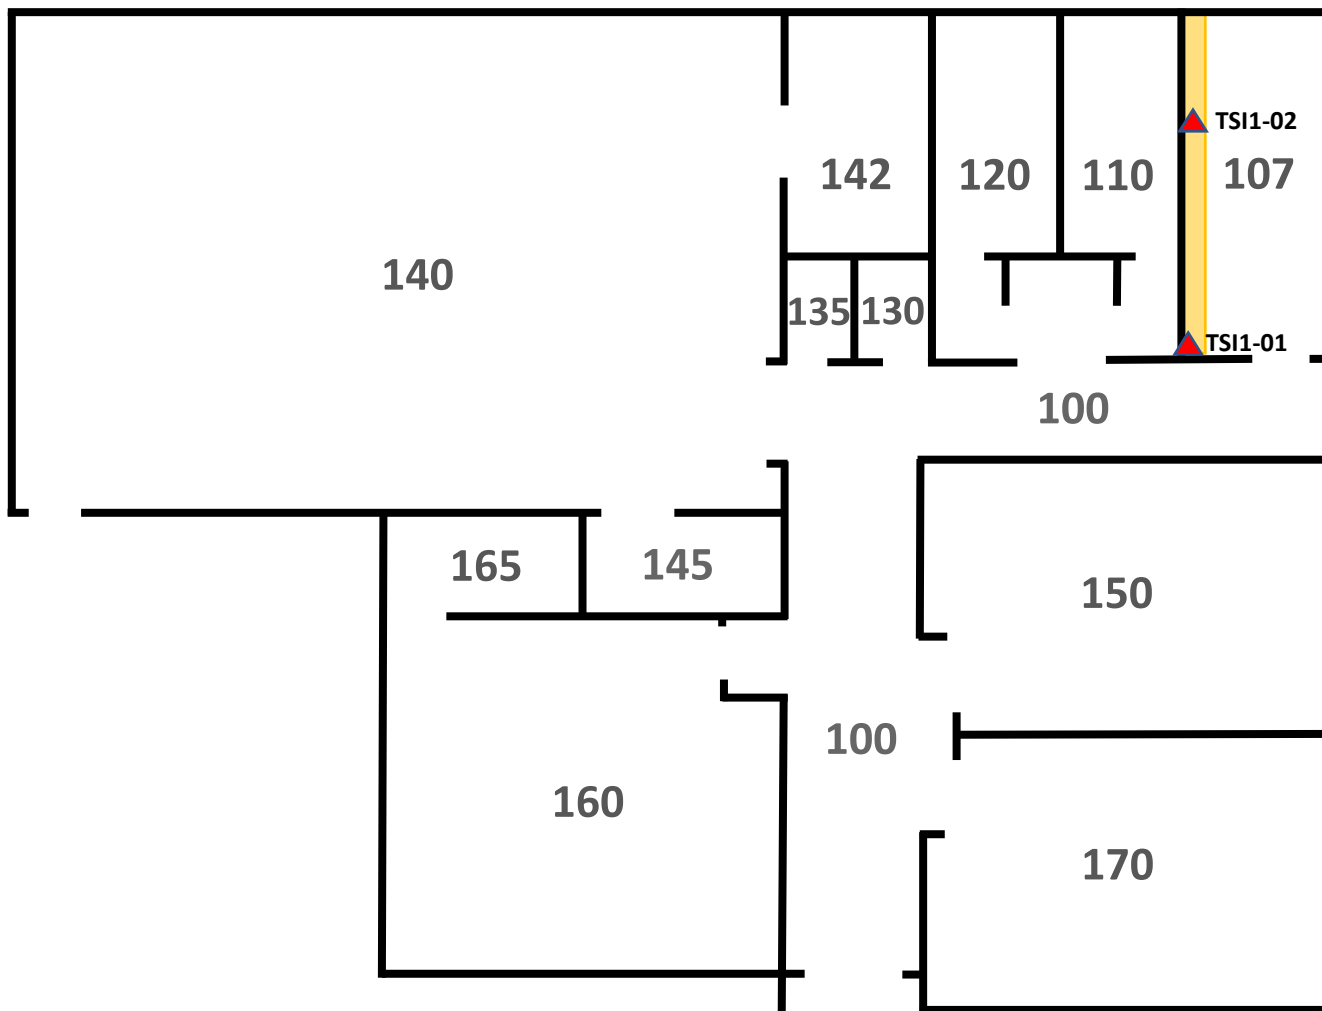
TSI1 - Yellow
fibrous insulation
on 1" copper pipe
~92 LF

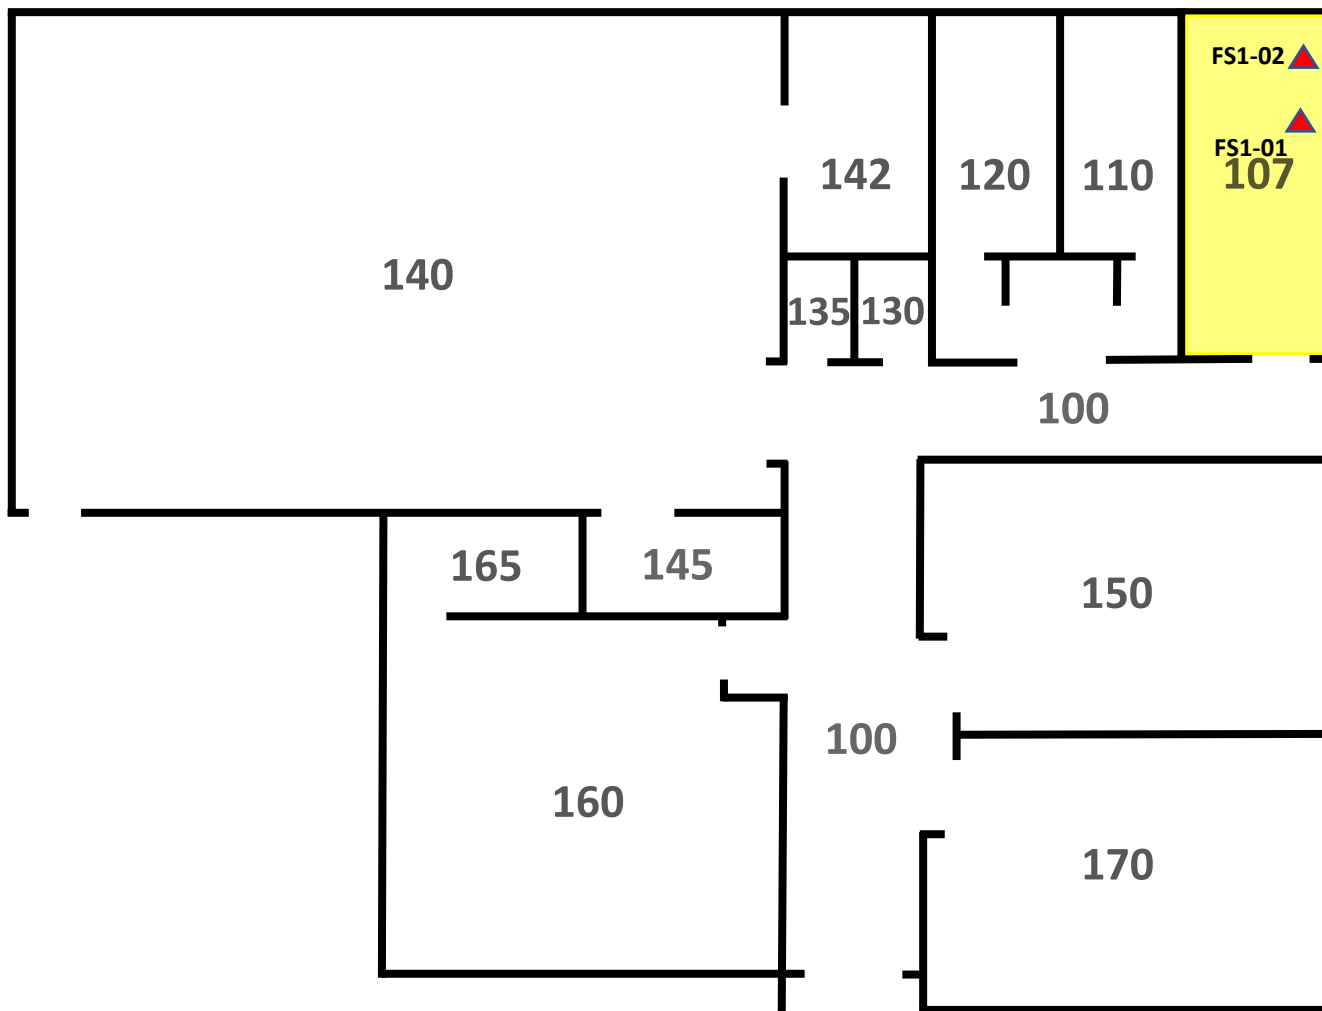
FS1 - Old, Off-
white flooring
sealant on
concrete
~10 SF
