STATEMENT OF WORK
EAST TROUBLESOME FIRE TIME CRITICAL REMOVAL ACTION
ROCKY MOUNTAIN NATIONAL PARK

BB&E, Inc. (BB&E) completed an inspection of 26 burned structures at Rocky Mountain National Park to assess the type and quantity of building debris in preparation for a Time Critical Removal Action (TCRA). The inspection was conducted on 9/29/2022 and 10/5/2022 in tandem with the soil/ash field sampling event. BB&E identified the following:

Site Inspection Field Sampling Event East Troublesome Fire Damaged Structures
Rocky Mountain Nation Park

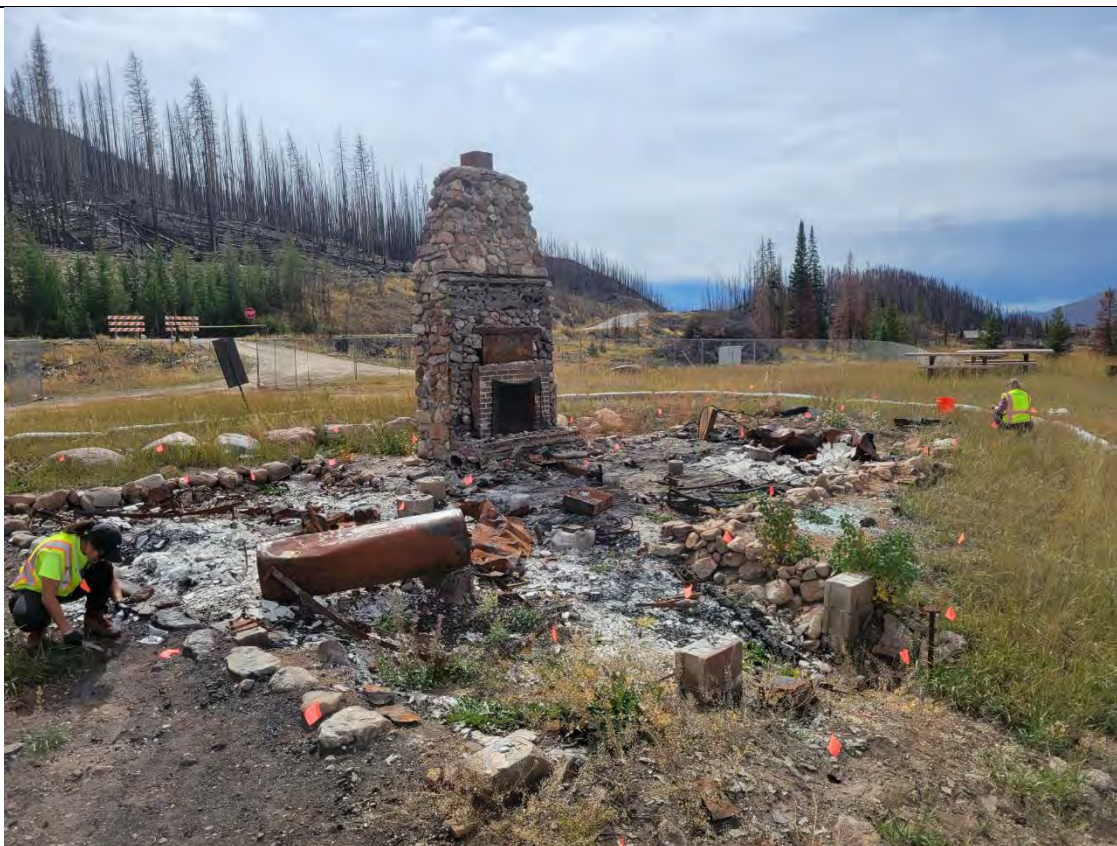
Building: 0731, GMR Mineral Cottage

Site ID/ Site Name:	0731 / GMR Mineral Cottage	Date:	9/29/2022 10:30 AM
Building Footprint (Length x Width) (ft):	38 x 29	Sample Footprint (Length x Width) (ft):	48 x 39
Building Footprint (sq. ft):	1102	Sample Footprint (sq. ft):	1872
Ash/ small inseparable debris depth in Building footprint (in):	0 in over 60%, 6 in over 40%.		
White Goods (type, count [1 each unless specified otherwise], and location):	Stove, refrigerator, metal sink, electrical box – south wall. Water tank – north wall Small heater/fan (2) – various locations.		
Identifiable hazardous materials (count, location, and type):	None		
Suspected or potential hazardous materials or containers (count, location, and type):	Fire extinguisher (discharged)		
Metal debris estimated volume:	250 lbs		
Other large debris that may be segregated for recycling or disposal estimated volume:	Metal sheeting, bed frames (2), metal piping, outlet boxes, fireplace grate.

Other notes:	Stone chimney center. Stone footers and stone foundation perimeter wall. Significant shattered glass along east and west wall. Fibrous material – north structure edge.

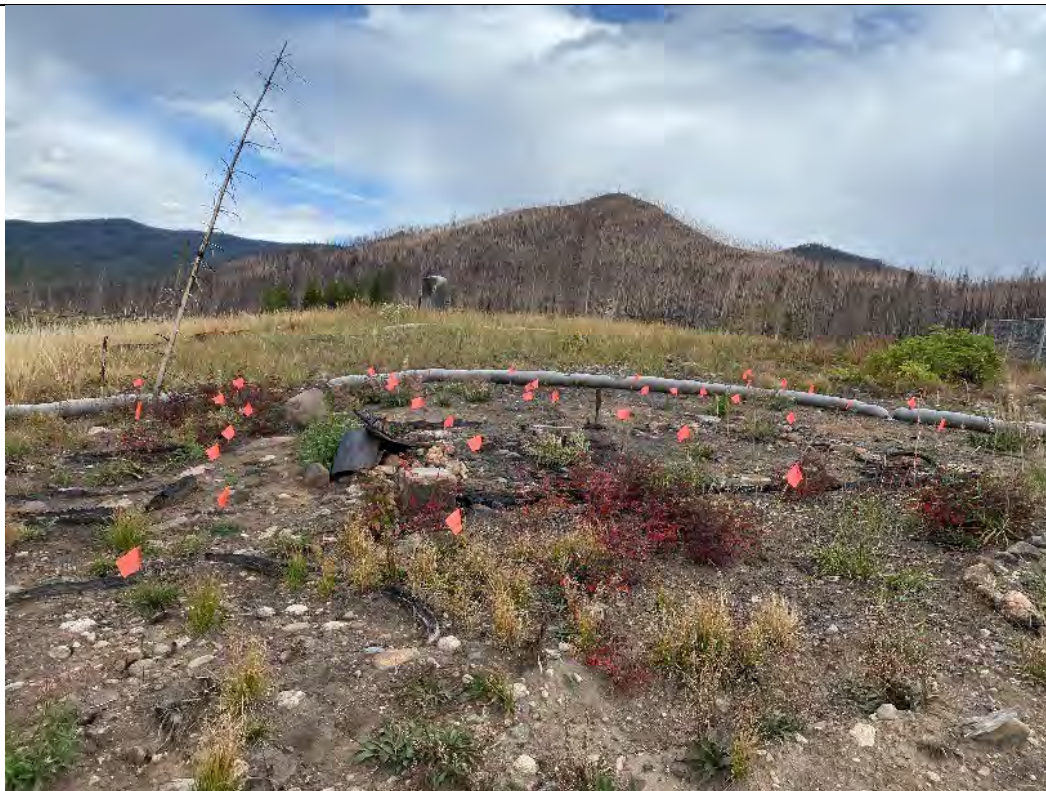
Building: 0728, GMR Wood Storage Cottage

Site ID/ Site Name:	0728 / GMR Wood Storage Shed	Date:	9/29/2022 12:06 PM
Building Footprint (Length x Width) (ft):	16 x 14	Sample Footprint (Length x Width) (ft):	26 x 24
Building Footprint (sq. ft):	224	Sample Footprint (sq. ft):	624
Ash/ small inseparable debris depth in Building footprint (in):	0-1 in		
White Goods (count, location, and type):	None		
Identifiable hazardous materials (count, location, and type):	None		
Suspected or potential hazardous materials or containers (count, location, and type):	Small container – possible mineral spirits (discharged)		
Metal debris estimated volume:	None		
Other large debris that may be segregated for recycling or disposal estimated volume:	Ironing board, vehicle jack, electrical outlet boxes, wiring and piping, bucket		
Other notes:	Minimal stone edging, concrete footers.

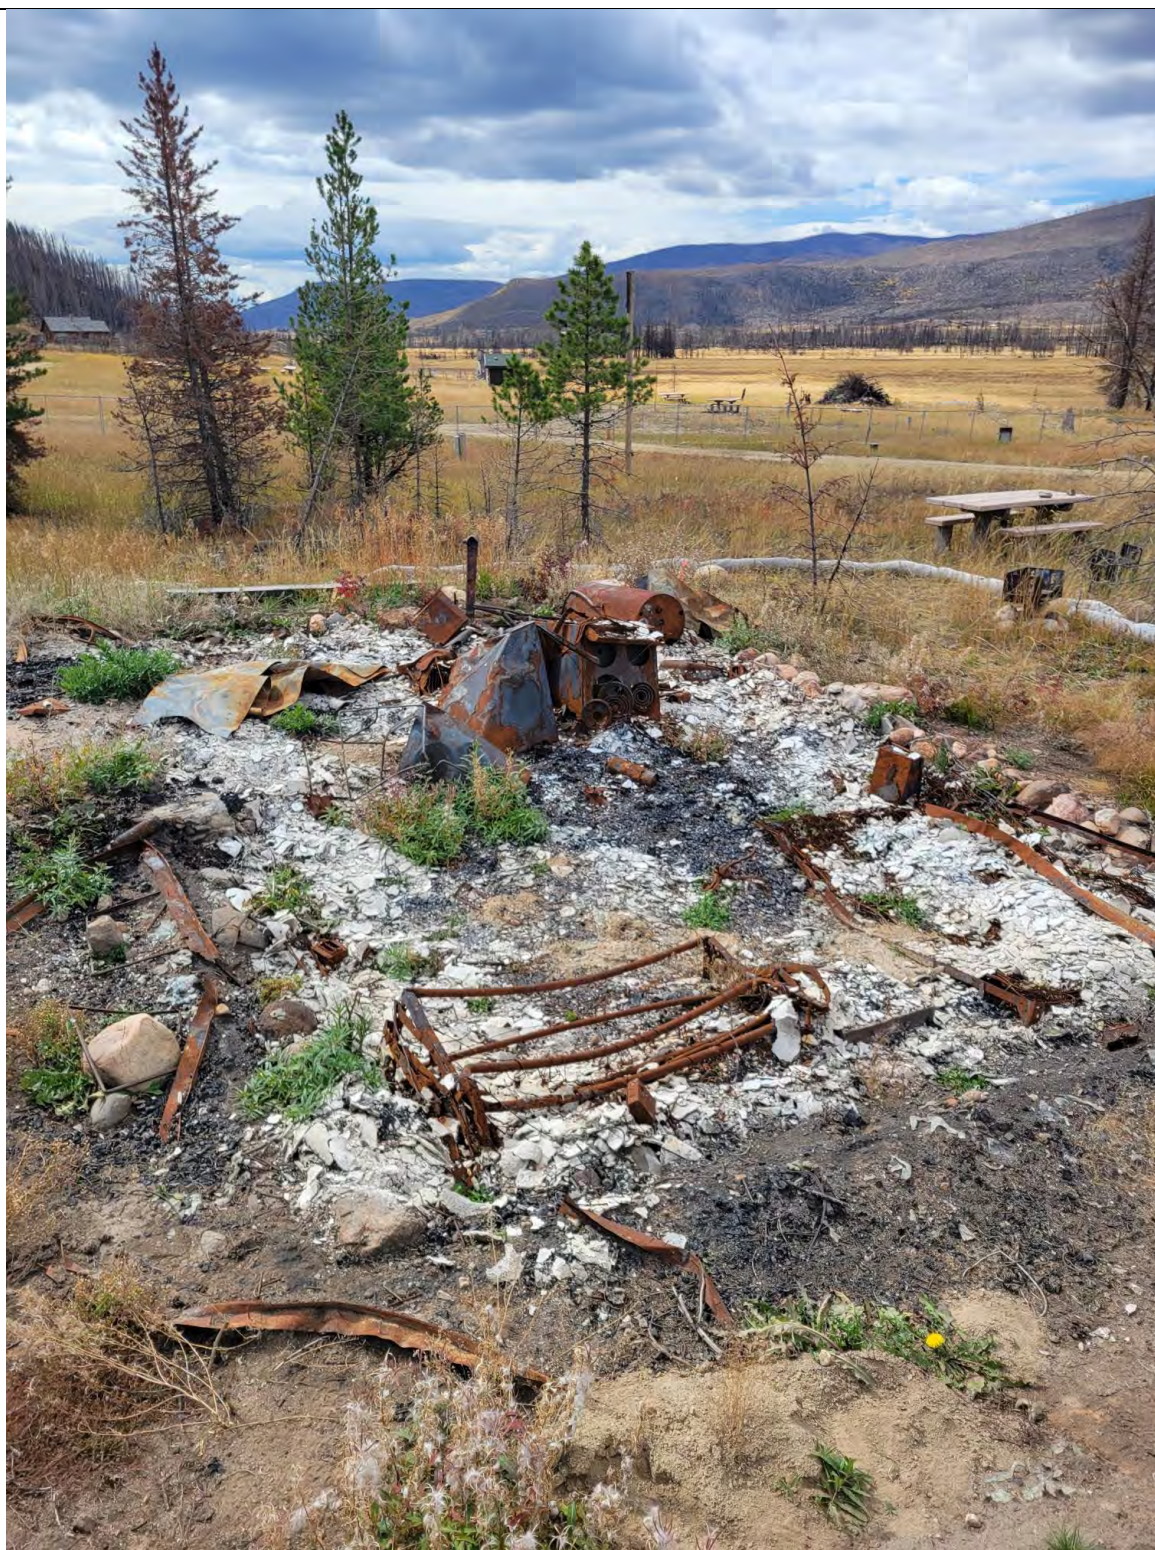
Building: 0727, GMR Pioneer Cottage

Site ID/ Site Name:	0727 / GMR Pioneer Cottage	Date:	9/29/2022 11:58AM
Building Footprint (Length x Width) (ft):	24 x 16	Sample Footprint (Length x Width) (ft):	34 x 26
Building Footprint (sq. ft):	384	Sample Footprint (sq. ft):	884
Ash/ small inseparable debris depth in Building footprint (in):	4 in over 50%. 12-24 in over 50%		
White Goods (count, location, and type):	Stove, refrigerator, water tank, electrical box, metal stove chimney piping, metal sink, space heater/fan.		
Identifiable hazardous materials (count, location, and type):	None		
Suspected or potential hazardous materials or containers (count, location, and type):	Fire extinguisher and unidentified spray cans (discharged)		
Metal debris estimated volume:	250 lbs		
Other large debris that may be segregated for recycling or disposal estimated volume:	Metal sheeting, bed and couch frame, metal chair, gutters, outlet boxes, metal piping, exhaust stove chimney housing.

Other notes:	No stone chimney, concrete foundation footers, stone foundation wall.

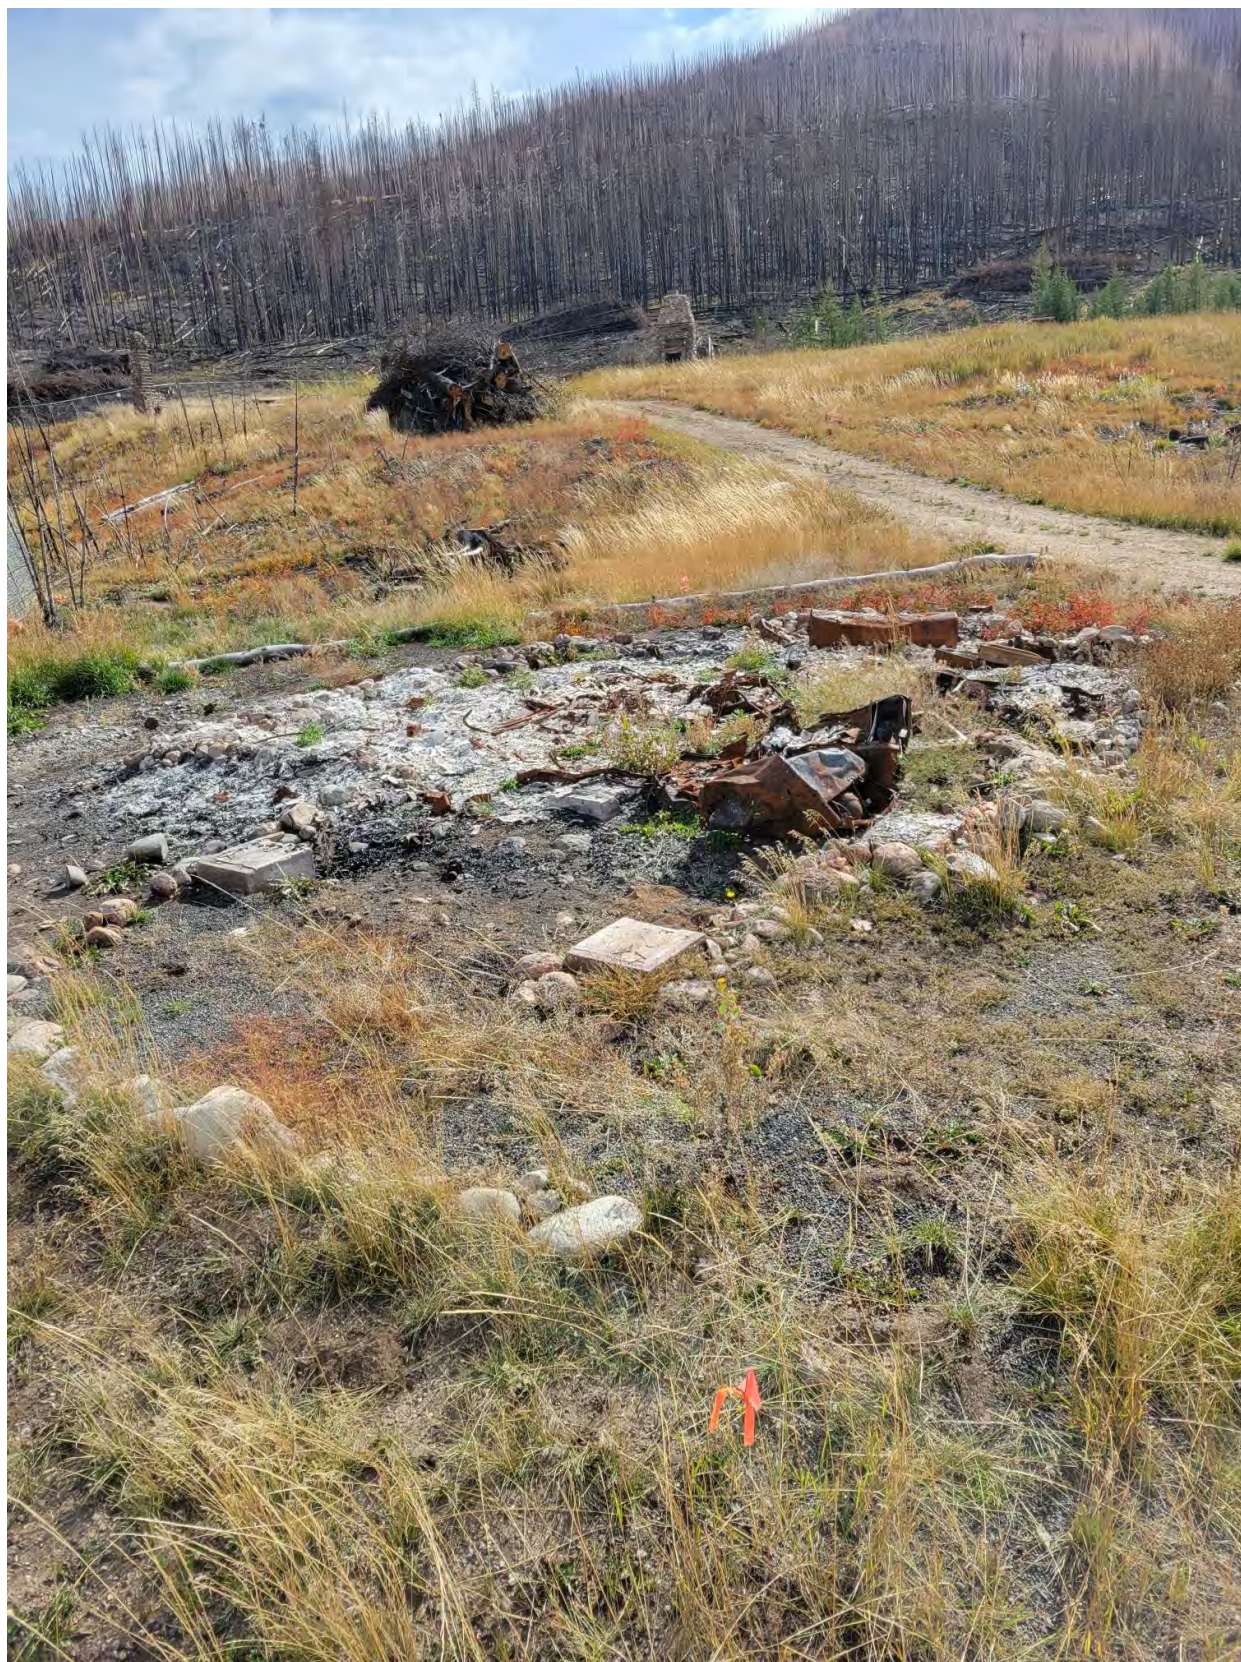
Building: 0733, GMR Arapaho Cottage

Site ID/ Site Name:	0733 / GMR Arapaho Cottage	Date:	9/29/2022 10:55AM
Building Footprint (Length x Width) (ft):	25 x 23.5	Sample Footprint (Length x Width) (ft):	35 x 33.5
Building Footprint (sq. ft):	587.5	Sample Footprint (sq. ft):	1172.5
Ash/ small inseparable debris depth in Building footprint (in):	8-12 in		
White Goods (count, location, and type):	Water tank (west wall), electrical boxes (2), stove, metal sink, refrigerator (kitchen SE corner), space heater/fan (2)		
Identifiable hazardous materials (count, location, and type):	None		
Suspected or potential hazardous materials or containers (count, location, and type):	Fire extinguisher, unknown spray cans (discharged)		
Metal debris estimated volume:	250 lbs		
Other large debris that may be segregated for recycling or disposal estimated volume:	Metal bed frame (2), metal piping, gutters, lamps, buckets, outlet boxes, metal shelving unit

Other notes:	No chimney, concrete footers & stone foundation wall, wall collapsed outward on north side. Some porcelain debris.

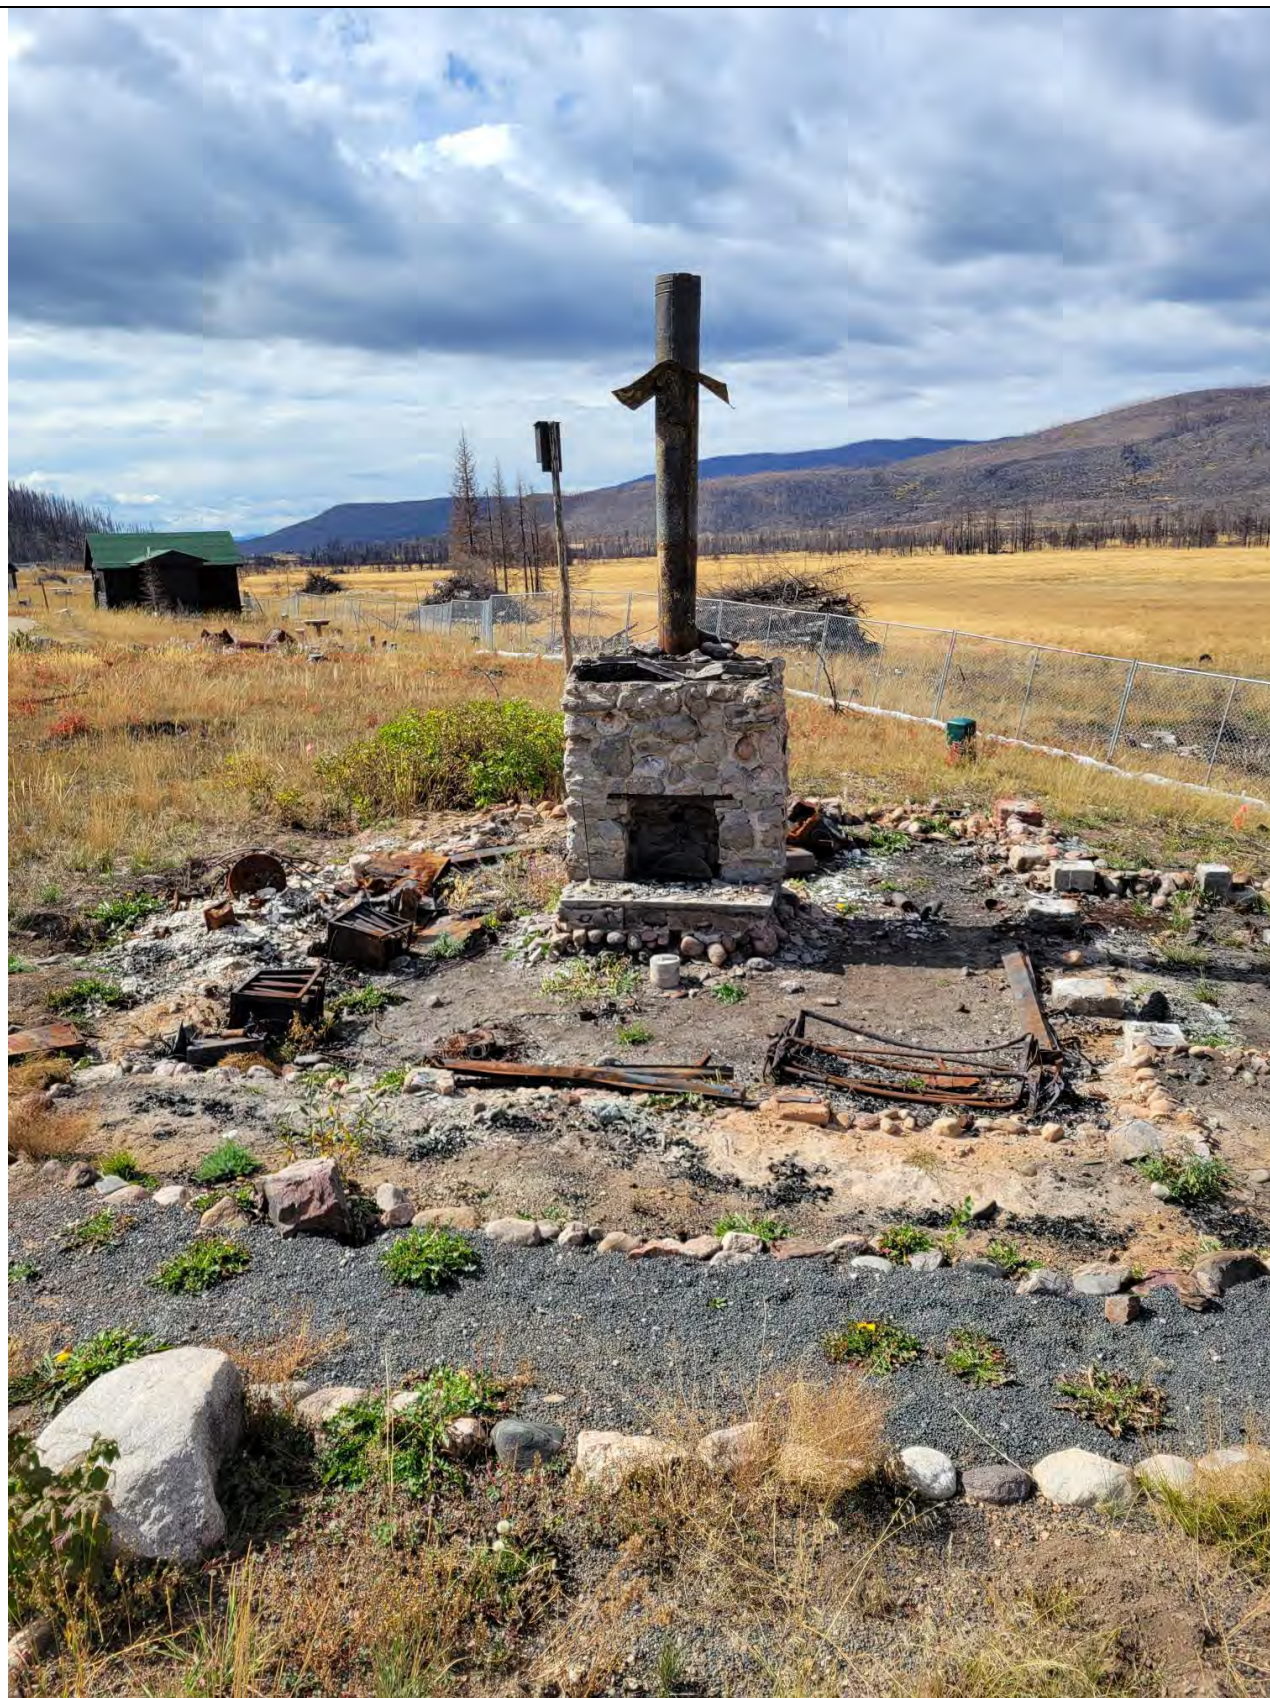
Building: 0734, GMR Onahu Cottage

Site ID/ Site Name:	0734 / GMR Onahu Cottage	Date:	9/29/2022 11:20AM
Building Footprint (Length x Width) (ft):	26 x 25	Sample Footprint (Length x Width) (ft):	36 x 35
Building Footprint (sq. ft):	650	Sample Footprint (sq. ft):	1260
Ash/ small inseparable debris depth in Building footprint (in):	0 in over 70%. 4-12 in over 30%		
White Goods (count, location, and type):	Stove, refrigerator, metal sink and counter (south wall). Water tank (east wall). Electrical box (northeast corner). Space heater/fan.		
Identifiable hazardous materials (count, location, and type):	None		
Suspected or potential hazardous materials or containers (count, location, and type):	Fire extinguisher (discharged)		
Metal debris estimated volume:	350 lb including metal chimney		
Other large debris that may be segregated for recycling or disposal estimated volume:	Metal bed and couch frame, metal chimney pipe, gutters, metal sheeting, metal shelves (2), misc piping, outlet boxes.

Other notes:	Chimney in center of structure, brick and concrete footers, stone foundation walls, wall collapse to the east.

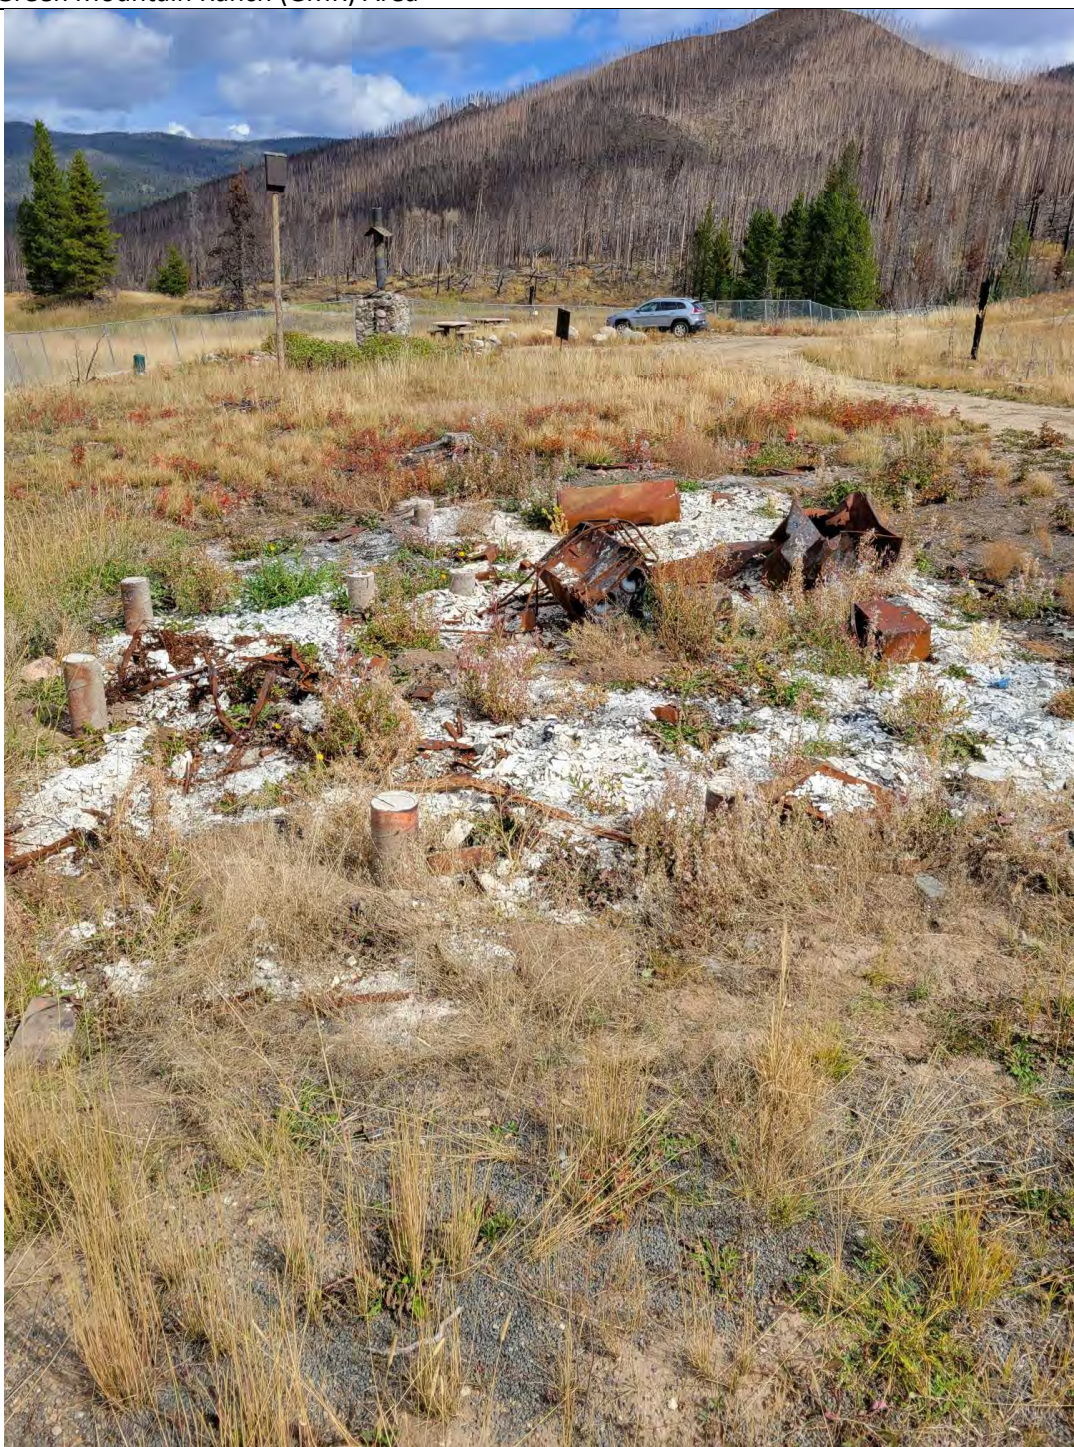
Building: 0735, GMR Cumulus Cottage

Site ID/ Site Name:	0735 / GMR Cumulus Cottage	Date:	9/29/2022 11:36AM
Building Footprint (Length x Width) (ft):	23 x 23	Sample Footprint (Length x Width) (ft):	33 x 33
Building Footprint (sq. ft):	529	Sample Footprint (sq. ft):	1089
Ash/ small inseparable debris depth in Building footprint (in):	6-12 in		
White Goods (count, location, and type):	Water tank (south wall), stove, microwave, metal sink, refrigerator (center), electrical boxes (3+), space heater/fan		
Identifiable hazardous materials (count, location, and type):	None		
Suspected or potential hazardous materials or containers (count, location, and type):	Fire extinguisher (discharged)		
Metal debris estimated volume:	200 lbs		
Other large debris that may be segregated for recycling or disposal estimated volume:	Metal gutters, metal chairs, bedframe, can light housings, metal piping		
Other notes:	No chimney, concrete pillar foundation footers, no stone. Fibrous material north edge of structure.

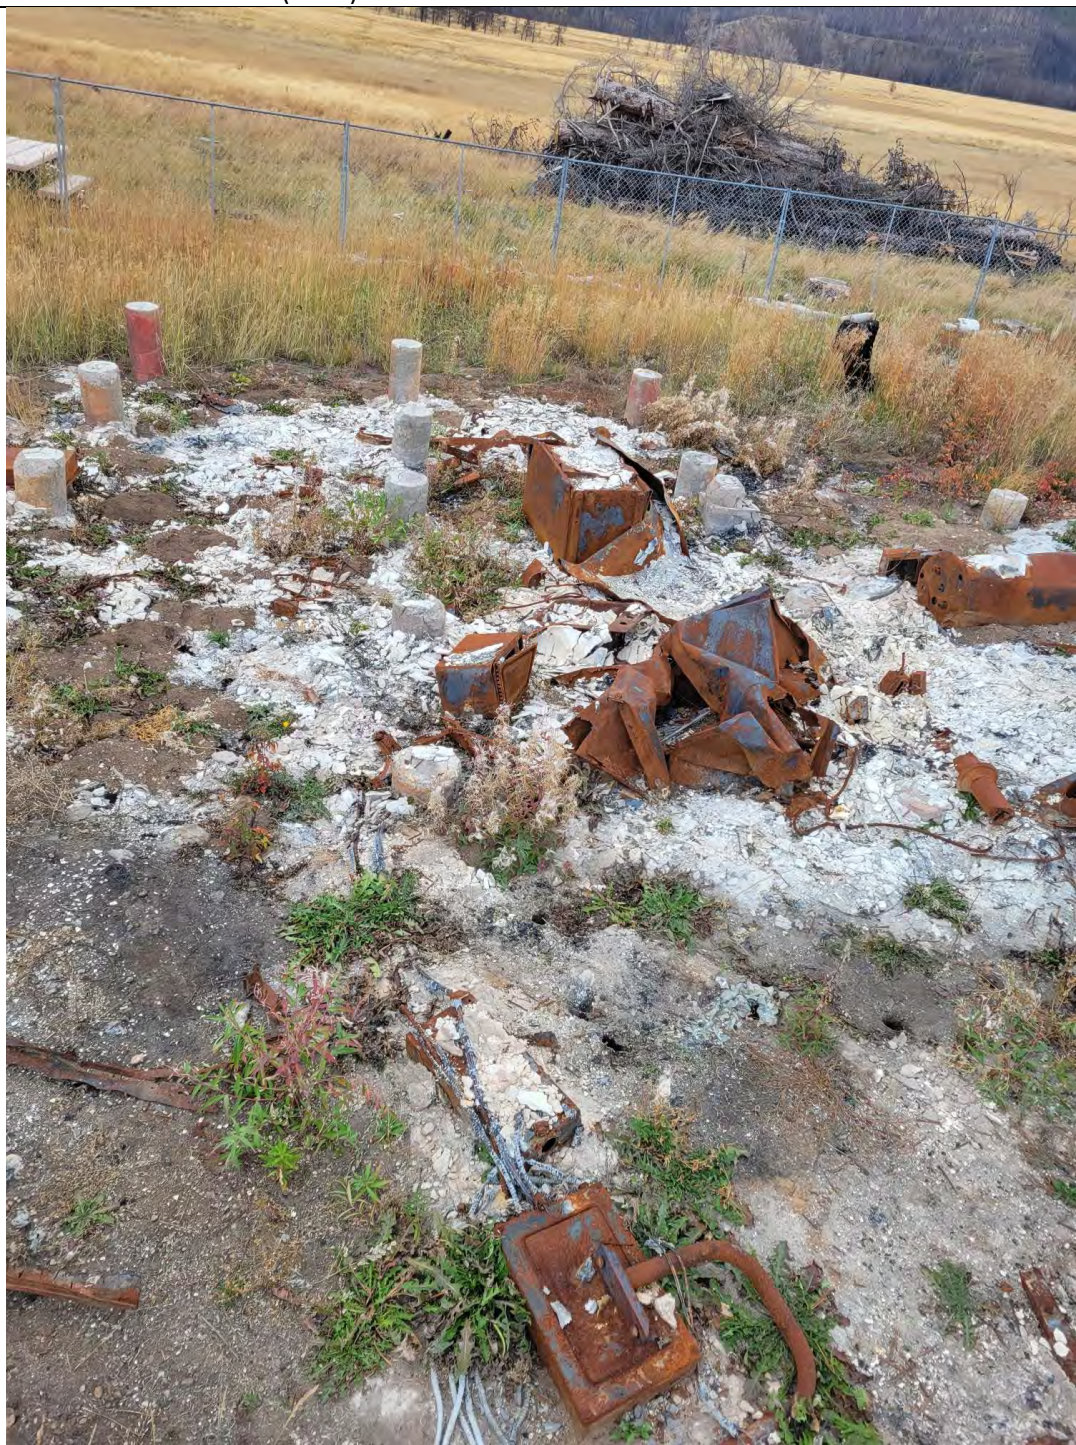
Building: 0737, GMR Cirrus Cottage

Site ID/ Site Name:	0737 / GMR Cirrus Cottage	Date:	9/29/2022 1:15PM
Building Footprint (Length x Width) (ft):	23 x 20	Sample Footprint (Length x Width) (ft):	33 x 30
Building Footprint (sq. ft):	460	Sample Footprint (sq. ft):	990
Ash/ small inseparable debris depth in Building footprint (in):	12-24 in		
White Goods (count, location, and type):	Stove, refrigerator, water tank, microwave, electrical boxes, space heater/fan.		
Identifiable hazardous materials (count, location, and type):	None		
Suspected or potential hazardous materials or containers (count, location, and type):	None		
Metal debris estimated volume:	210 lbs		
Other large debris that may be segregated for recycling or disposal estimated volume:	Gutters, can light fixtures, bed frame, metal stove exhaust pipe, metal piping, metal sheeting, exhaust fan housing, picnic table metal shell.		
Other notes:	Concrete footers, significant fibrous material south and east side of structure.

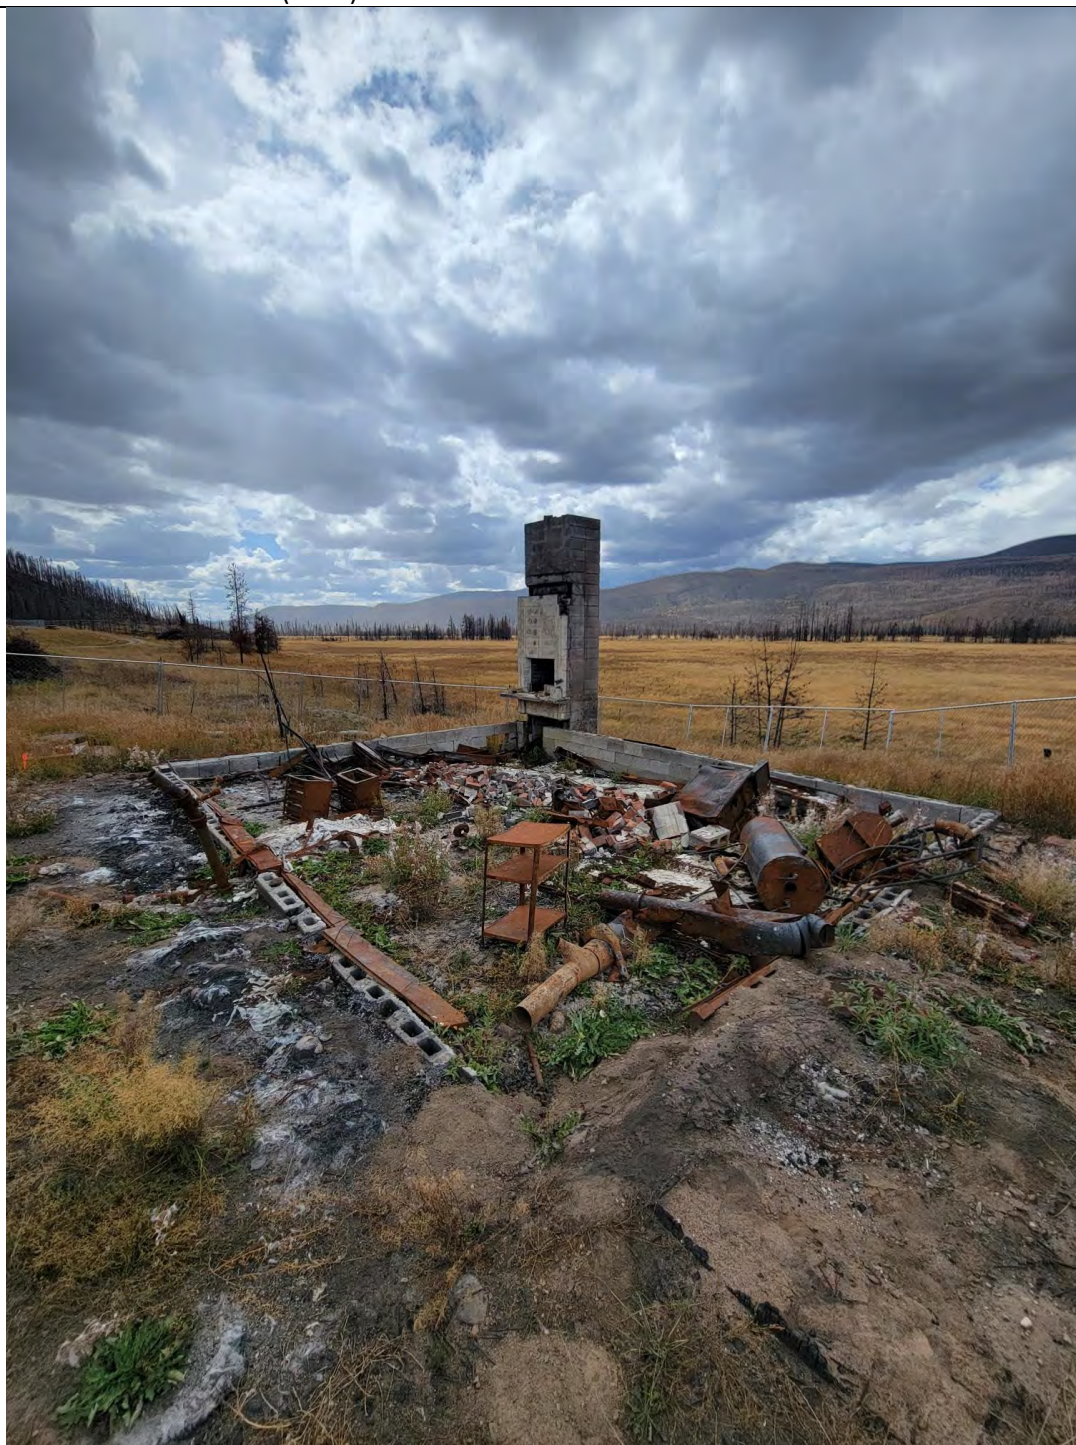
Building: 0740, GMR Meadow Cottage

Site ID/ Site Name:	0740 / GMR Meadow Cottage	Date:	9/29/2022 1:50PM
Building Footprint (Length x Width) (ft):	25 x 21	Sample Footprint (Length x Width) (ft):	35 x 31
Building Footprint (sq. ft):	525	Sample Footprint (sq. ft):	1085
Ash/ small inseparable debris depth in Building footprint (in):	3 in		
White Goods (count, location, and type):	Water tank, stove, refrigerator, large metal utility sink, electrical boxes, wall furnace housing, potbelly stove/furnace.		
Identifiable hazardous materials (count, location, and type):	None		
Suspected or potential hazardous materials or containers (count, location, and type):	Fire extinguisher (discharged)		
Metal debris estimated volume:	250 lbs		
Other large debris that may be segregated for recycling or disposal estimated volume:	Metal shelving units, gutters, misc piping, exhaust piping for potbelly stove, bedframes (2), can light housings, lamp post.

Other notes:	Cinder block foundation, collapsed bricks in center of structure, in ground exposed piping (shower/bath), cinder block chimney, some fibrous material on east side.

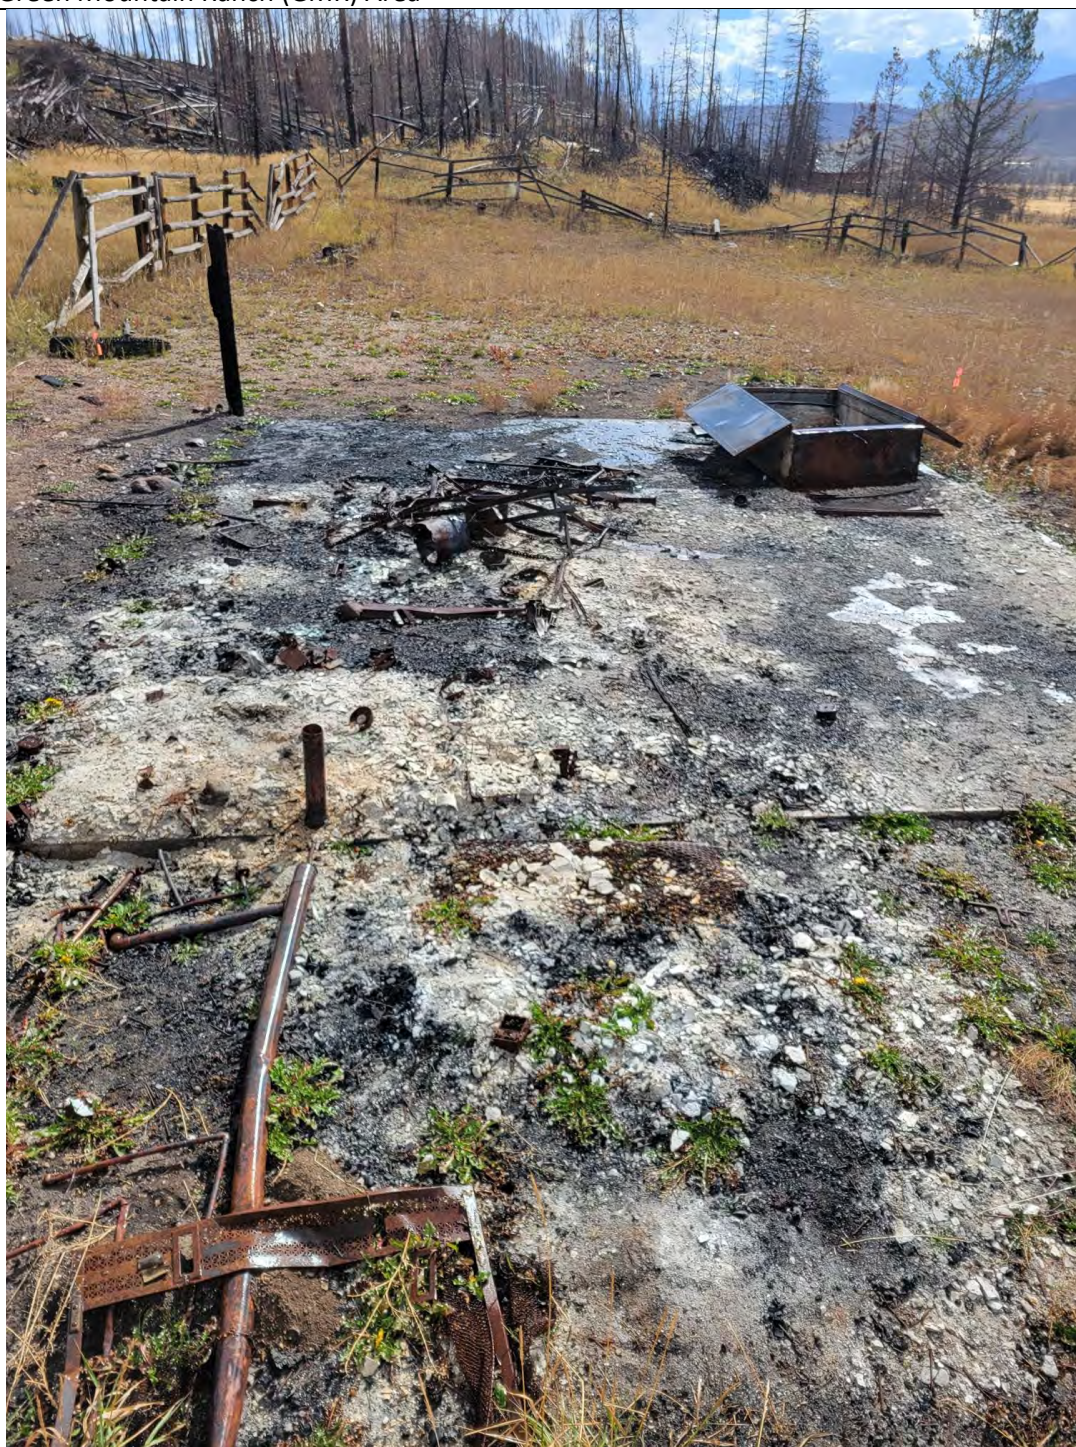
Building: 0724, GMR Barn

Site ID/ Site Name:	0724 / GMR Barn	Date:	9/29/2022 3:00PM
Building Footprint (Length x Width) (ft):	26 x 21.5	Sample Footprint (Length x Width) (ft):	36 x 31.5
Building Footprint (sq. ft):	559	Sample Footprint (sq. ft):	1134
Ash/ small inseparable debris depth in Building footprint (in):	1-4 in		
White Goods (count, location, and type):	None		
Identifiable hazardous materials (count, location, and type):	None		
Suspected or potential hazardous materials or containers (count, location, and type):	None		
Metal debris estimated volume:	60lbs		
Other large debris that may be segregated for recycling or disposal estimated volume:	Metal storage rack, electrical box, outlets, buckets, misc piping		
Other notes:	Concrete slab, north wall collapsed outward, sinkhole to north of structure.

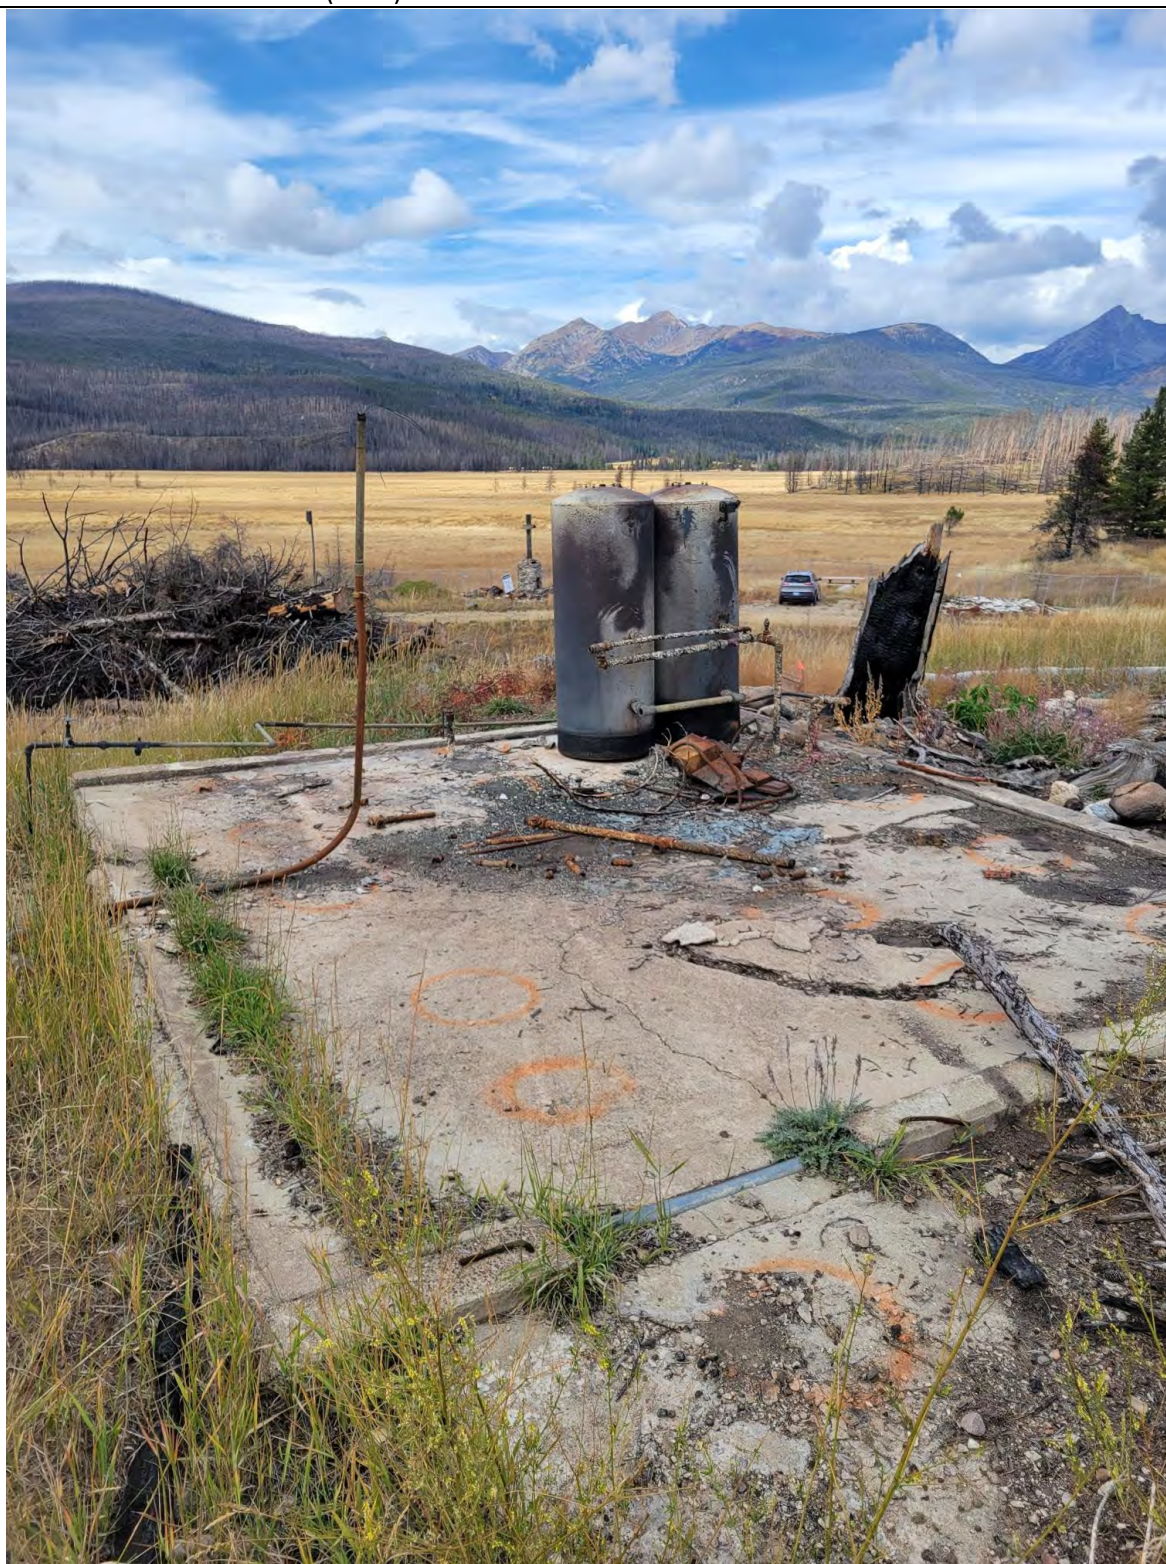
Building: 0853, GMR Pumphouse

Site ID/ Site Name:	0853 / GMR Old Pumphouse	Date:	9/29/2022 12:13PM
Building Footprint (Length x Width) (ft):	14 x 17	Sample Footprint (Length x Width) (ft):	24 x 27
Building Footprint (sq. ft):	238	Sample Footprint (sq. ft):	648
Ash/ small inseparable debris depth in Building footprint (in):	0-1 in		
White Goods (count, location, and type):	Large water tanks (2), water tank piping, control boxes (2)		
Identifiable hazardous materials (count, location, and type):	None		
Suspected or potential hazardous materials or containers (count, location, and type):	None		
Metal debris estimated volume:	150 lbs		
Other large debris that may be segregated for recycling or disposal estimated volume:	Misc metal piping, electrical outlet boxes		
Other notes:	Concrete slab foundation, piping in foundation, medium sinkhole to south of structure (4 ft x 4 ft wide, 6 ft deep) likely UST collapse.

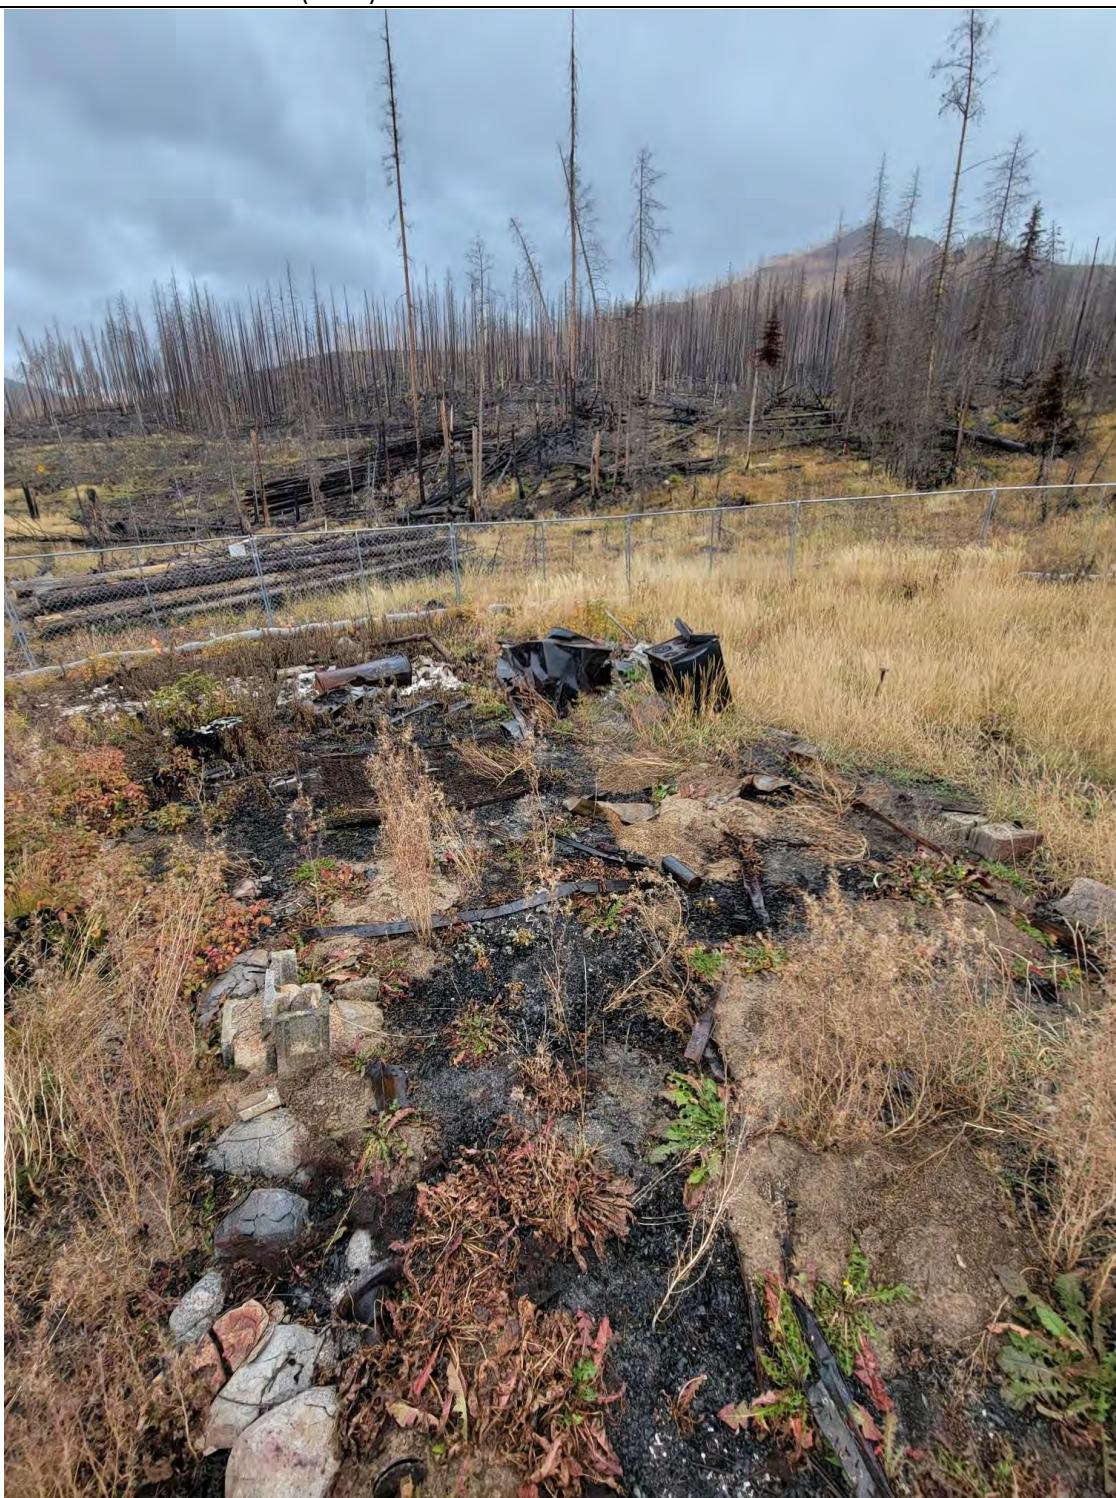
Building: 0579, Onahu Ranch Bakuni Cottage
Park Region: Green Mountain Ranch (GMR) Area

Site ID/ Site Name:	0579 / Onahu Ranch Bakuni Cottage	Date:	9/29/2022 2:47PM
Building Footprint (Length x Width) (ft):	11.5 x 31	Sample Footprint (Length x Width) (ft):	21.5 x 41
Building Footprint (sq. ft):	356.5	Sample Footprint (sq. ft):	881.5
Ash/ small inseparable debris depth in Building footprint (in):	1-2 in		
White Goods (count, location, and type):	Stove, water tank, refrigerator, sink, electrical box (2), microwave		
Identifiable hazardous materials (count, location, and type):	None		
Suspected or potential hazardous materials or containers (count, location, and type):	Fire extinguisher (discharged)		
Metal debris estimated volume:	200 lbs		
Other large debris that may be segregated for recycling or disposal estimated volume:	Gutters, lamps, metal sheeting, bed frame, outlet boxes		
Other notes:	Cinder block footings, in ground plumbing, roofing material, collapsed bricks.

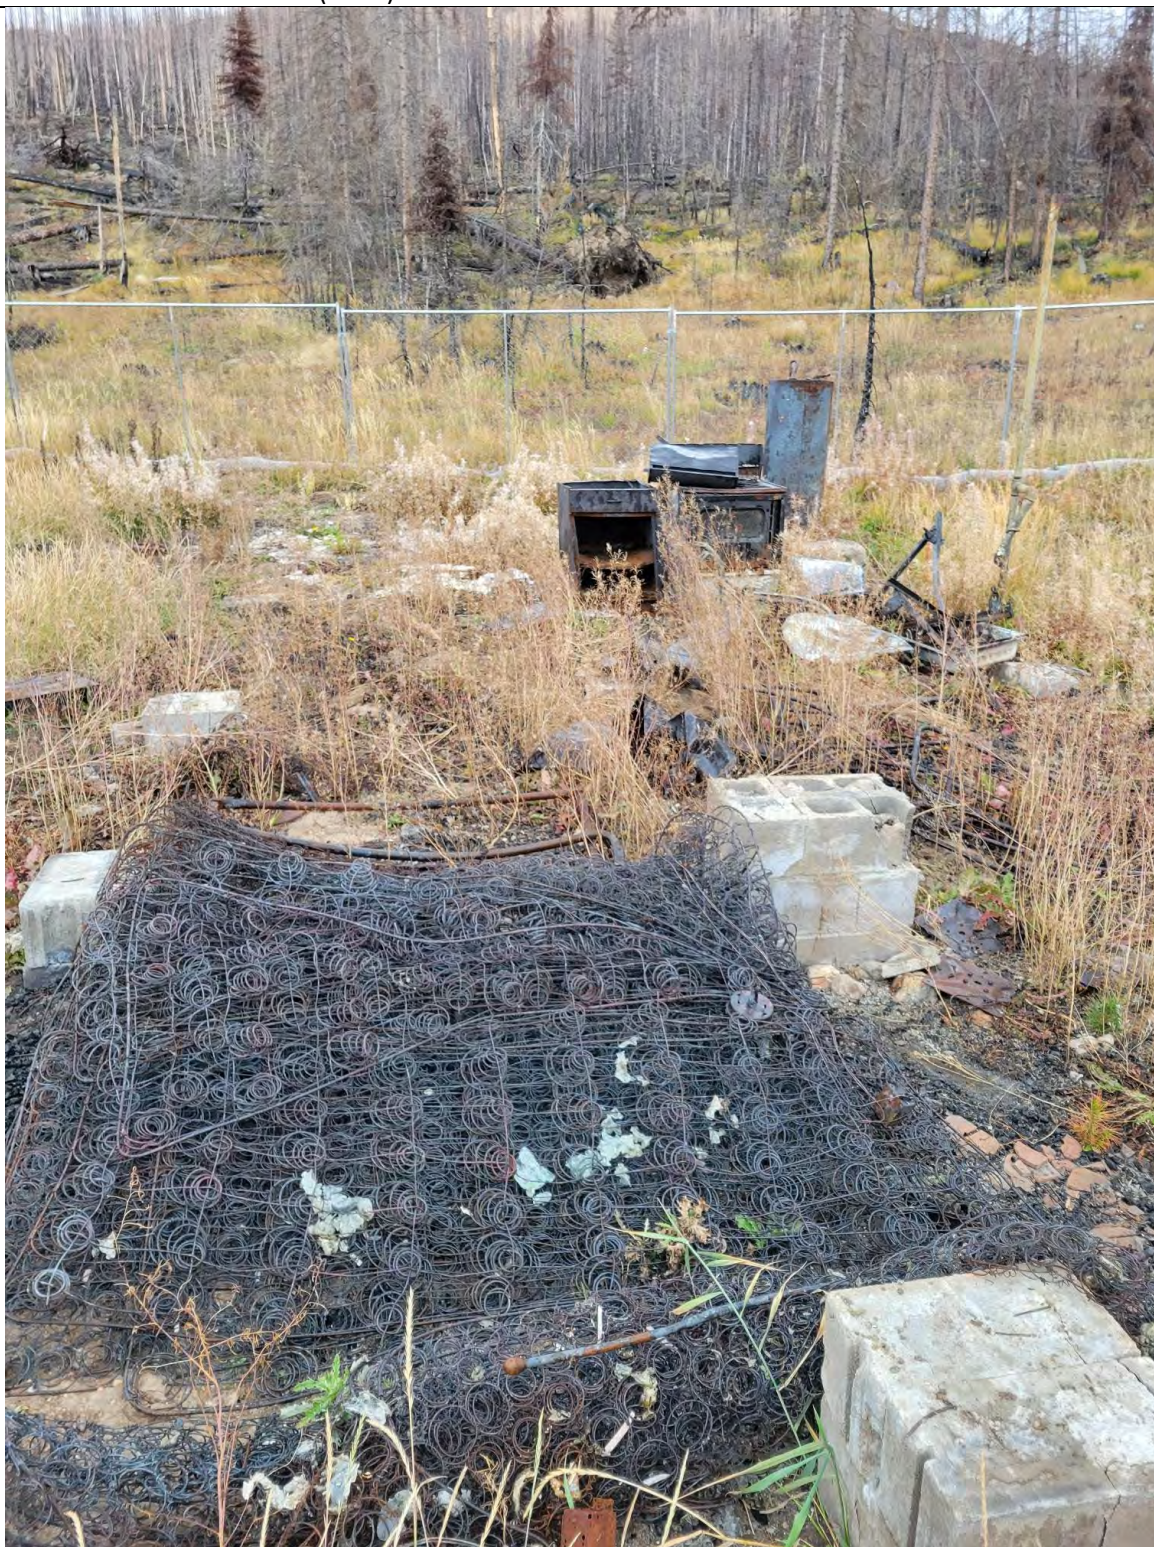
Building: 0578, Onahu Ranch Na Ha Non Cottage

Site ID/ Site Name:	0578 / Onahu Ranch Na Ha Non Cottage	Date:	9/29/2022 2:40 PM
Building Footprint (Length x Width) (ft):	15 x 30	Sample Footprint (Length x Width) (ft):	25 x 40
Building Footprint (sq. ft):	450	Sample Footprint (sq. ft):	1000
Ash/ small inseparable debris depth in Building footprint (in):	2-4 in		
White Goods (count, location, and type):	Stove, refrigerator, water tank, kitchen cabinet, sink, electrical box, space heater/fan, stove exhaust fan housing		
Identifiable hazardous materials (count, location, and type):	None		
Suspected or potential hazardous materials or containers (count, location, and type):	None		
Metal debris estimated volume:	200 lbs		
Other large debris that may be segregated for recycling or disposal estimated volume:	Gutters, bed frame (large), metal piping, misc metal frames		
Other notes:	Concrete footings, no bricks, no chimney.
