STATEMENT OF WORK
EAST TROUBLESOME FIRE TIME CRITICAL REMOVAL ACTION
ROCKY MOUNTAIN NATIONAL PARK

BB&E, Inc. (BB&E) completed an inspection of 26 burned structures at Rocky Mountain National Park to assess the type and quantity of building debris in preparation for a Time Critical Removal Action (TCRA). The inspection was conducted on 9/29/2022 and 10/5/2022 in tandem with the soil/ash field sampling event. BB&E identified the following:

Site Inspection Field Sampling Event East Troublesome Fire Damaged Structures
Rocky Mountain Nation Park

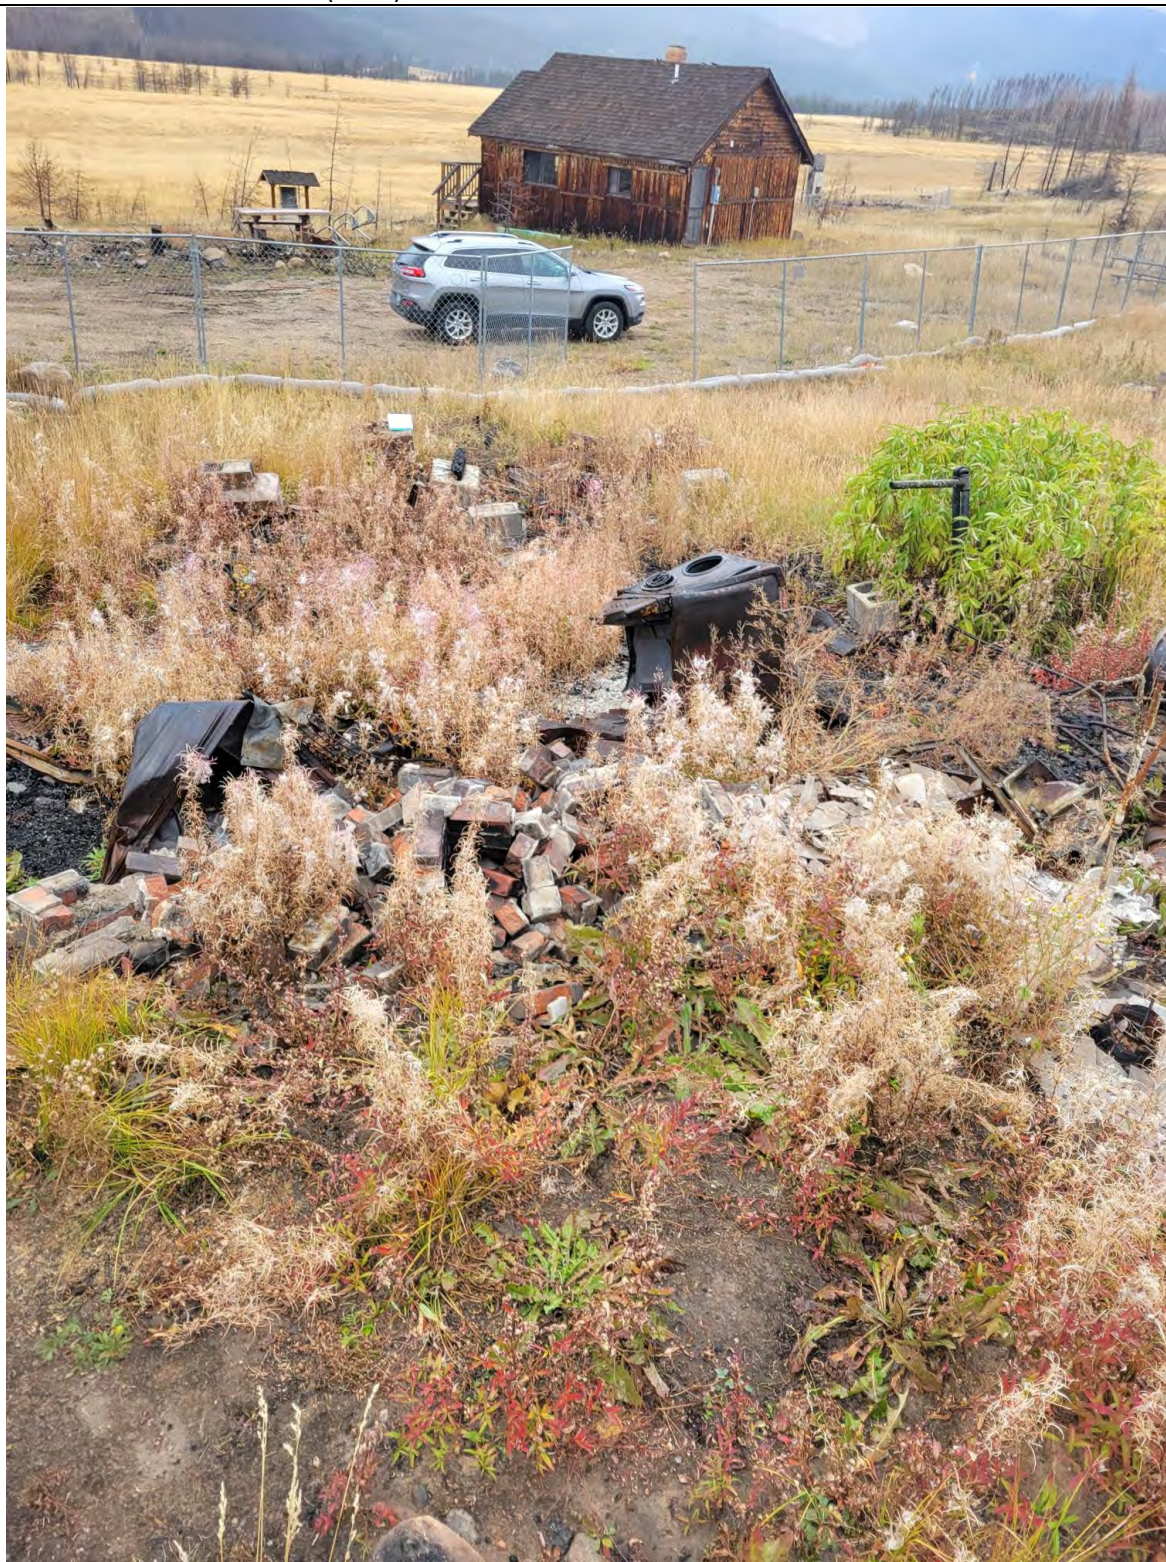
Building: 0577, Onahu Ranch Ho Ta Ta Ha Cottage

Site ID/ Site Name:	0577 / Onahu Ranch Ho Ta Ta Ha Cottage	Date:	9/29/2022 2:33PM
Building Footprint (Length x Width) (ft):	12 x 28	Sample Footprint (Length x Width) (ft):	22 x 38
Building Footprint (sq. ft):	336	Sample Footprint (sq. ft):	836
Ash/ small inseparable debris depth in Building footprint (in):	2-4 in		
White Goods (count, location, and type):	Stove, refrigerator, water tank, sinks (2), utility boxes.		
Identifiable hazardous materials (count, location, and type):	None		
Suspected or potential hazardous materials or containers (count, location, and type):	None		
Metal debris estimated volume:	150 lbs		
Other large debris that may be segregated for recycling or disposal estimated volume:	Gutters, bedframe, metal ladder/stand, metal countertop, metal chairs, lamp post, piping, electrical outlet boxes.		
Other notes:	Concrete footers, in ground metal plumbing (bath), roofing materials, bricks.

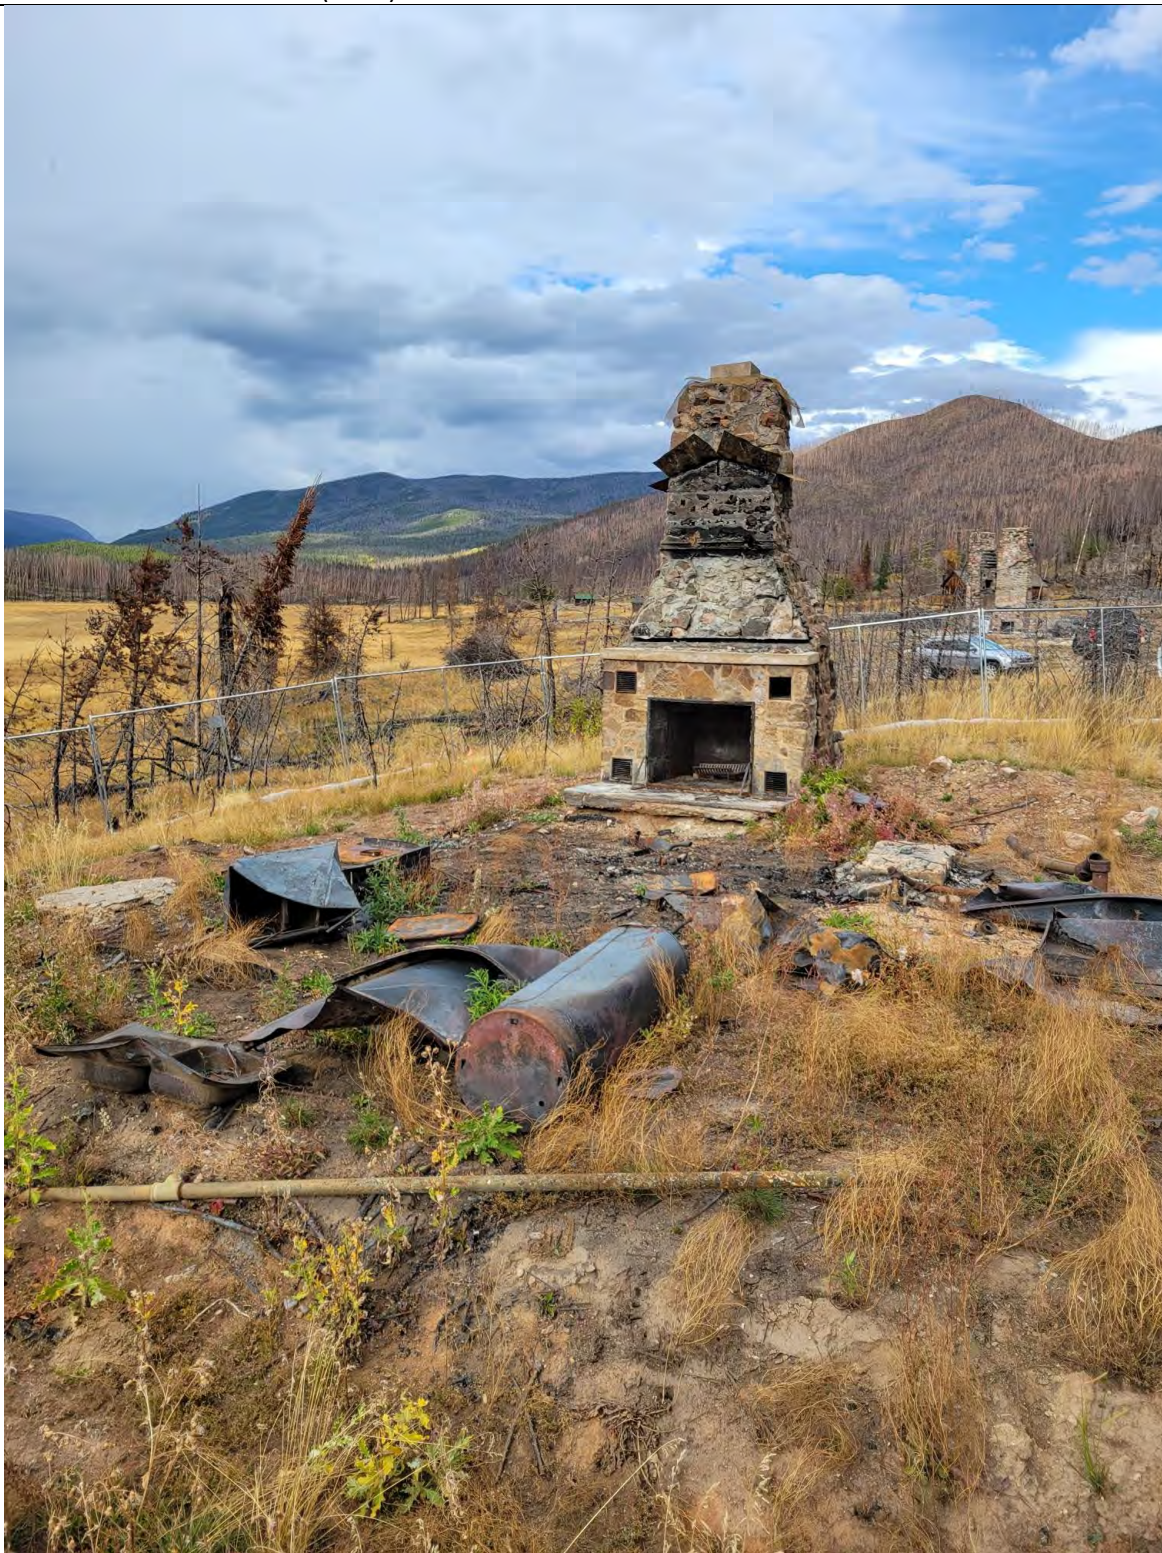
Building: 0583, Onahu Ranch Abasaw Aw Xa Cottage
Park Region: Green Mountain Ranch (GMR) Area

Site ID/ Site Name:	0583 / Onahu Ranch Abasaw Aw Xa Cottage	Date:	9/29/2022 3:40PM
Building Footprint (Length x Width) (ft):	21.5 x 26.3	Sample Footprint (Length x Width) (ft):	31.5 x 36.3
Building Footprint (sq. ft):	565.45	Sample Footprint (sq. ft):	1143.45
Ash/ small inseparable debris depth in Building footprint (in):	0-1 in		
White Goods (count, location, and type):	Water tank, stove, sink, large space heater unit, electrical boxes (2)		
Identifiable hazardous materials (count, location, and type):	None		
Suspected or potential hazardous materials or containers (count, location, and type):	None		
Metal debris estimated volume:	200 lbs		
Other large debris that may be segregated for recycling or disposal estimated volume:	Metal sheeting, piping, gutters, metal storage unit, metal sheeting		
Other notes:	Chimney, large concrete footers, picnic table legs, in ground piping.

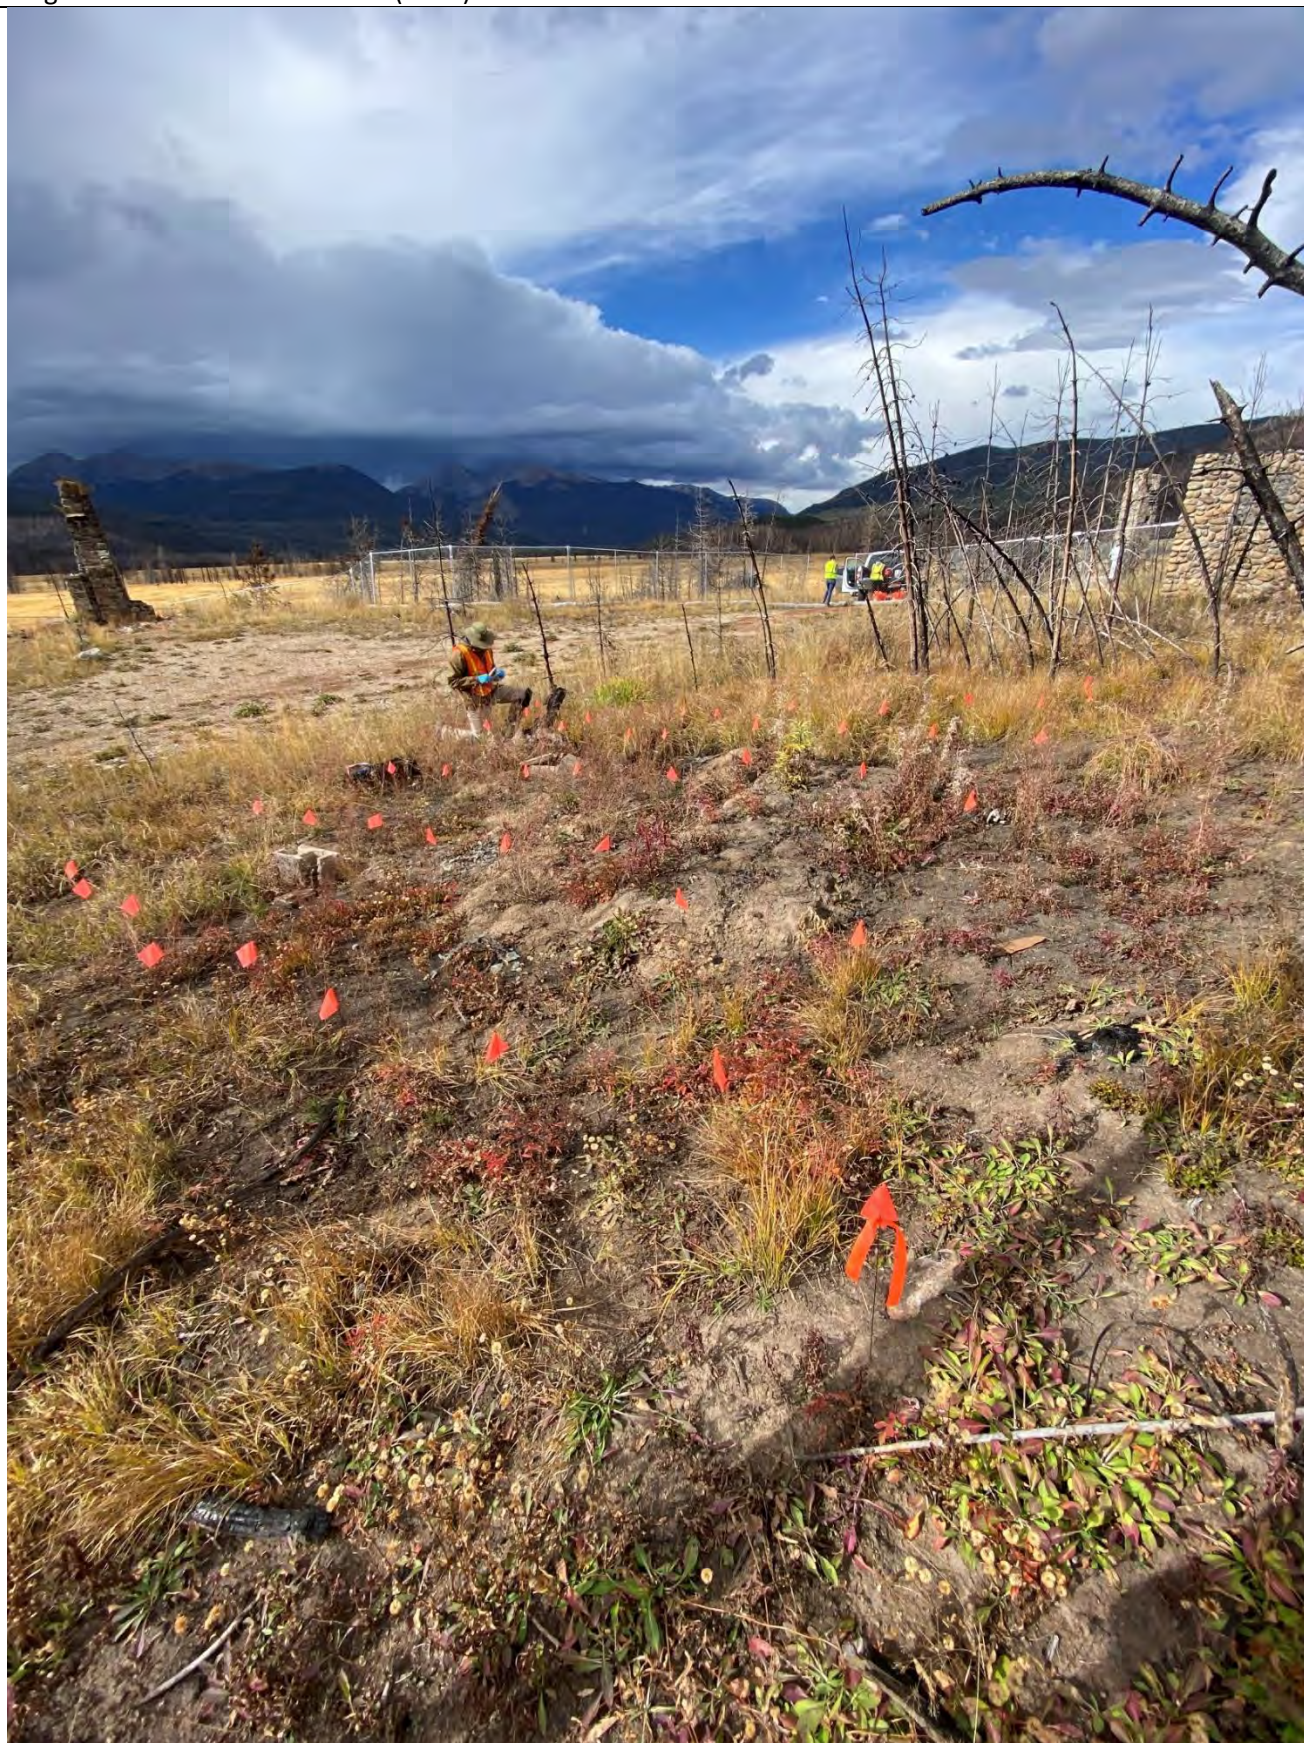
Building: 0624, Onahu Ranch Tool Shed

Site ID/ Site Name:	0624 / Onahu Ranch Tool Shed	Date:	9/29/2022 3:55PM
Building Footprint (Length x Width) (ft):	17 x 10	Sample Footprint (Length x Width) (ft):	27 x 20
Building Footprint (sq. ft):	170	Sample Footprint (sq. ft):	540
Ash/ small inseparable debris depth in Building footprint (in):	0		
White Goods (count, location, and type):	None		
Identifiable hazardous materials (count, location, and type):	None		
Suspected or potential hazardous materials or containers (count, location, and type):	None		
Metal debris estimated volume:	None		
Other large debris that may be segregated for recycling or disposal estimated volume:	None		
Other notes:	Cinder blocks

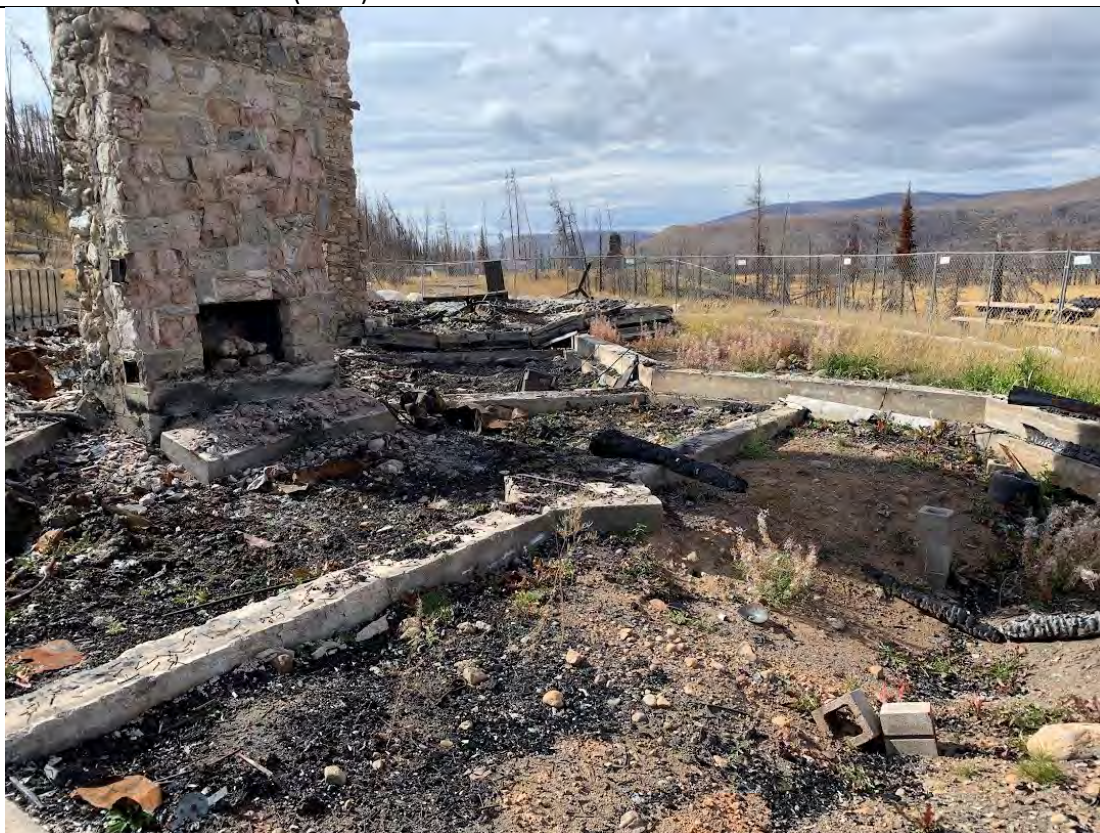
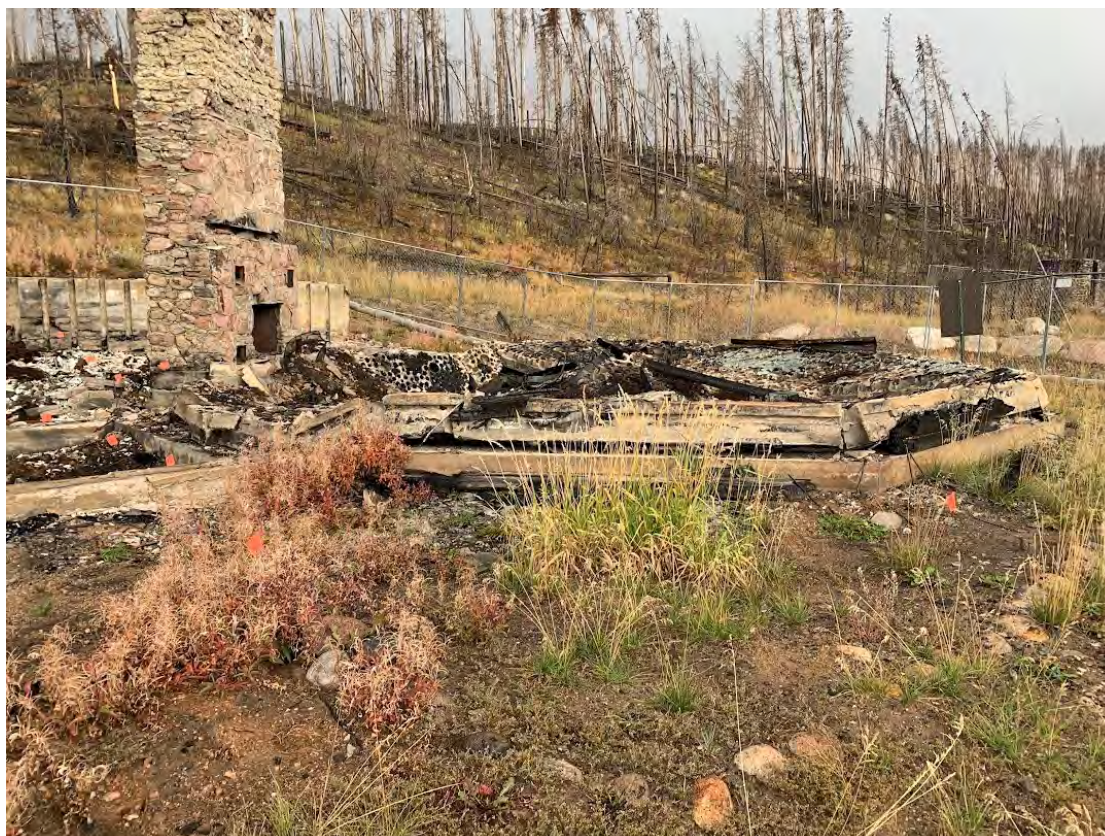
Building: 0575, Onahu Ranch Lodge

Site ID/ Site Name:	0575 / Onahu Ranch Lodge	Date:	9/29/2022
Building Footprint (Length x Width) (ft):	55 x 41	Sample Footprint (Length x Width) (ft):	65 x 51
Building Footprint (sq. ft):	2255	Sample Footprint (sq. ft):	3315
Ash/ small inseparable debris depth in Building footprint (in):	Varies widely. 2-4 in on west half of building (50% of structure). 2-5 ft on east half of building where basement/crawlspace collapsed and debris piled (50% of structure).		
White Goods (count, location, and type):	Water tank, possibly other white good buried.		
Identifiable hazardous materials (count, location, and type):	None observed, possibly buried.		
Suspected or potential hazardous materials or containers (count, location, and type):	None observed, possibly buried.		
Metal debris estimated volume:	Tentatively 200 lbs, unknown quantity buried.		
Other large debris that may be segregated for recycling or disposal estimated volume:	Misc metal sheeting, fire place grates, metal piping, lighting housings, likely other large debris/recyclables buried.

Other notes:	Substantial ruins include two stone chimneys (2 stories), partial foundation, concrete flooring, concrete retaining wall (east edge) and collapsed basement/crawl space.

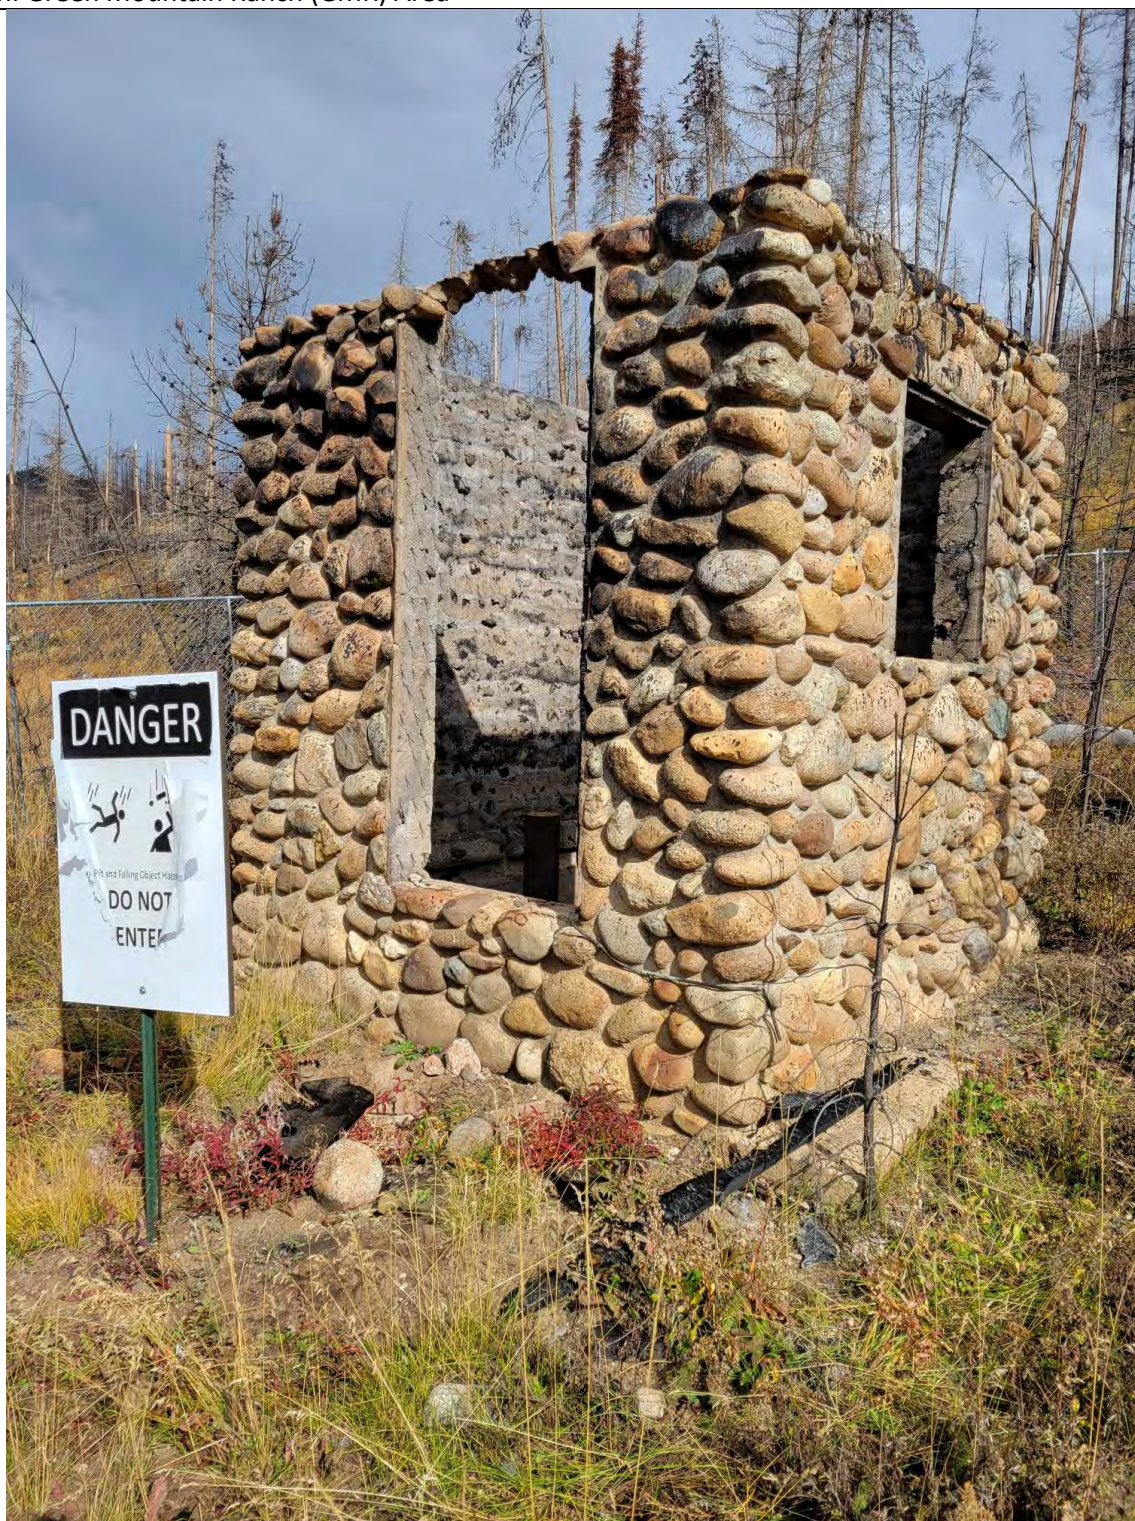
Building: 0587, Onahu Ranch Pumphouse

Site ID/ Site Name:	0587 / Onahu Ranch Pumphouse	Date:	9/29/2022 3:24PM
Building Footprint (Length x Width) (ft):	7.5 x 10.5	Sample Footprint (Length x Width) (ft):	17.5 x 20.5
Building Footprint (sq. ft):	78.75	Sample Footprint (sq. ft):	358.75
Ash/ small inseparable debris depth in Building footprint (in):	Unknown in pit, assumed 12 inches.		
White Goods (count, location, and type):	Large water tank in pit (approximately 3 feet diameter by 8 ft height) and associated piping		
Identifiable hazardous materials (count, location, and type):	None		
Suspected or potential hazardous materials or containers (count, location, and type):	None		
Metal debris estimated volume:	750 lbs		
Other large debris that may be segregated for recycling or disposal estimated volume:	NA		
Other notes:	Structure walls standing, pit approximately 8 feet deep, minimal debris surrounding building, roof collapsed into pit, plastic bins NW of structure (possibly garbage bins, melted)

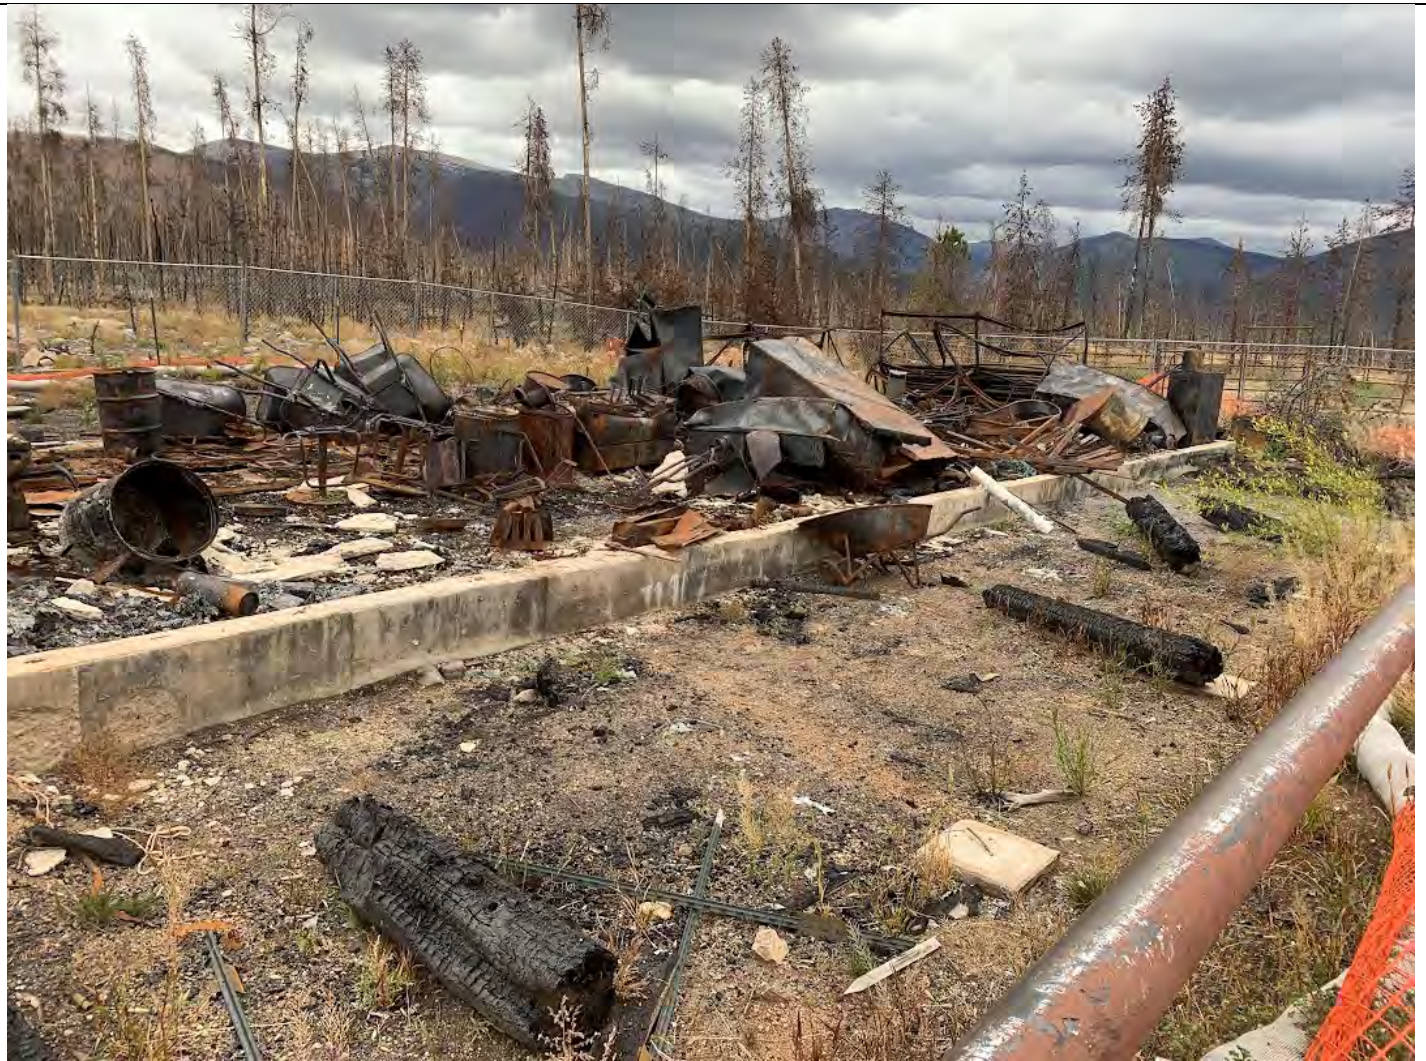
Building: 0783, Timber Creek Road Camp Barn
Park Region: Timber Creek Road Camp

Site ID/ Site Name:	783 / Timber Creek Road Camp Barn	Date:	9/29/2022 5:00 PM
Building Footprint (Length x Width) (ft):	56 x 21	Sample Footprint (Length x Width) (ft):	66 x 31
Building Footprint (sq. ft):	1176	Sample Footprint (sq. ft):	2046
Ash/ small inseparable debris depth in Building footprint (in):	0-1 in		
White Goods (count, location, and type):	None		
Identifiable hazardous materials (count, location, and type):	2 drums (unknown contents) – center and north, compressed gas cylinder (unknown contents or discharge status) – north, fire extinguisher (discharge status unknown)– north wall.		
Suspected or potential hazardous materials or containers (count, location, and type):	Numerous fuel containers throughout unknown contents (discharged). Large portable generator – east center wall. Spray cans (discharged)		
Metal debris estimated volume:	Significant metal debris, quantity difficult to estimate due to piling of debris. Approximately 1800 lbs.

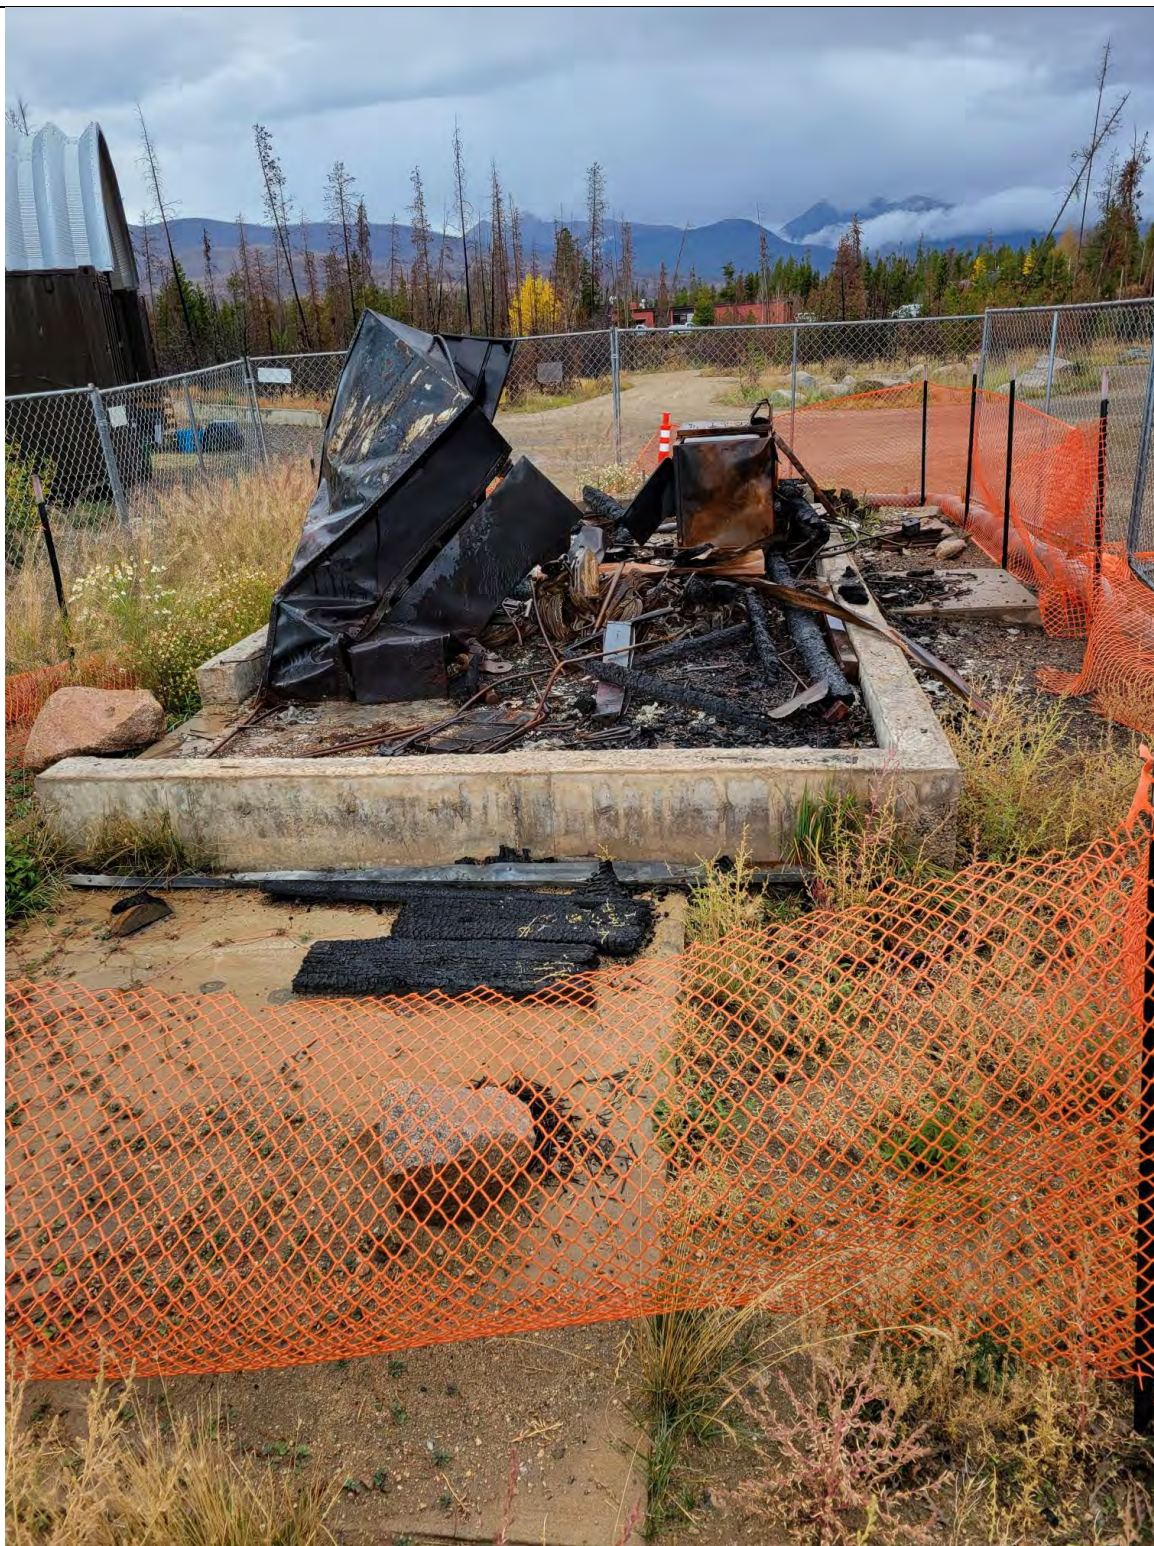
Building: 0572, Timber Creek Road Camp Barn Tack Shed
Park Region: Timber Creek Road Camp

5.16.5. Ash, and small debris from the Tack Shed site (Building ID 572) was identified through TCLP testing to possess the Toxicity Characteristic for lead and must be transported and disposed as Hazardous Waste in accordance with RCRA.

572	Timber Creek Road Camp Barn Tack Shed	312	792	0	4	21	4	0.5	7	Yes - full building footprint	Not observed - discharged aerosol spray cans	Ash and small debris Hazardous - TCLP lead
Area Total				5	4	74	24	3	35

Site ID/ Site Name:	572 / Timber Creek Road Camp Barn Tack Shed	Date:	9/29/2022 4:45 PM
Building Footprint (Length x Width) (ft):	12 x 26	Sample Footprint (Length x Width) (ft):	22 x 36
Building Footprint (sq. ft):	312	Sample Footprint (sq. ft):	792
Ash/ small inseparable debris depth in Building footprint (in):	1-3 in		
White Goods (count, location, and type):	Washer and Dryer, water tank, electrical box.		
Identifiable hazardous materials (count, location, and type):	None		
Suspected or potential hazardous materials or containers (count, location, and type):	Spray cans (discharged)		
Metal debris estimated volume:	300 lbs		
Other large debris that may be segregated for recycling or disposal estimated volume:	Metal storage unit, metal sheeting, metal piping, metal chair, metal cabling spools (several of various gauges), gutters, misc hand tools/ small size equipment.		
Other notes:	Concrete foundation slab, storage pad extends to south of structure.

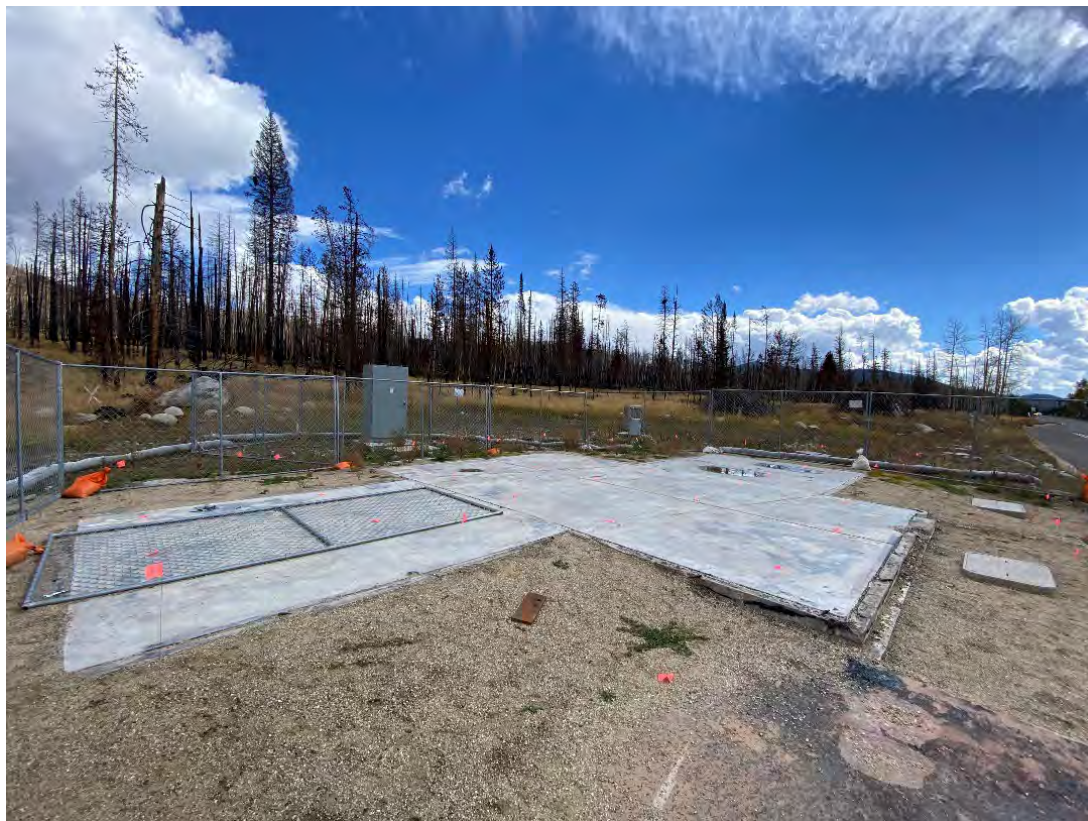
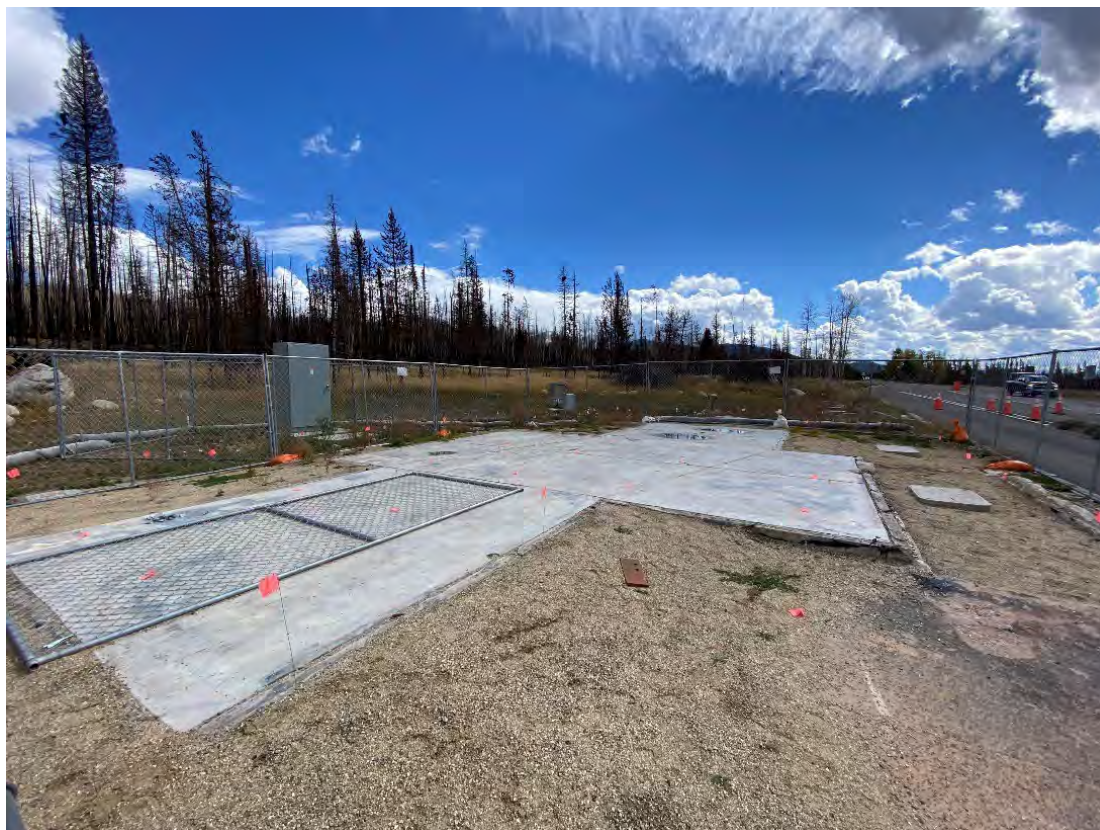
Building: 1141, Remit Office

Site ID/ Site Name:	1141 / Grand Lake Entrance Station	Date:	9/29/2022
Building Footprint (Length x Width) (ft):	39.7 x 24.1	Sample Footprint (Length x Width) (ft):	49.7 x 34.1
Building Footprint (sq. ft):	956.77	Sample Footprint (sq. ft):	1694.77
Ash/ small inseparable debris depth in Building footprint (in):	None		
White Goods (count, location, and type):	None		
Identifiable hazardous materials (count, location, and type):	None		
Suspected or potential hazardous materials or containers (count, location, and type):	None		
Metal debris estimated volume:	None		
Other large debris that may be segregated for recycling or disposal estimated volume:	None		
Other notes:	Site debris/ash was formerly removed.
