AMENDMENT OF SOLICITATION/MODIFICATION OF CONTRACT		1. CONTRACT ID CODE		PAGE OF PAGES	
				12	
2. AMENDMENT/MODIFICATION NO.		3. EFFECTIVE DATE		4. REQUISITION/PURCHASE REQ. NO.	
0003		01/29/2024		5. PROJECT NO. (If applicable)	
6. ISSUED BY		CODE		ROMO 316223	
NPS, DSC Contracting Services Div		PDS		7. ADMINISTERED BY (If other than Item 6)	
12795 W. Alameda Pkwy				CODE	
P.O. Box 25287					
Denver CO 80225-0287					
8. NAME AND ADDRESS OF CONTRACTOR (No., street, county, State and ZIP Code)		(x)		9A. AMENDMENT OF SOLICITATION NO.	
				140P2024R0022	
		x		9B. DATED (SEE ITEM 11)	
				01/02/2024	
				10A. MODIFICATION OF CONTRACT/ORDER NO.	
				10B. DATED (SEE ITEM 13)	
CODE		FACILITY CODE

The purpose of this amendment is to:

b) Provide Sampling and Analysis Plan dated 5/4/23.

The National Park Service (NPS) is conducting a Site Investigation (SI) to determine the applicability of a Time Critical Removal Action (TCRA) in accordance with the Comprehensive Environmental Response, Compensation, and Liability Act (CERCLA) and the framework provided in the National Oil and Hazardous Substances Pollution Contingency Plan (also known as the National Contingency Plan, NCP) to address p

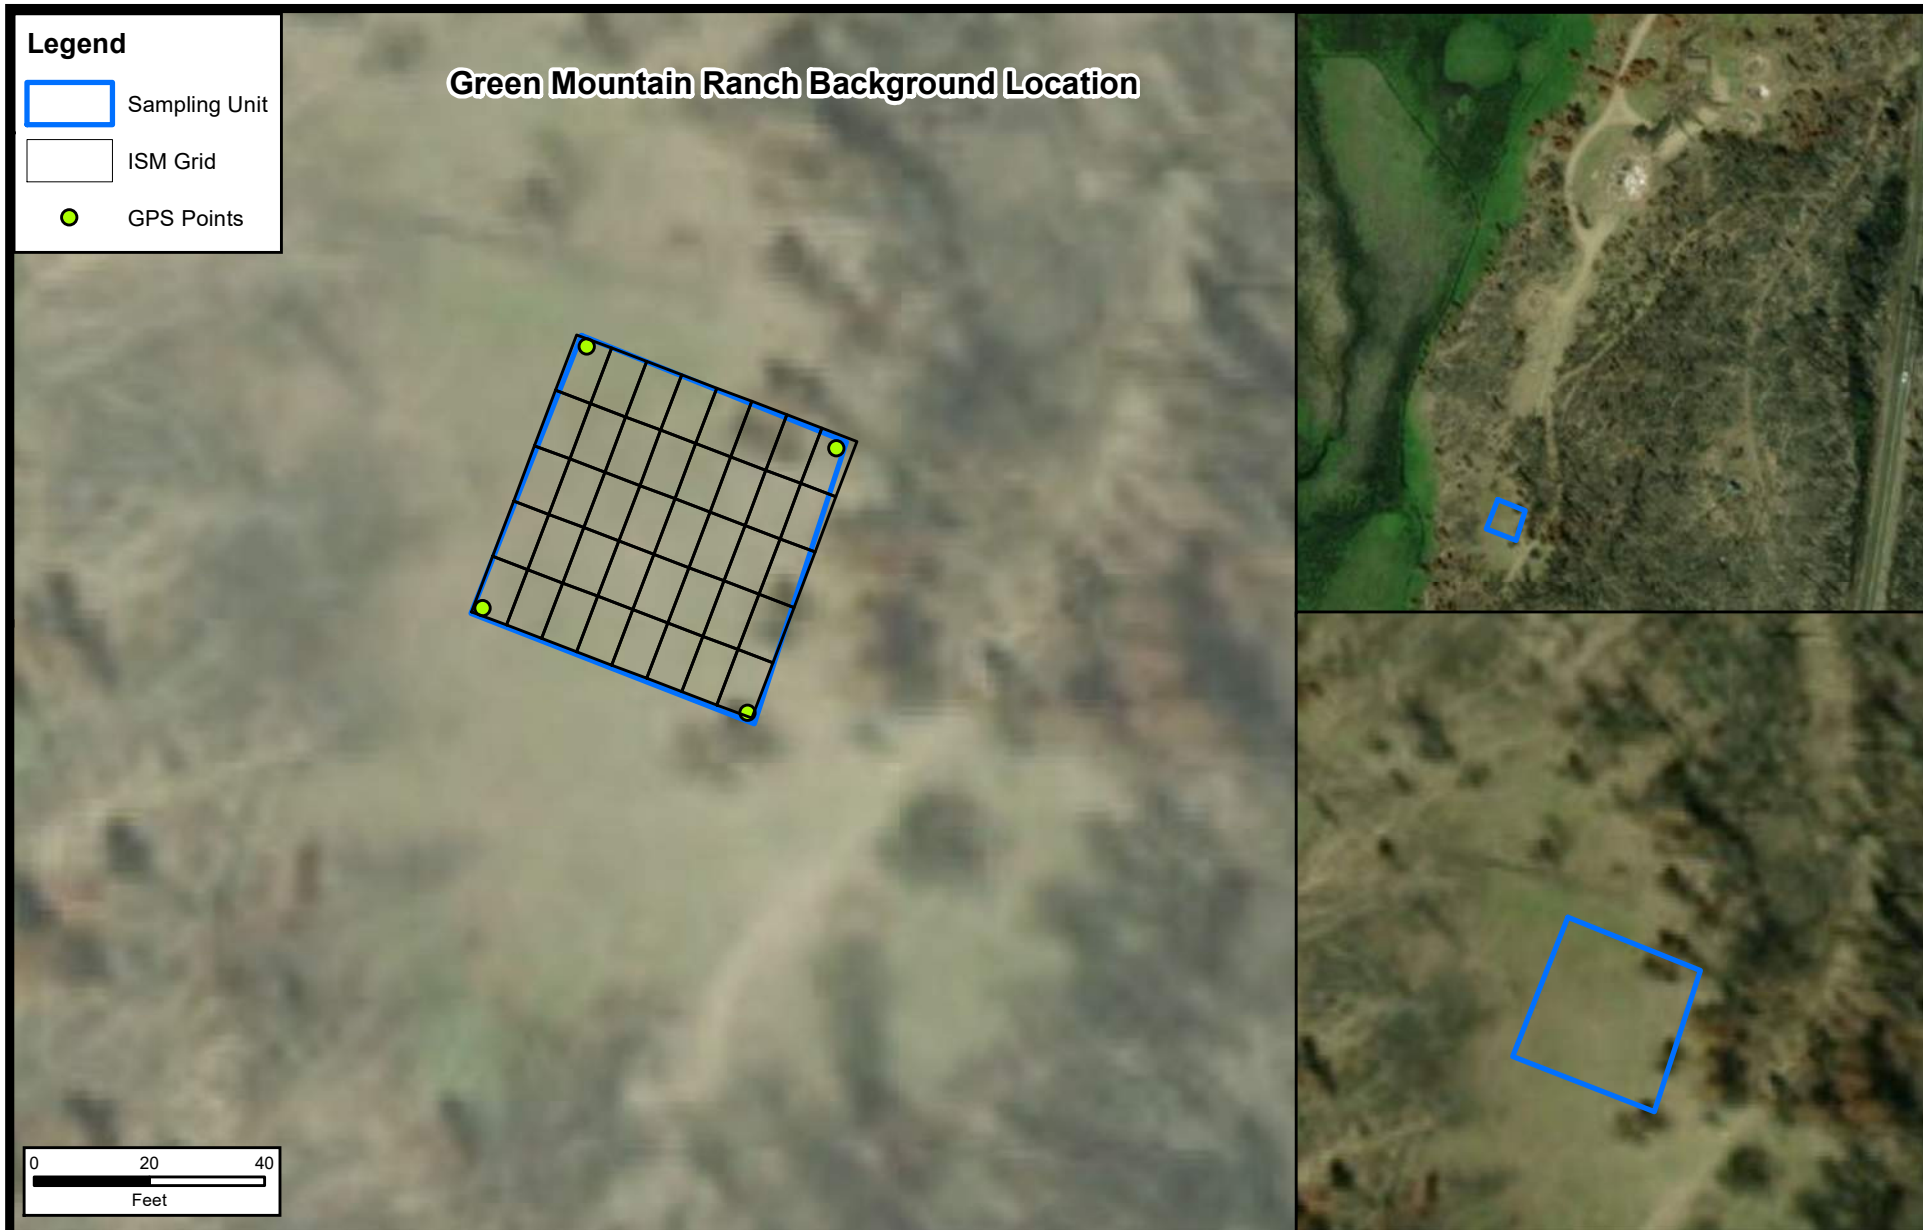
Figure 3a
Green Mountain Ranch Background Location
Green Mountain - Onahu Ranch Area
Time Critical Removal Action Site Inspection Sampling and Analysis Plan
Rocky Mountain National Park - Estes Park, CO

Figures 1 and 2 indicate the location and general size of the burned structures. Figures 3a-3f depict the location and size of the background SUs.

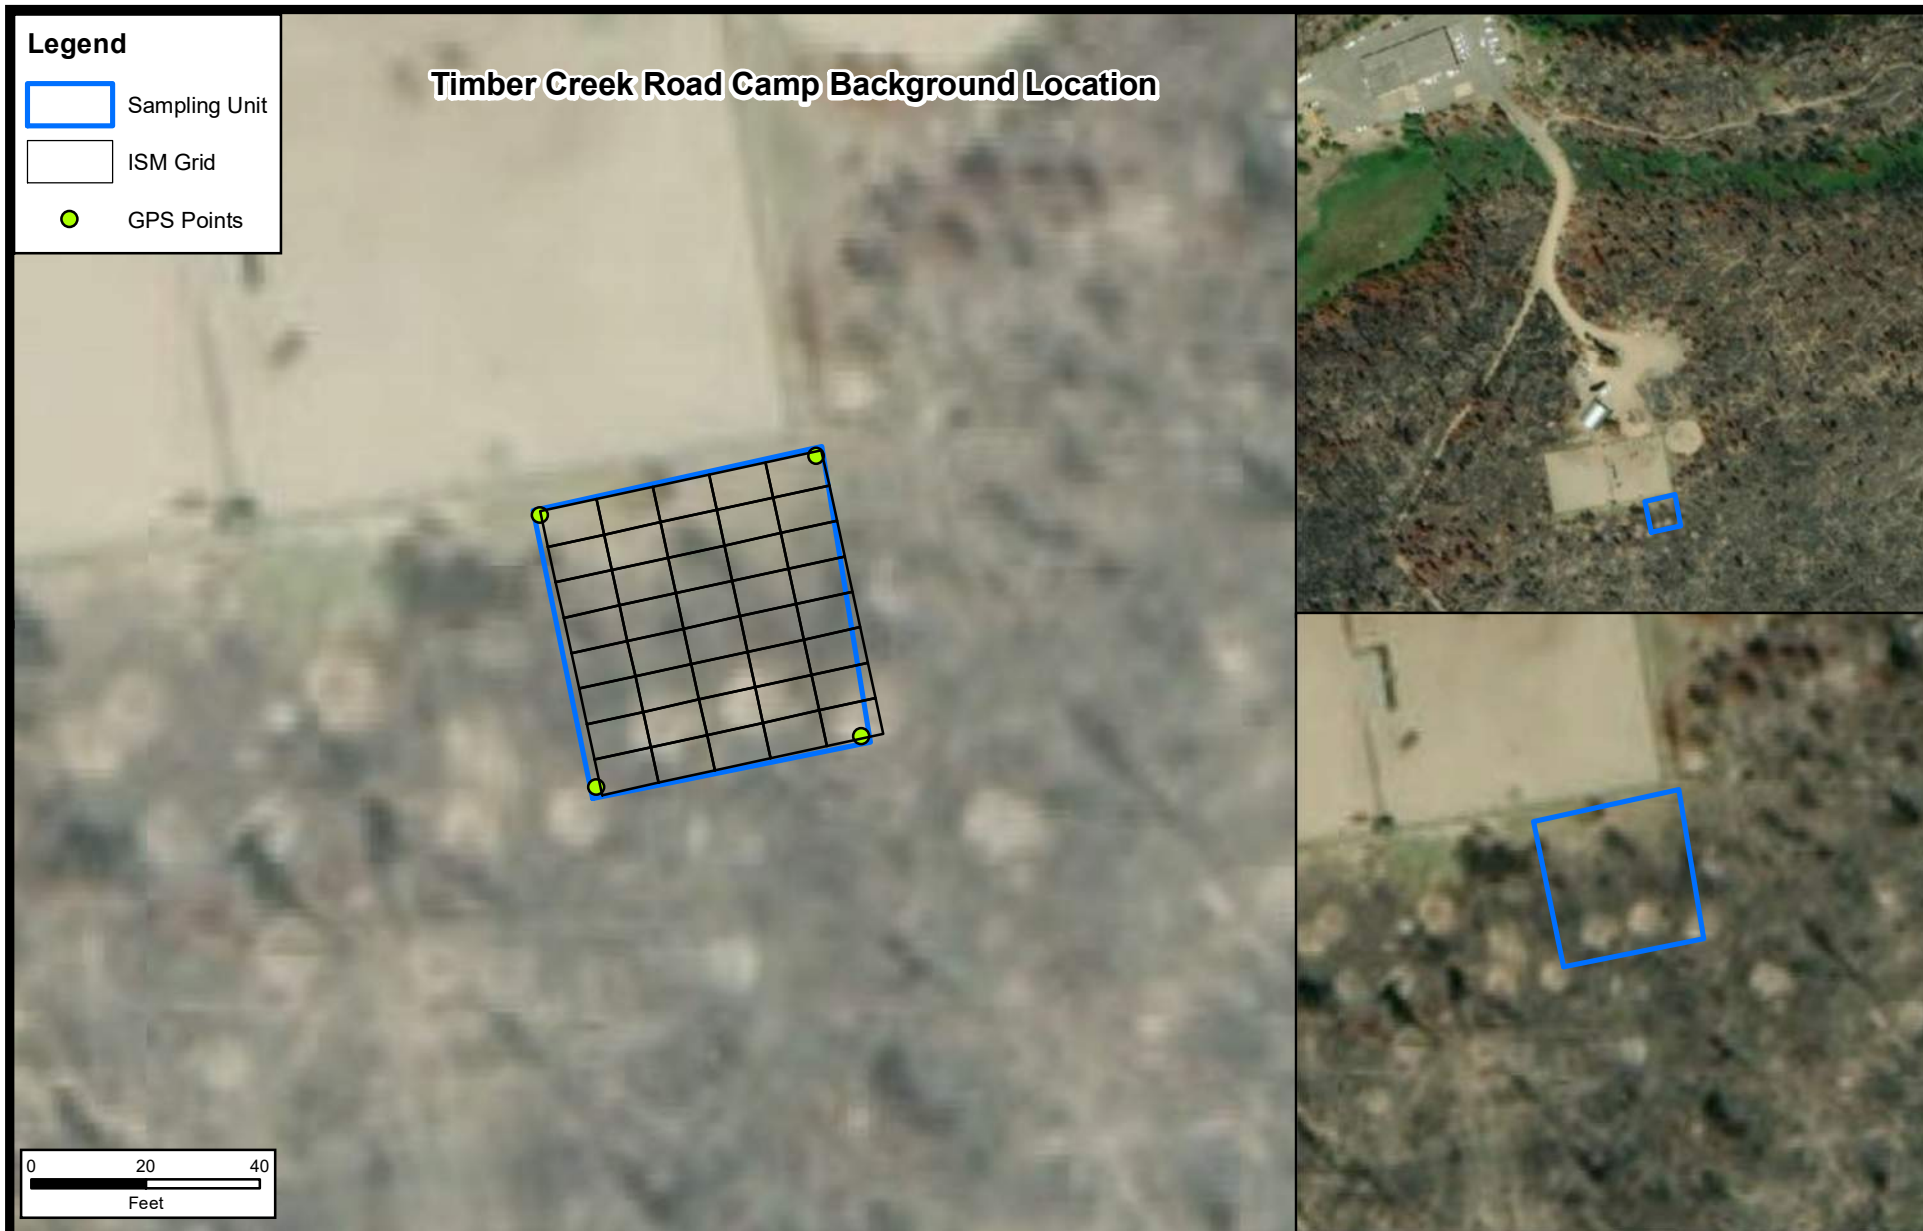
Figure 3b
Timber Creek Road Camp Background Location
Timber Creek Road Camp Buildings
Time Critical Removal Action Site Inspection Sampling and Analysis Plan
Rocky Mountain National Park - Estes Park, CO

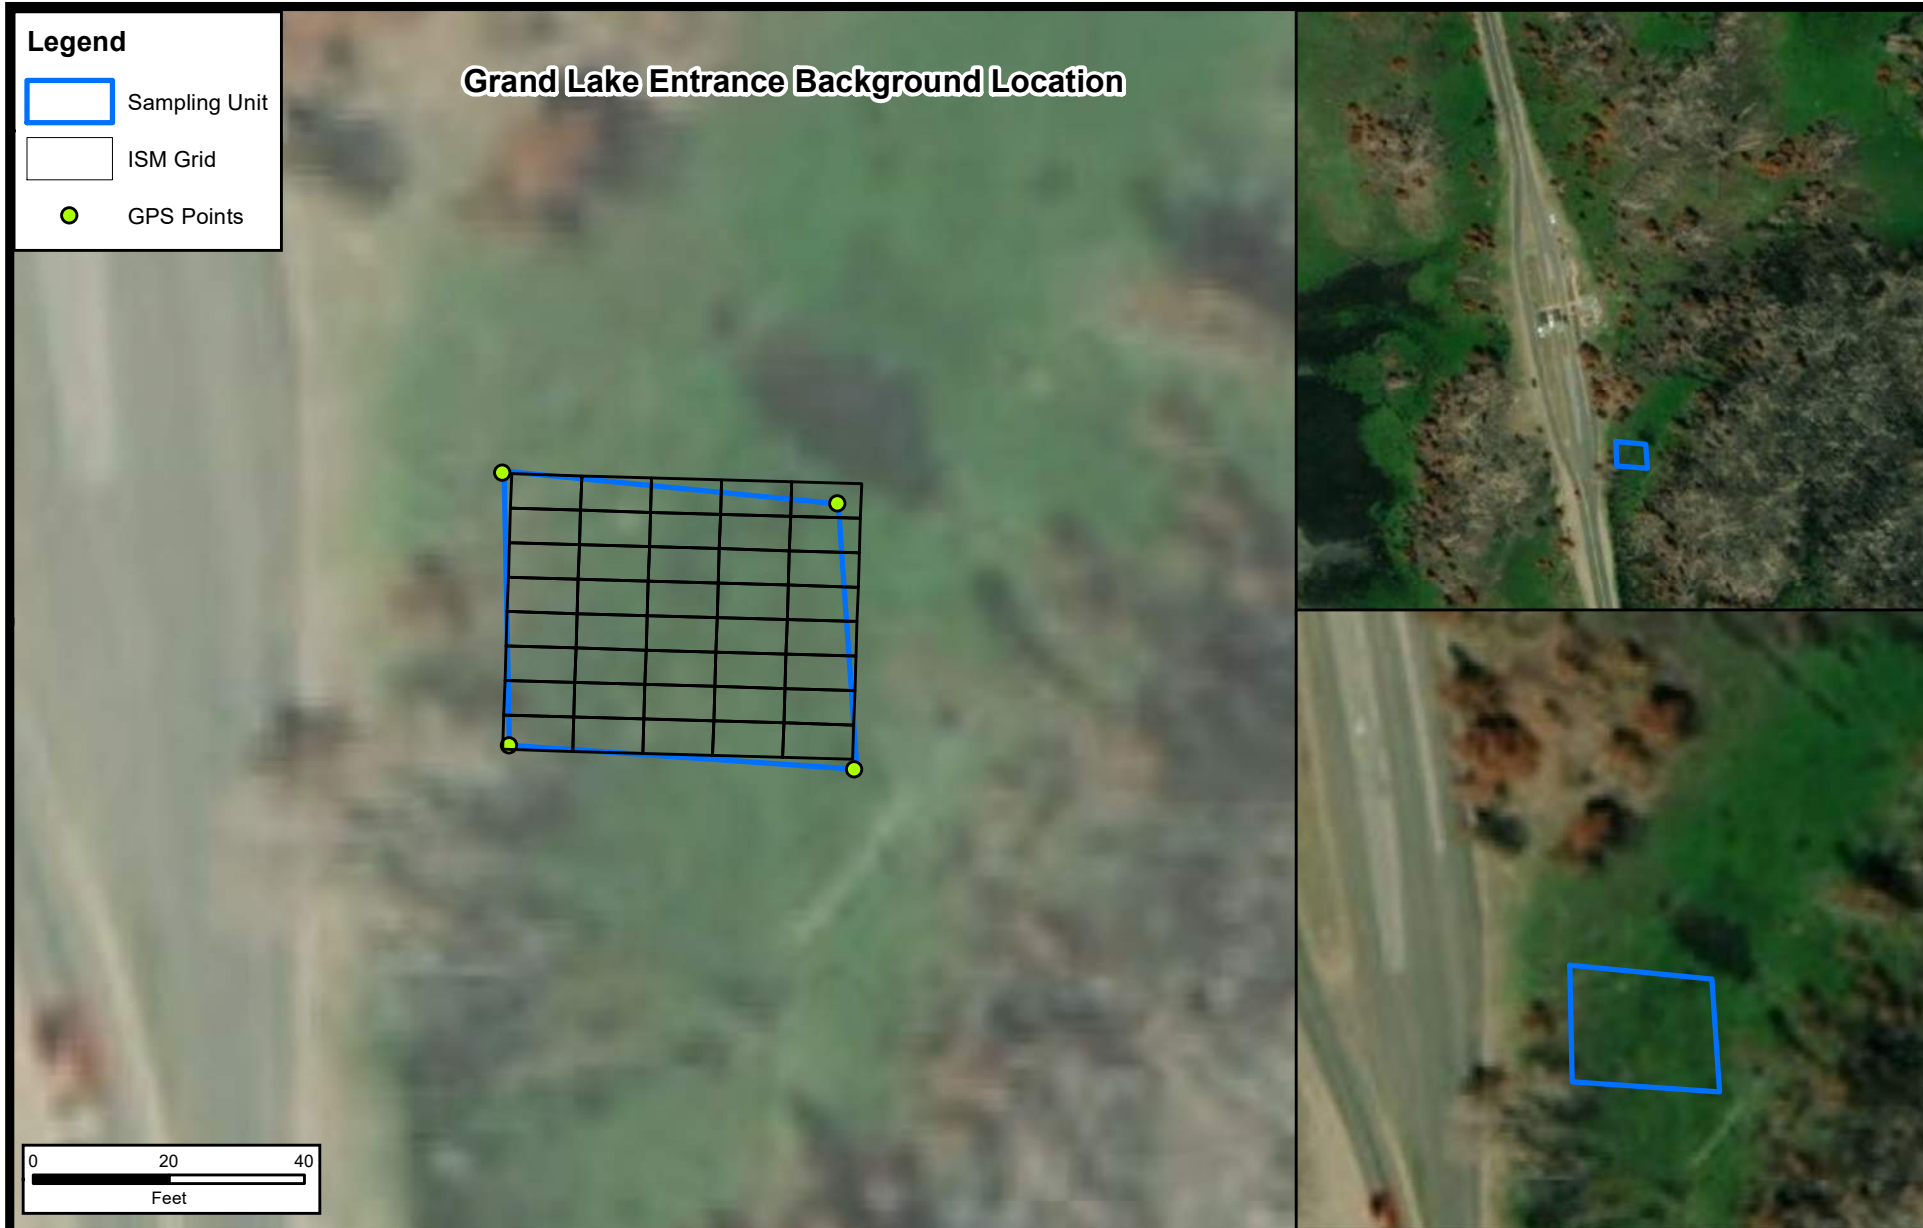
Figure 3c
Grand Lake Entrance Background Location
Grand Lake Entrance Buildings
Time Critical Removal Action Site Inspection Sampling and Analysis Plan
Rocky Mountain National Park - Estes Park, CO

Structure Number	MATRIX	DEPTH	TYPE	TITLE 22 METALS BY 6020A, MERCURY BY 7471B, Waste Disposal TCLP ¹	Chrome VI by 7196	PCBs by 8082A	Dioxins & Furans by 8290
GrMtnWest	Soil/Ash	0-0.25 ft	1 DU with 8 increments at each of the five cottages on the west side of the Green Mountain area (0733, 0734, 0735, 0737, 0740)	0	0	0	1
0853	Soil/Ash	0-0.25 ft	Green Mountain Ranch Pumphouse	1	0	0	1
R-Moraine	Soil/Ash	0-0.25 ft	Northwest of the Moraine Stables structures, See Figure 3a	3	0	0	3
R-Fern	Soil/Ash	0-0.25 ft	North of the Fern Lake Ranger Stations, See Figure 3b	3	1	0	3
R-Timber Creek	Soil/Ash	0-0.25 ft	South of the paddock area at Timber Creek Road Camp, See Figure 3c	3	1	0	3
R-Green	Soil/Ash	0-0.25 ft	Located in the center of the Green Mountain area, west of Structure 0724, See Figure 3d	3	0	0	3
R-Betty Dick	Soil/Ash	0-0.25 ft	West of the Betty Dick Ranch building, See Figure 3e	3	0	0	3
R-Grand Lake Entrance	Soil/Ash	0-0.25 ft	South of the Grand Lake Entrance Station, See Figure 3f	3	0	0	3

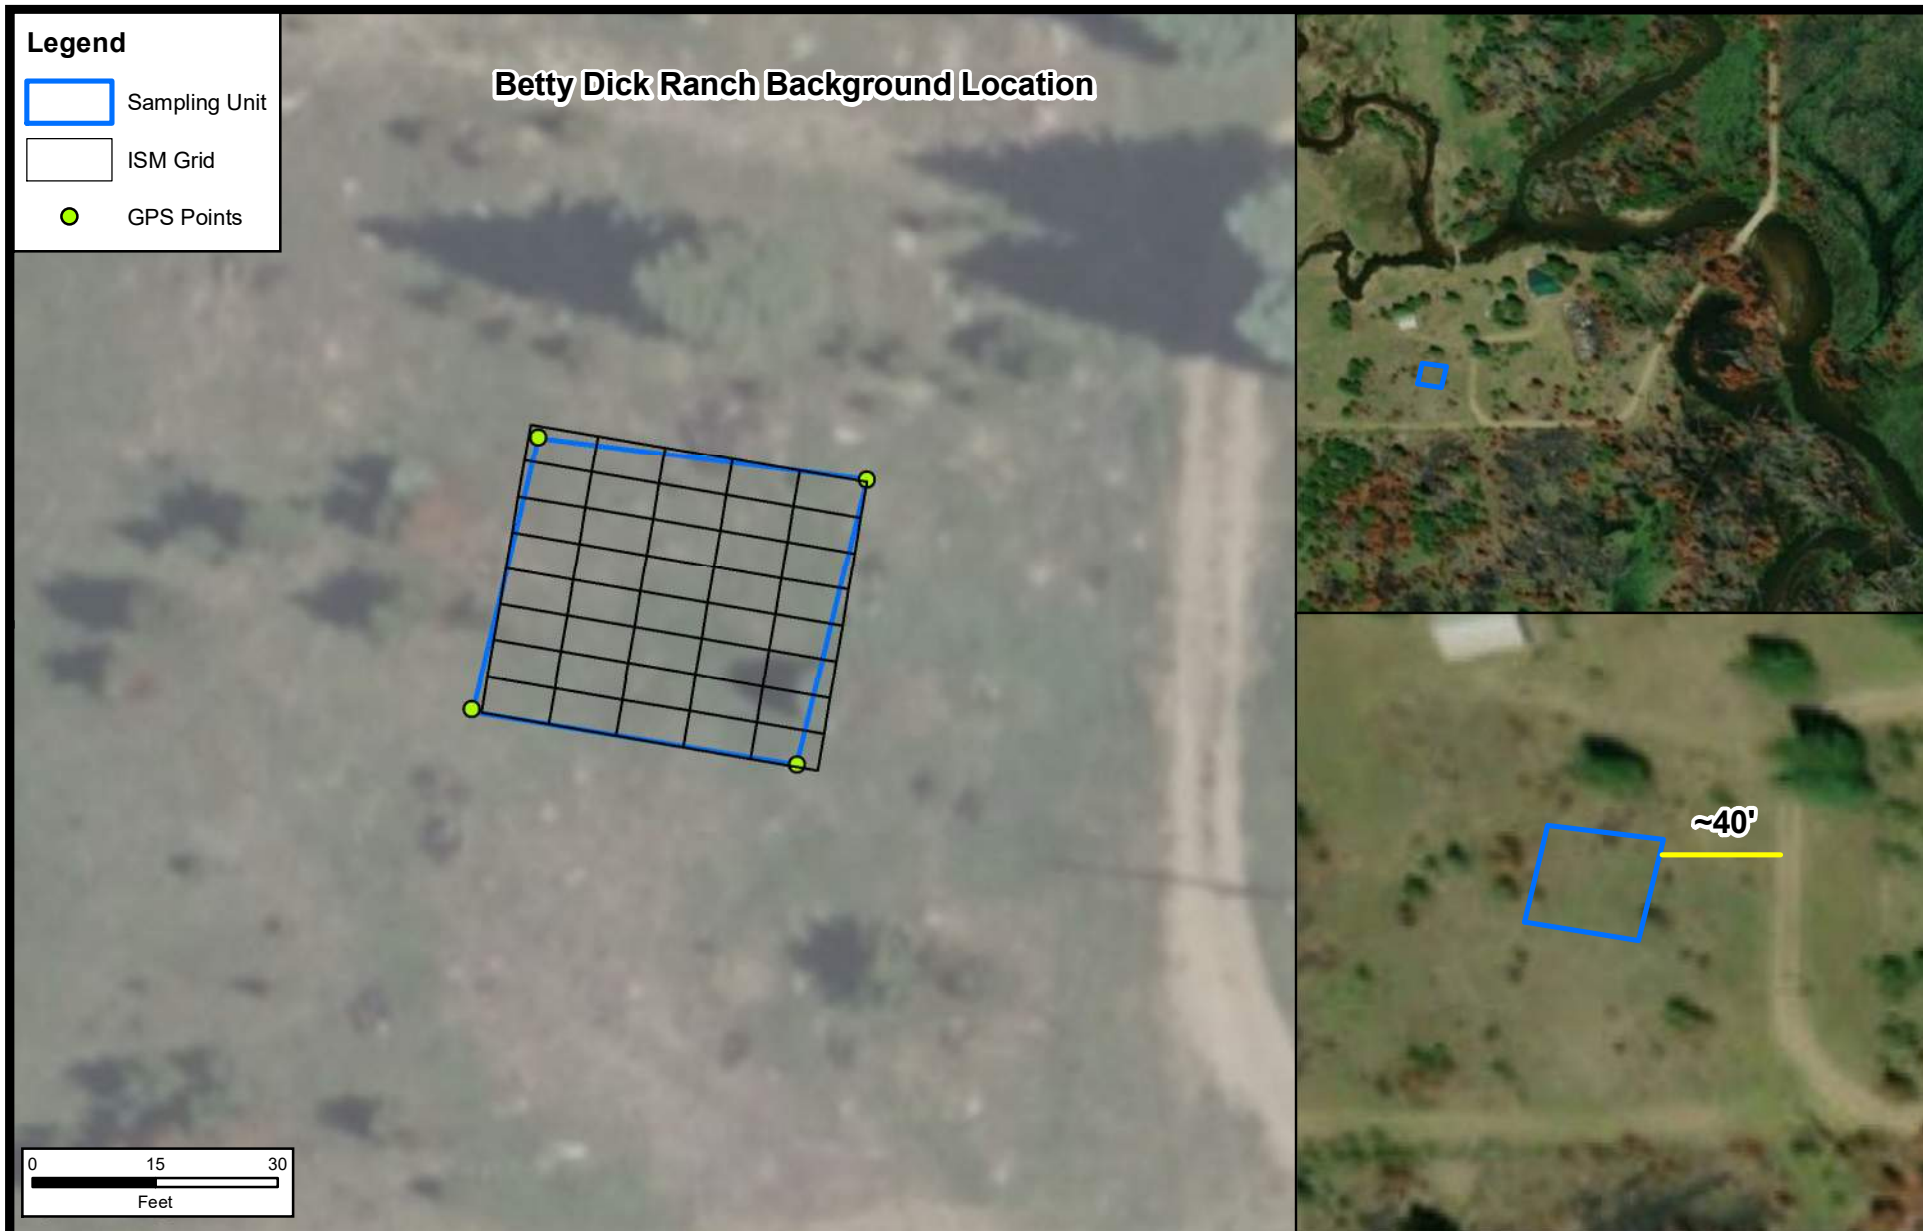
Figure 3d
Betty Dick Ranch Background Location
Betty Dick Ranch Area
Time Critical Removal Action Site Inspection Sampling and Analysis Plan
Rocky Mountain National Park - Estes Park, CO

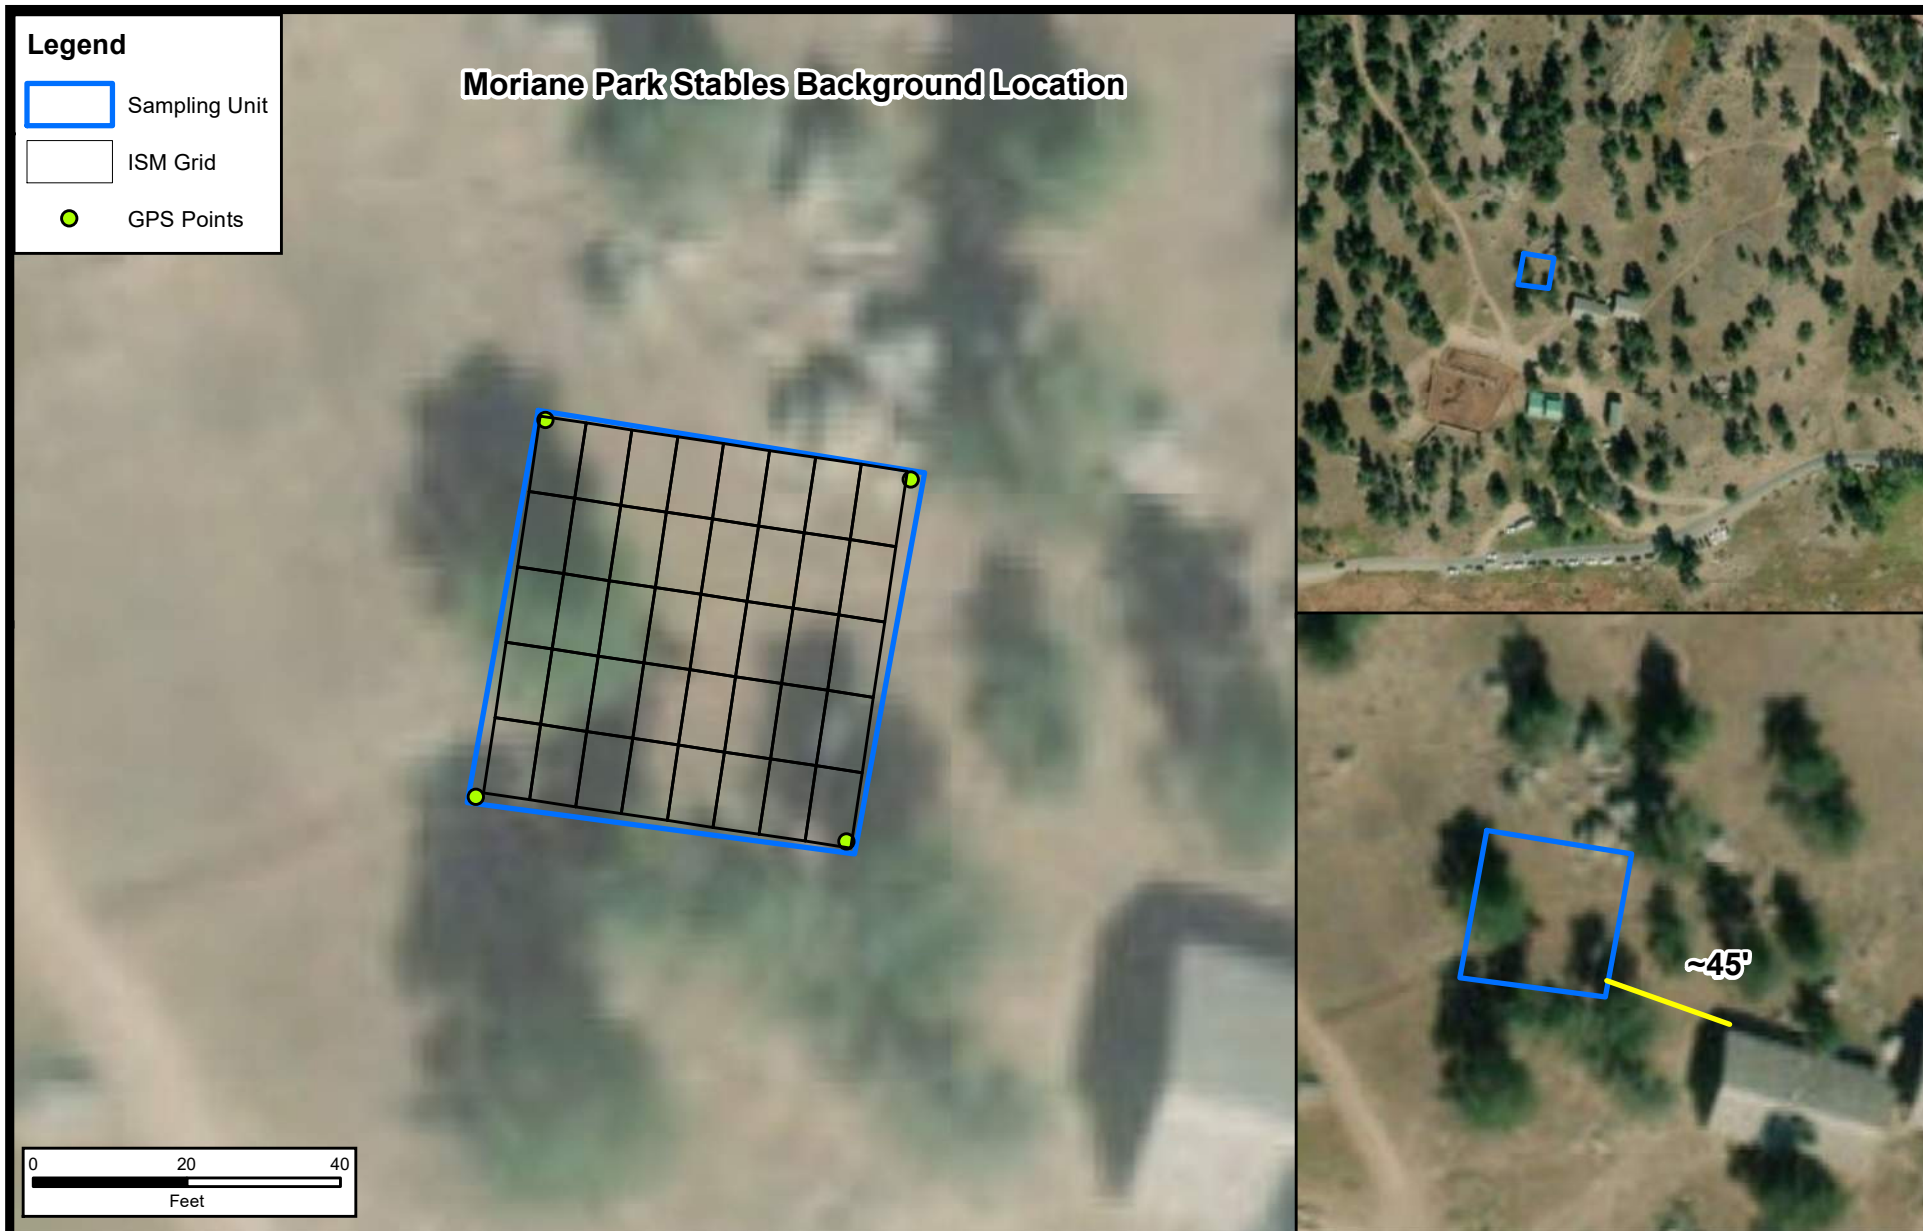
Figure 3e
Moraine Park Stables Background Location
Moraine Park Stables Buildings
Time Critical Removal Action Site Inspection Sampling and Analysis Plan
Rocky Mountain National Park - Estes Park, CO

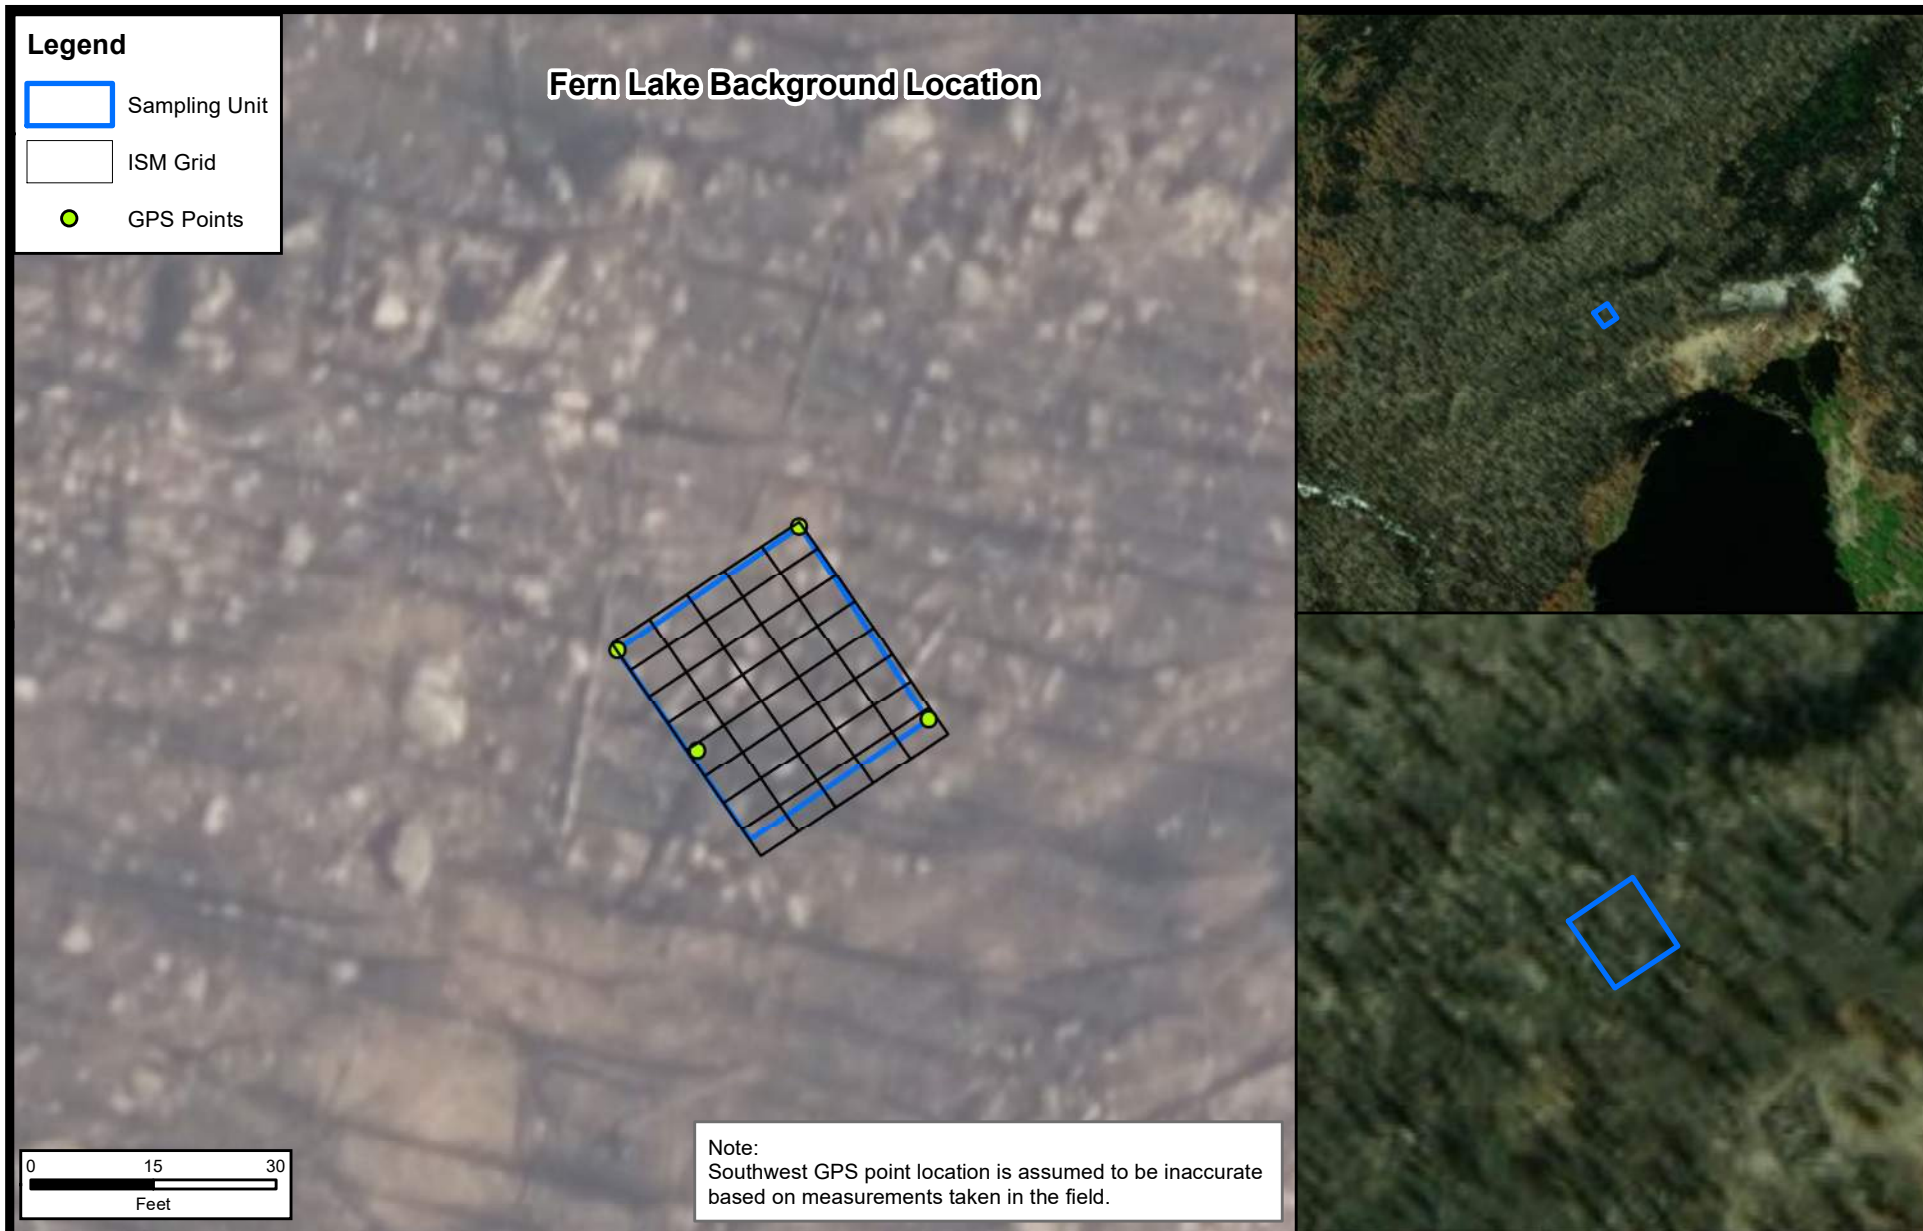
Figure 3f
Fern Lake Background Location
Fern Lake Buildings
Time Critical Removal Action Site Inspection Sampling and Analysis Plan
Rocky Mountain National Park - Estes Park, CO

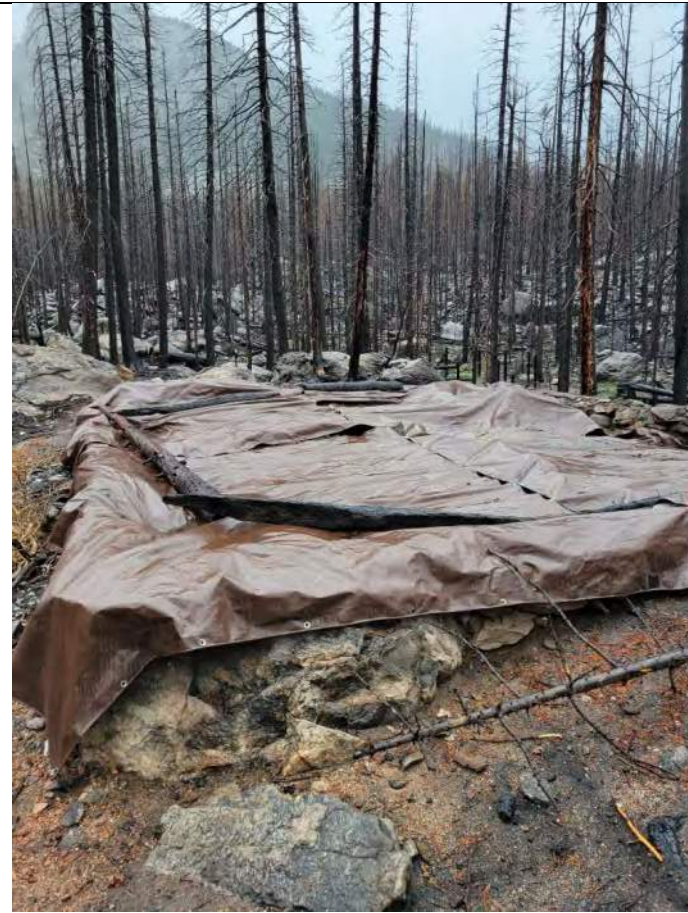
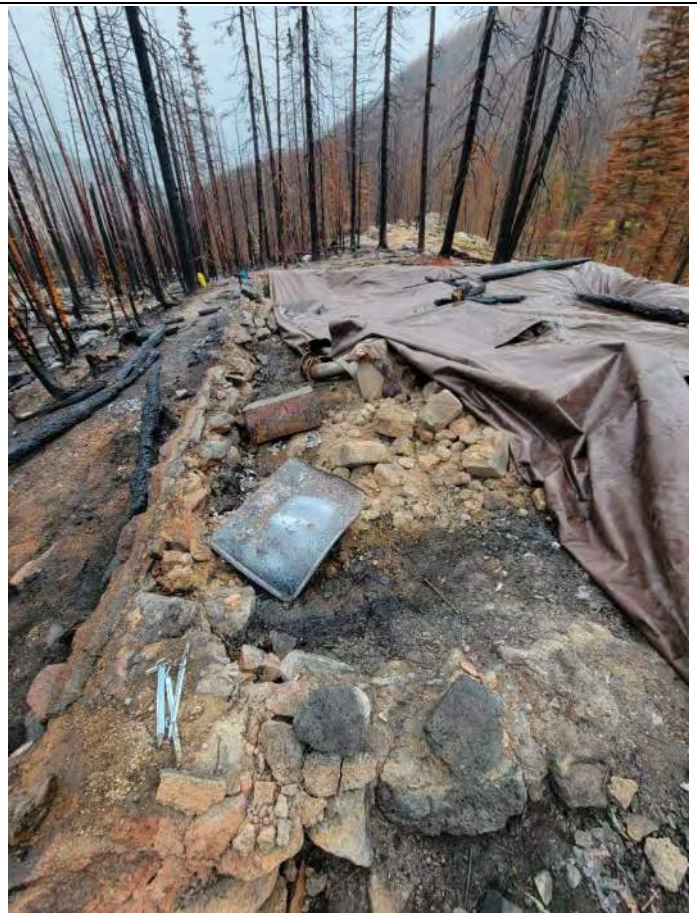
Building: B-0014, Fern Lake Patrol Cabin

After the fire event, burn areas were fenced off to limit access, erosion barriers were placed on downgradient slopes, and the Fern Lake Patrol Cabin Site (014) was covered by a tarp. Due to their front country locations, proximity to areas of public access, and physical safety hazards, NPS removed remaining standing structures, building debris and ash from the Grand Lake Entrance Station (1141) and Harbison Meadow Picnic Area Vault Toilet (1183) in 2021. A concessionaire removed ash and building debris from the Moraine Stables Bunkhouse (893) and Moraine Stables Dorm (1086) shortly after the fire in 2020. To reduce physical safety hazards, NPS removed large debris from the Fern Lake Patrol Cabin (014), leaving smaller debris and ash. A concrete slab and other hard surfacing remain at the Grand Lake Entrance Station (1141). In 2022, Harbison Meadow Picnic Area Vault Toilet (1183) was completely removed and rebuilt in approximately its original location. Shallow surface soils within an approximate five-to-eight-foot buffer surrounding concrete surfaces and structures at the Grand Lake Entrance Station (1141) and Harbison Meadow Picnic Area Vault Toilet (1183) were removed to a depth of approximately six inches during debris removal activities. Construction activity near the Timber Creek Road Camp Barn Tack Shed (572) resulted in the placement of a small amount of fill material within the burn site. It does not appear that potential contaminated debris or soil was removed from the Tack Shed area.

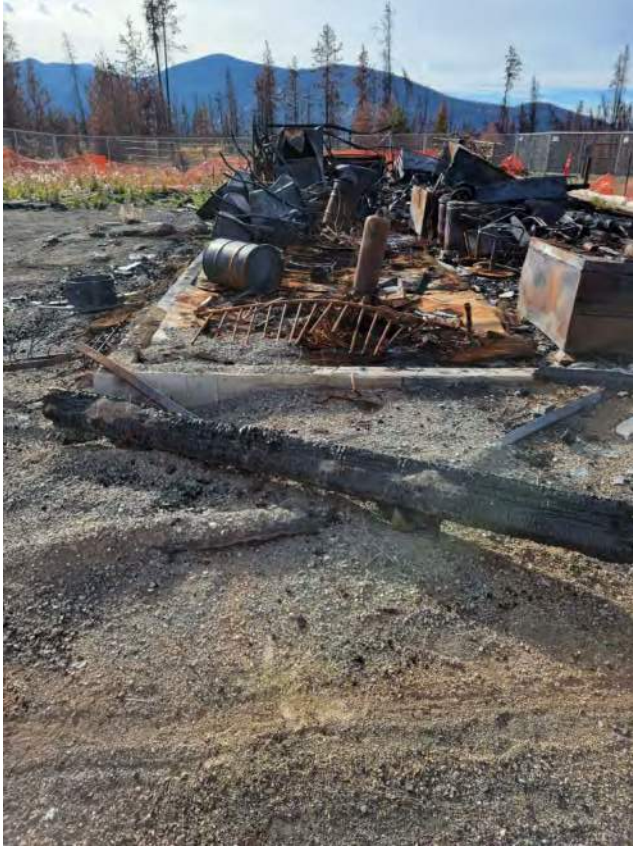
East Troublesome Fire Damaged Structures
Rocky Mountain Nation Park

Building: B-0572, Timber Creek Road Camp Barn Tack Shed
Park Region: Colorado River District
Date: 10/8/2021

Eight burned structures were analyzed for TCLP metals; only the Timber Creek Road Camp Tack Shed (572) burned structure failed TCLP analysis for lead. Therefore, the ash/soil at this site should be classified as hazardous waste.

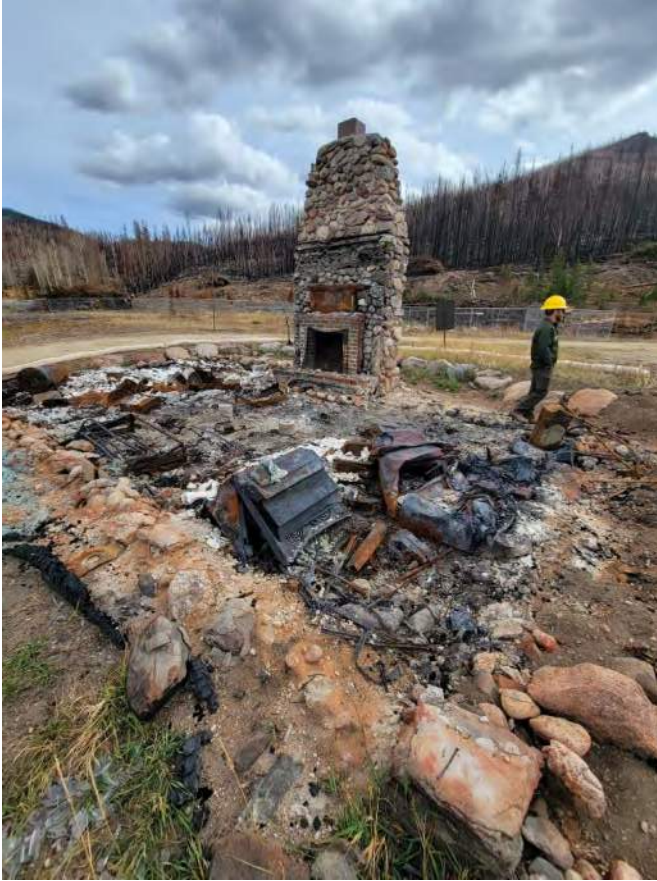
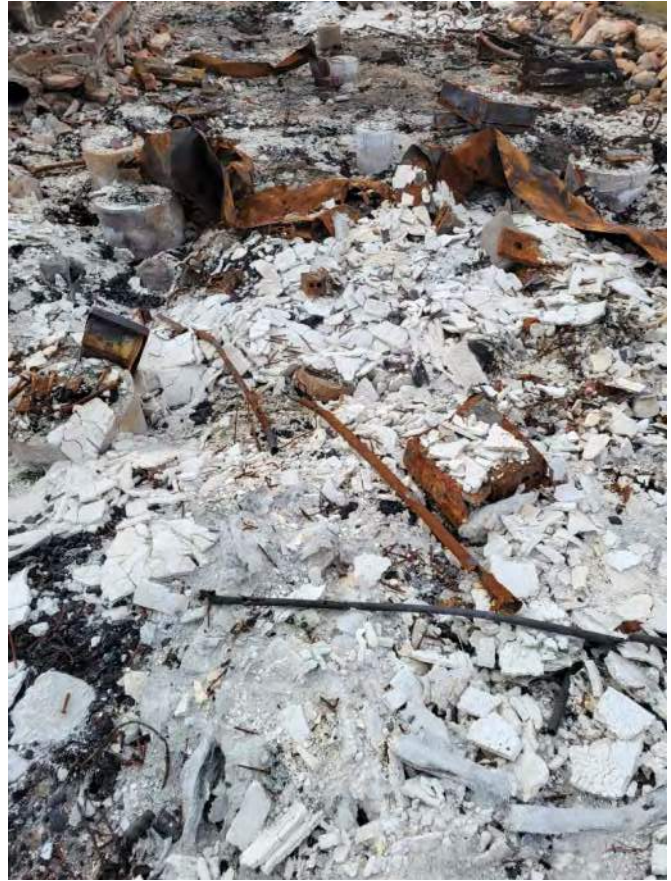
Building: Q-0731, Green Mountain Ranch Mineral Cottage
Park Region: Colorado River District
Date: 10/8/2021

these are more likely to have burned than to have been released to the ground. Asbestos was previously detected in buildings GMR Mineral Cottage (731) and GMR Arapaho Cottage (733). Other potential hazardous materials such as custodial chemicals, aerosols, and compressed gasses (e.g., propane) may have been present in small quantities, and likely consumed by the fire. Polynuclear aromatic hydrocarbons (PAHs) will have been released as the buildings burned, but because burning forests also release PAHs, NPS presumes that a cleanup of other hazardous substances will also address building-related PAHs.
